Town of Valdese
Public Safety Building Report
2021

Re: Inspection of Cracks in Building for
Fire Department and Police Department

VALDESE FIRE DEPARTMENT
Public Safety Buidling Inspection

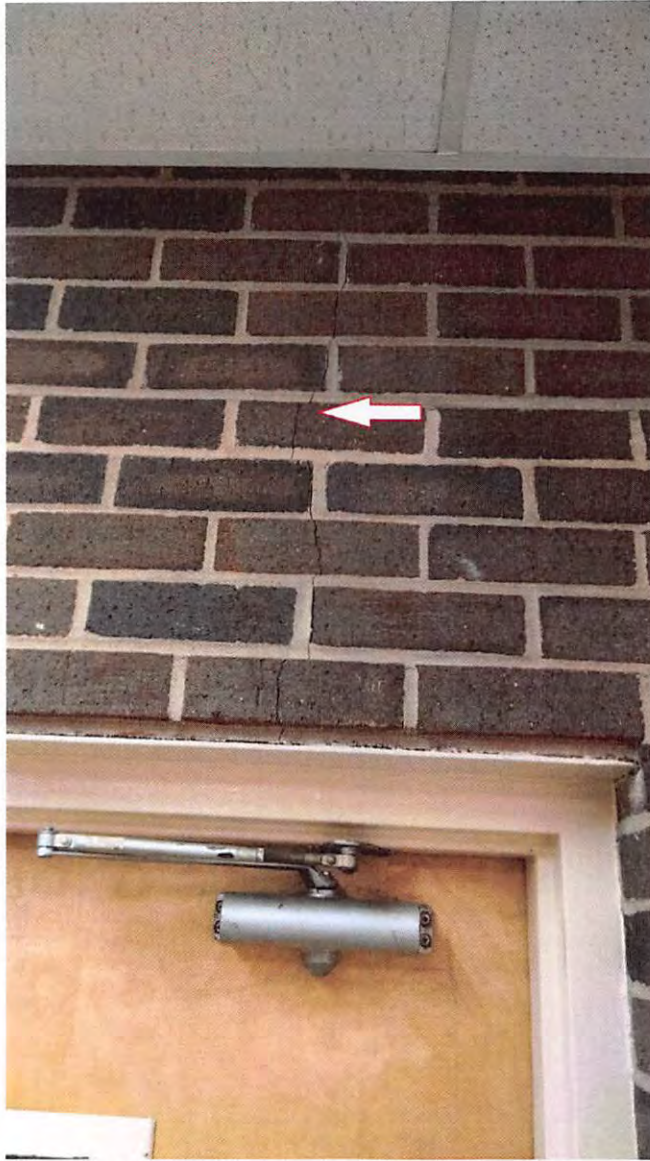
VERTICAL CRACK ABOVE DOOR NEAR FIRE CHIEF'S OFFICE.

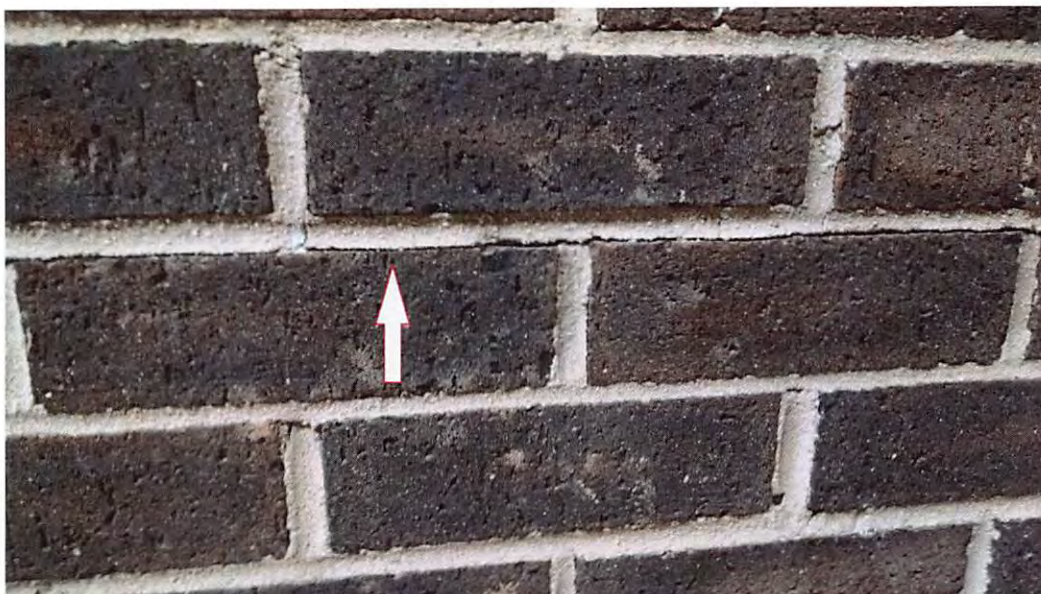
HORIZONTAL CRACK IN WALL IN LOUNGE AREA. THIS IS AN INTERIOR WALL.

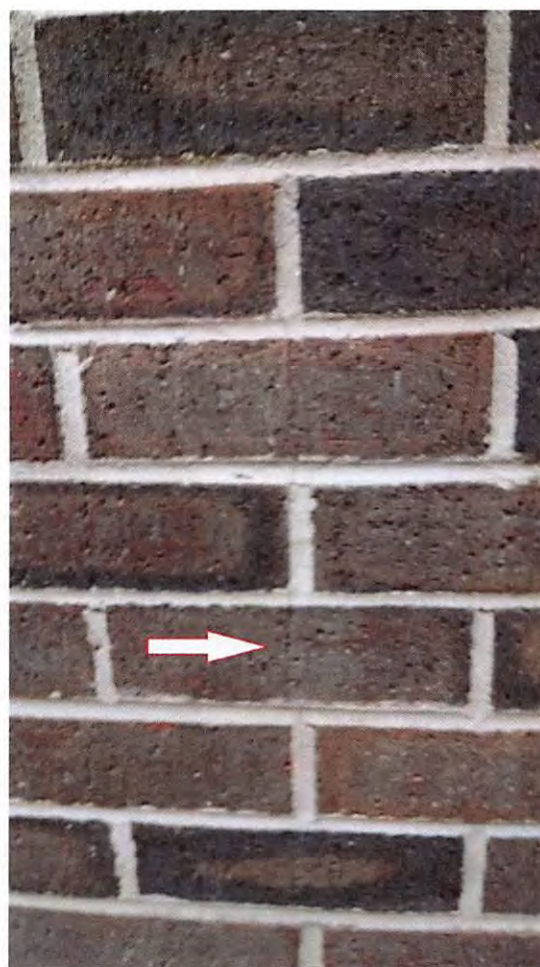
VERTICAL CRACK BEGINNING IN LOUNGE AREA WALL.

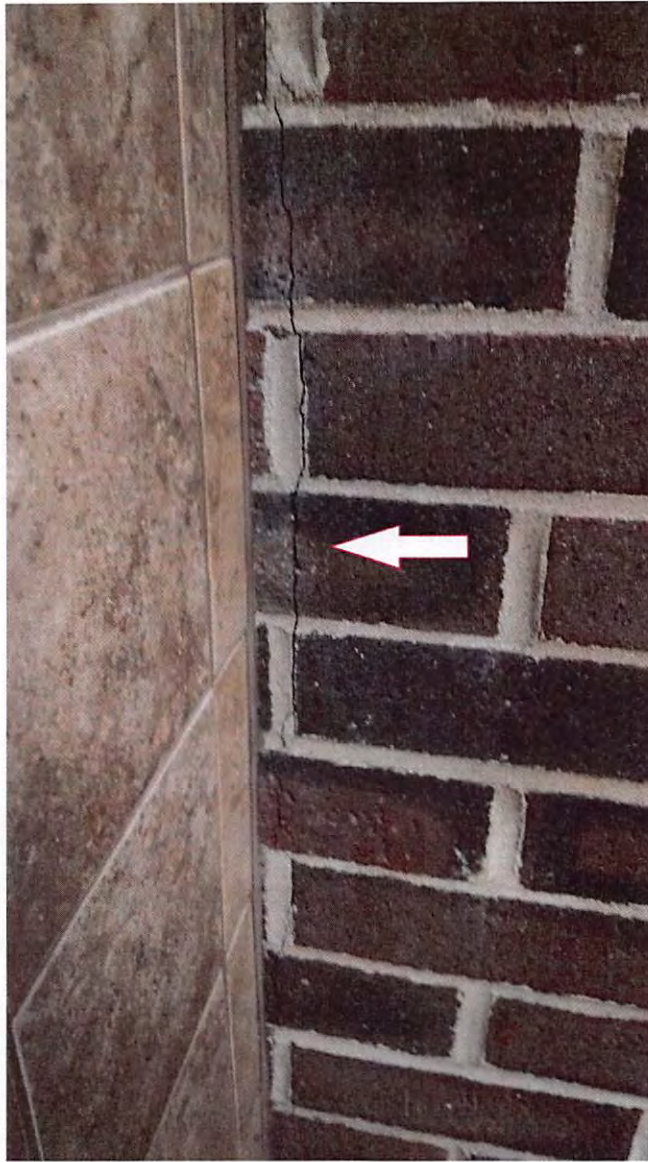
VERTICAL CRACK IN WALL IN MEN'S RESTROOM. THIS IS AN INTERIOR WALL.

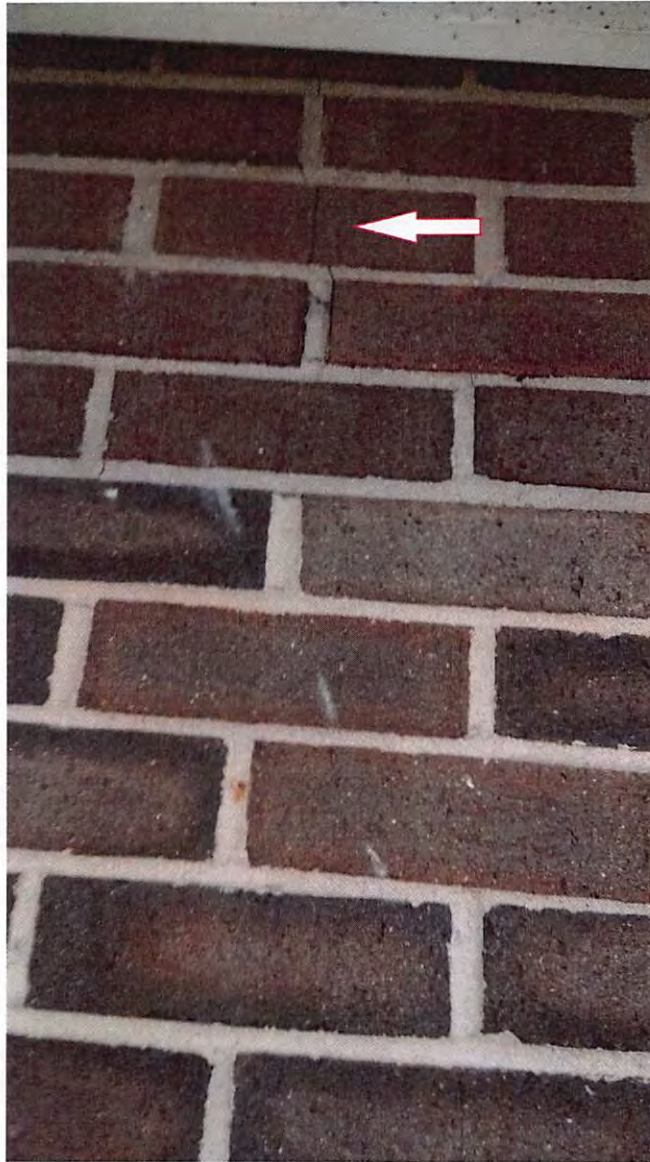
VERTICAL AND HORIZONTAL CRACKS IN INTERVIEW ROOM WALL. THIS WALL IS AN EXTERIOR WALL.

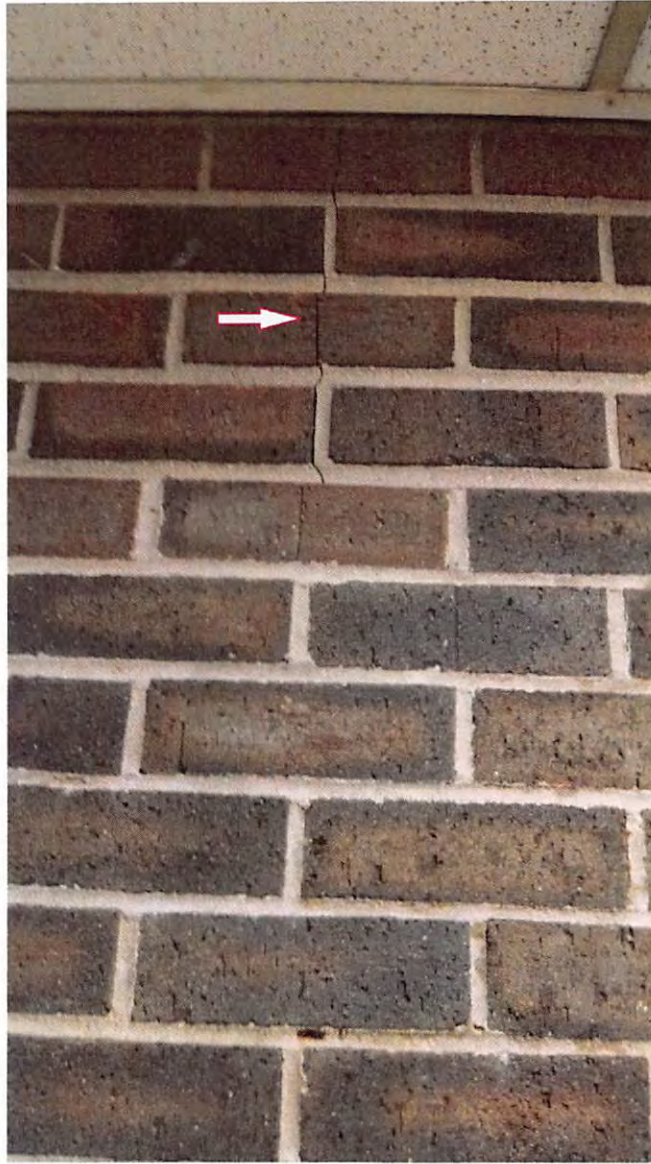
VERTICAL CRACK IN FINGERPRINTING ROOM WALL. THIS WALL IS AN EXTERIOR WALL.

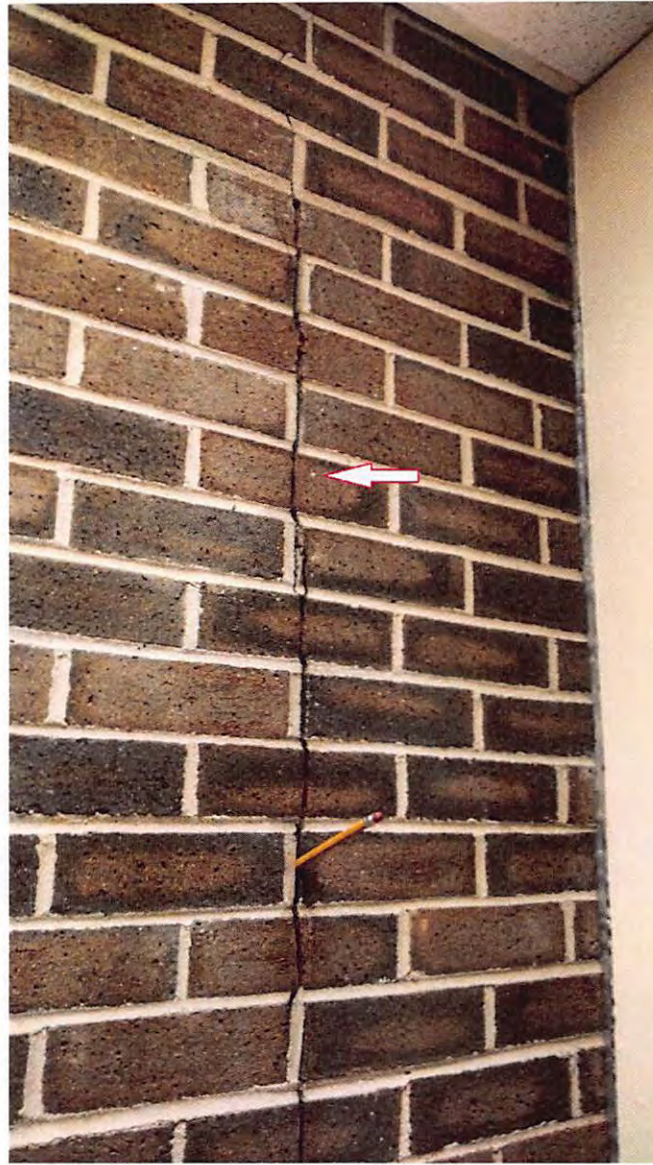
VERTICAL CRACK IN FINGERPRINTING ROOM WALL. THIS WALL IS AN EXTERIOR WALL.

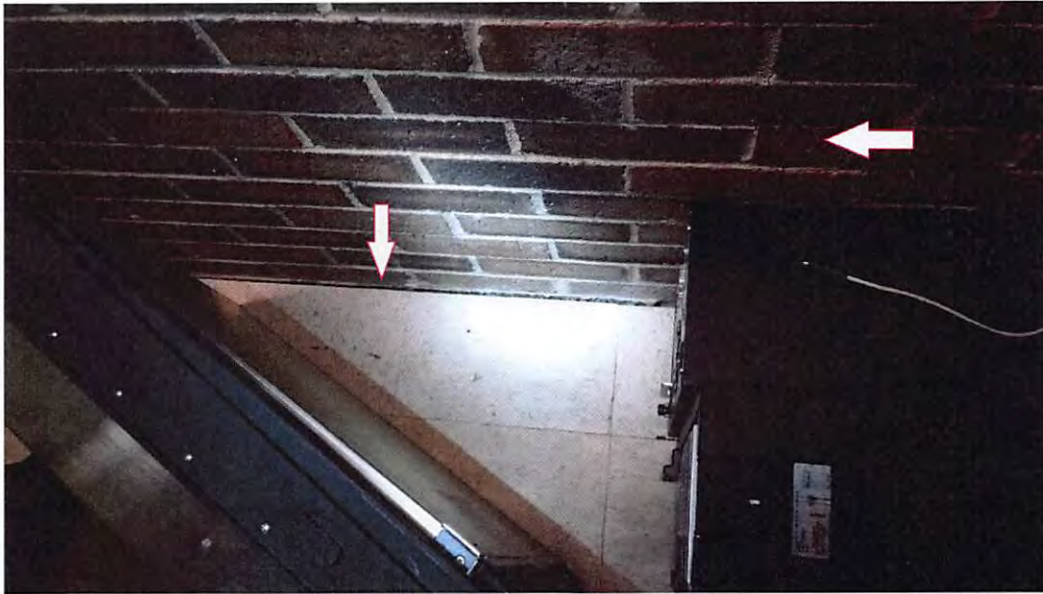
HORIZONTAL AND VERTICAL CRACK IN WALL IN SERVER ROOM. FLOOR HAS ALSO SUNKEN AND MOVED AWAY FROM WALL.

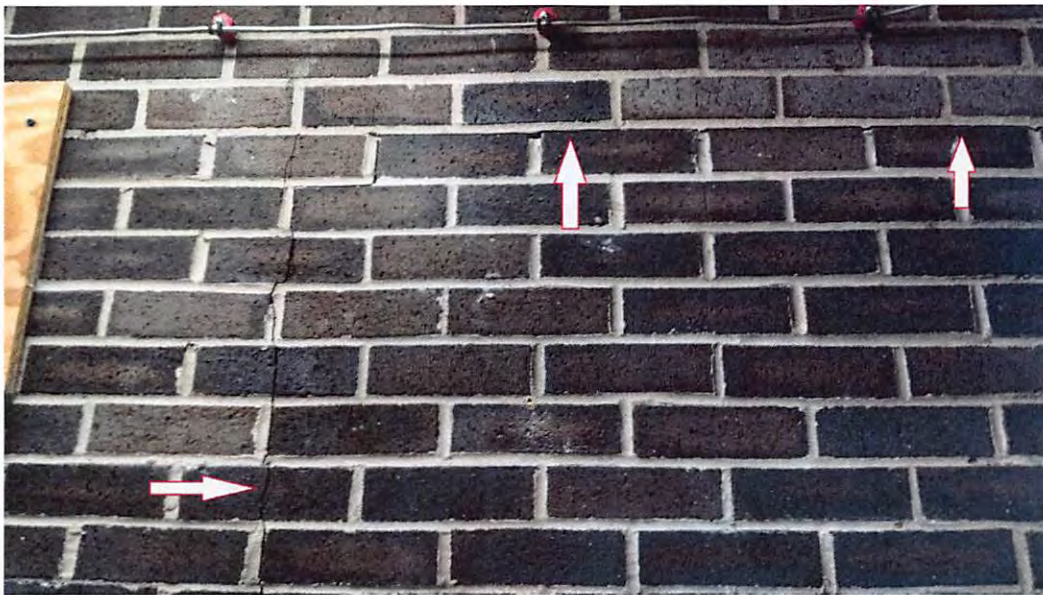
HORIZONTAL AND VERTICAL CRACK IN WALL IN SERVER ROOM.

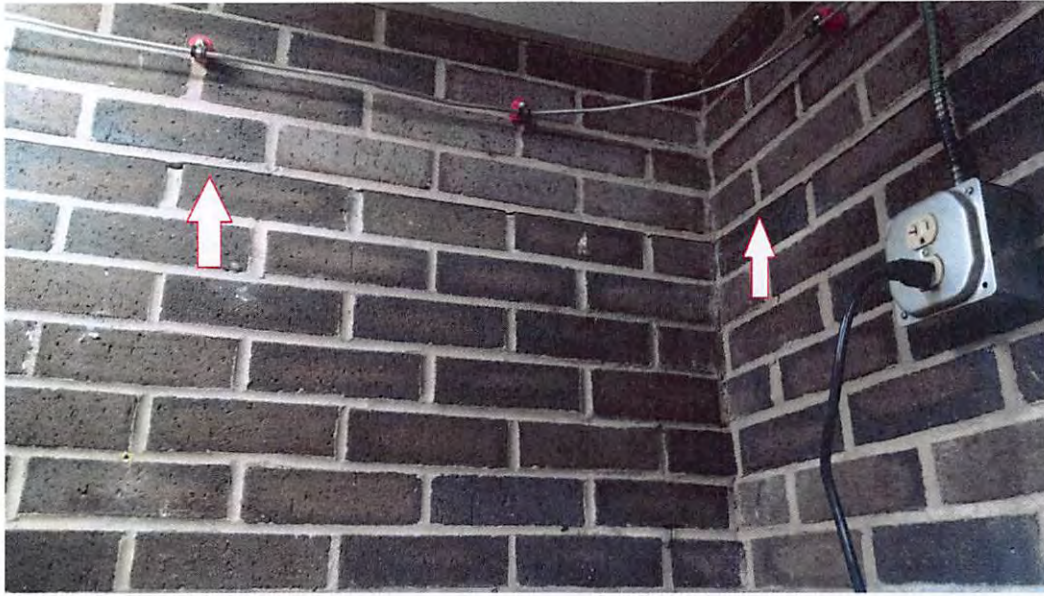
HORIZONTAL CRACK ALONG WALL IN SERVER ROOM.

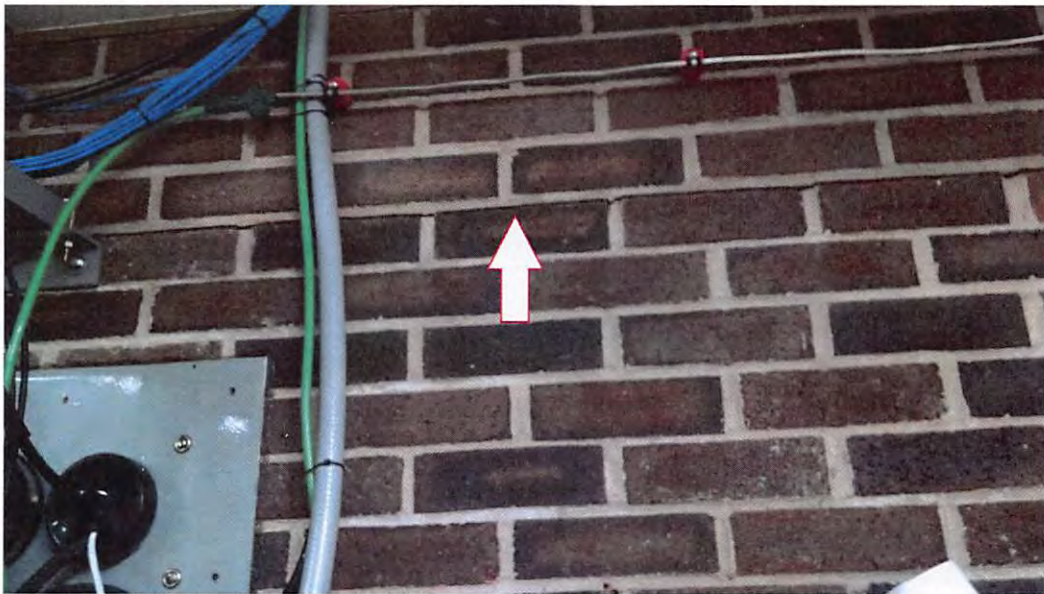
HORIZONTAL CRACK ALONG WALL IN SERVER ROOM.

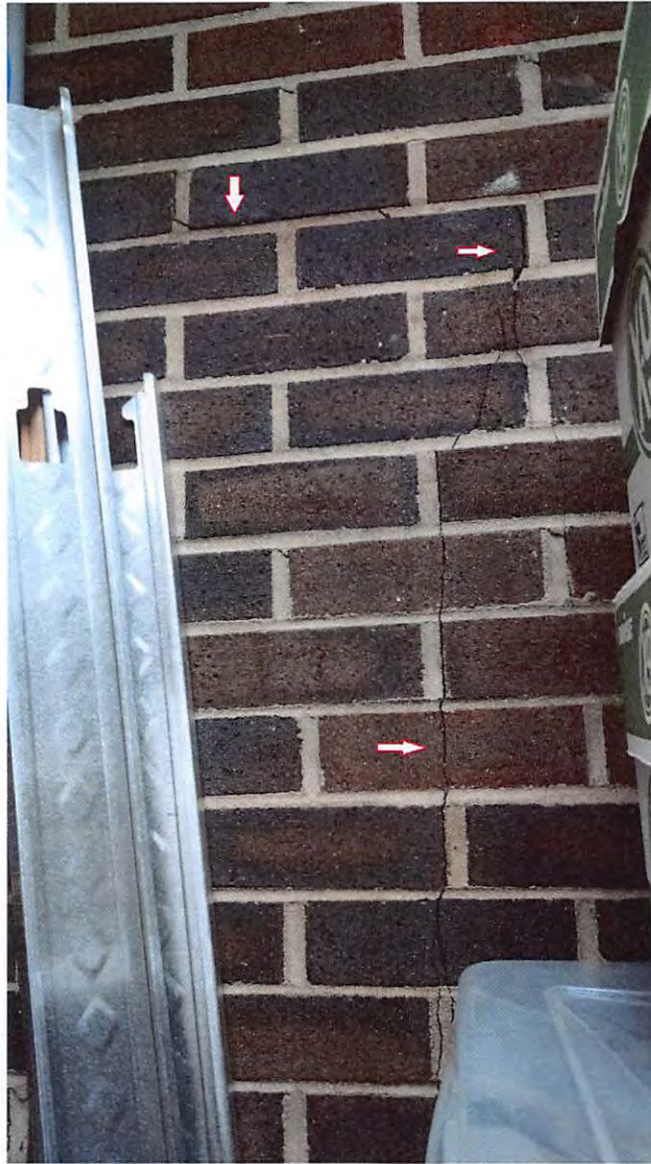
HORIZONTAL AND VERTICAL CRACK IN WALL IN ARMS ROOM.

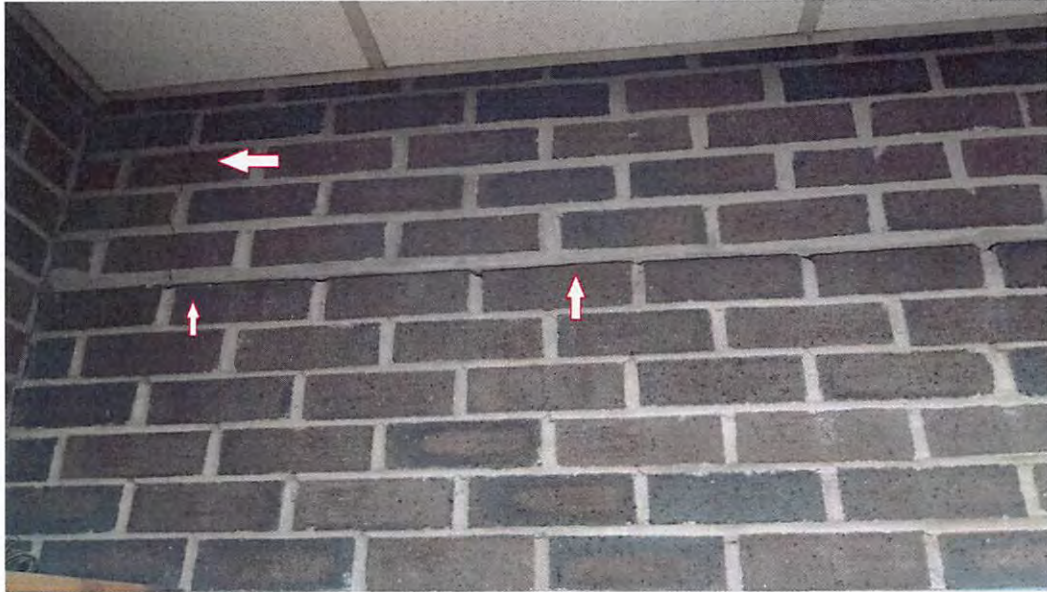
VIEW OF A DIFFERENT HORIZONTAL AND VERTICAL CRACK IN WALL OF ARMS ROOM.

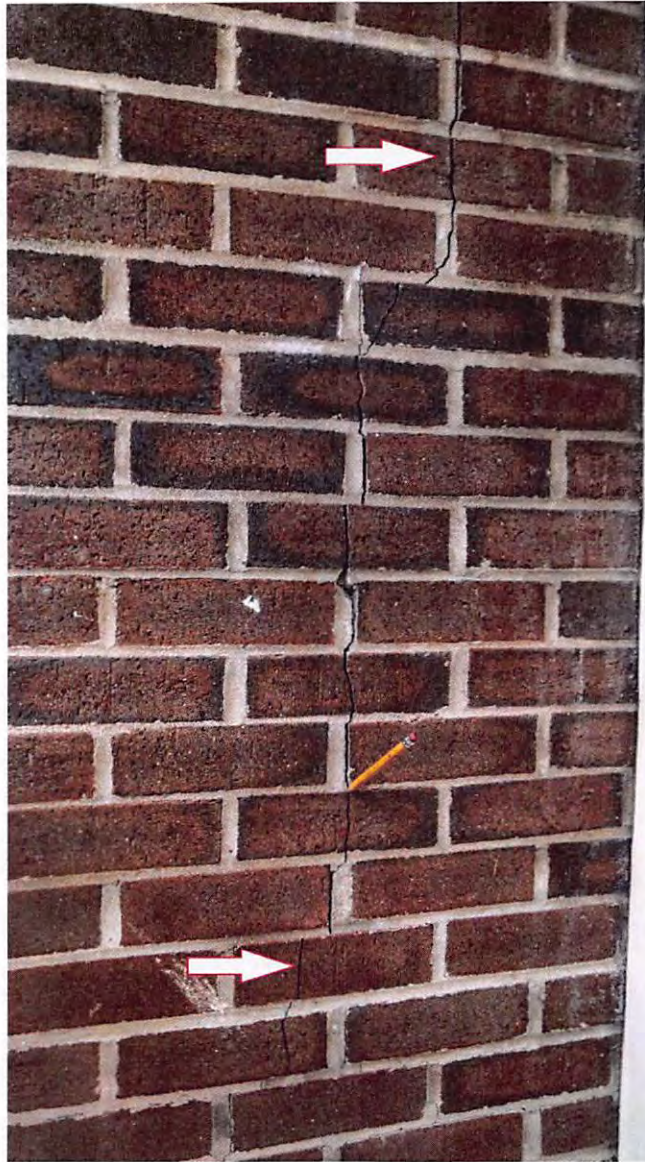
VERTICAL CRACK IN WALL IN WALL IN SQUAD ROOM. THIS IS AN EXTERIOR WALL.

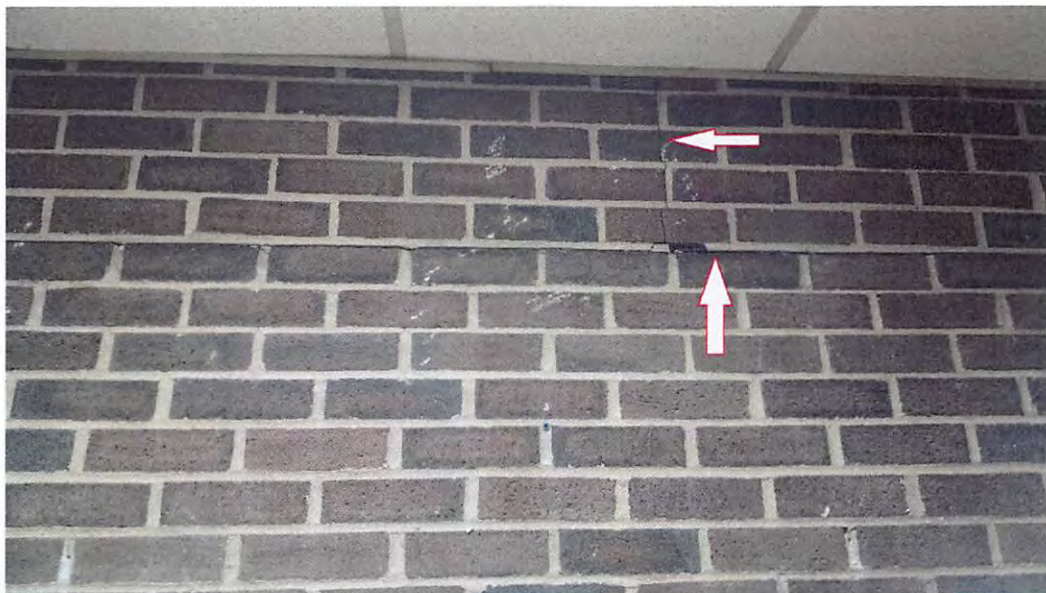
ANOTHER VIEW OF THE SAME CRACK IN SQUAD ROOM SHOWING VERTICAL PORTION OF CRACK.

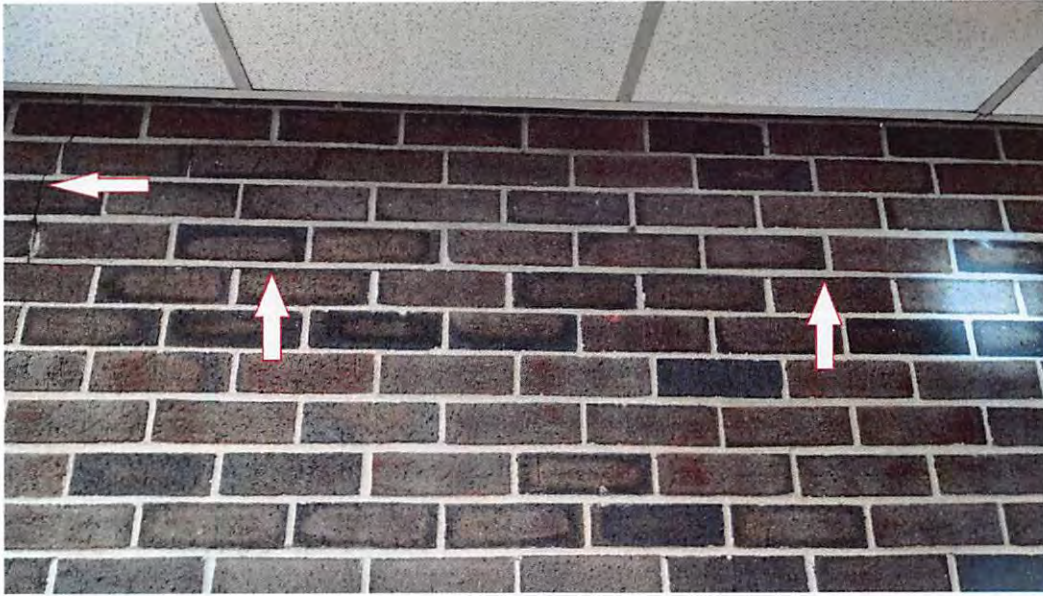
HORIZONTAL AND VERTICAL CRACK IN WALL OF POLICE CHIEF'S OFFICE. THIS IS AN EXTERIOR WALL.

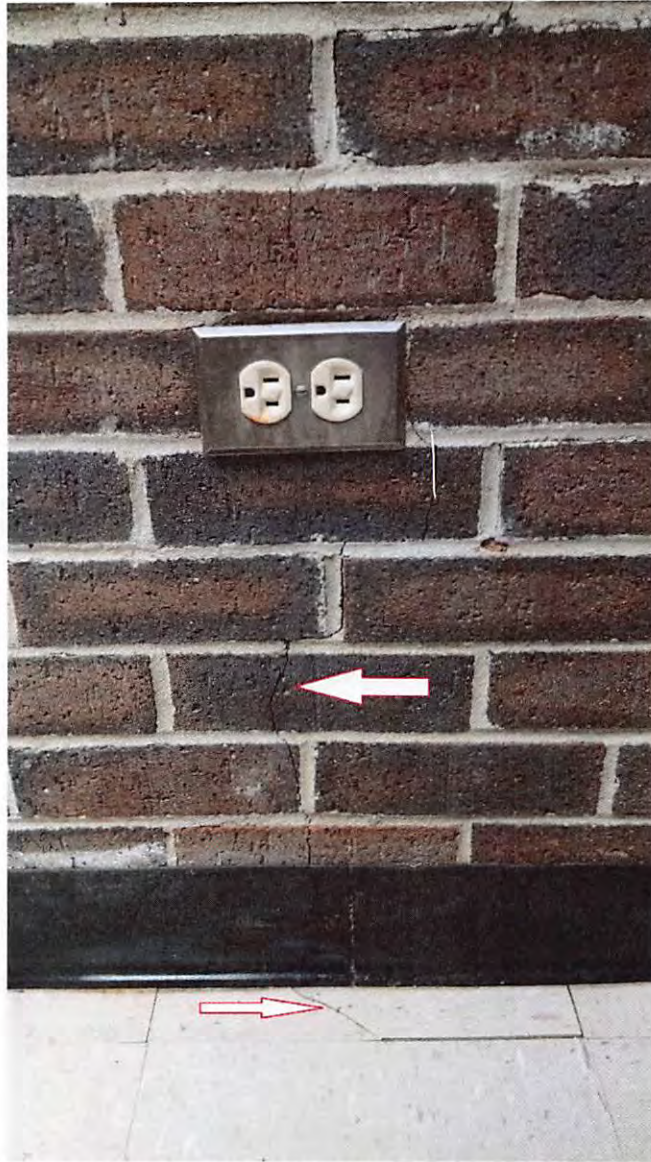
ANOTHER CRACK IN WALL IN POLICE CHIEF'S OFFICE. THIS IS AN EXTERIOR WALL.

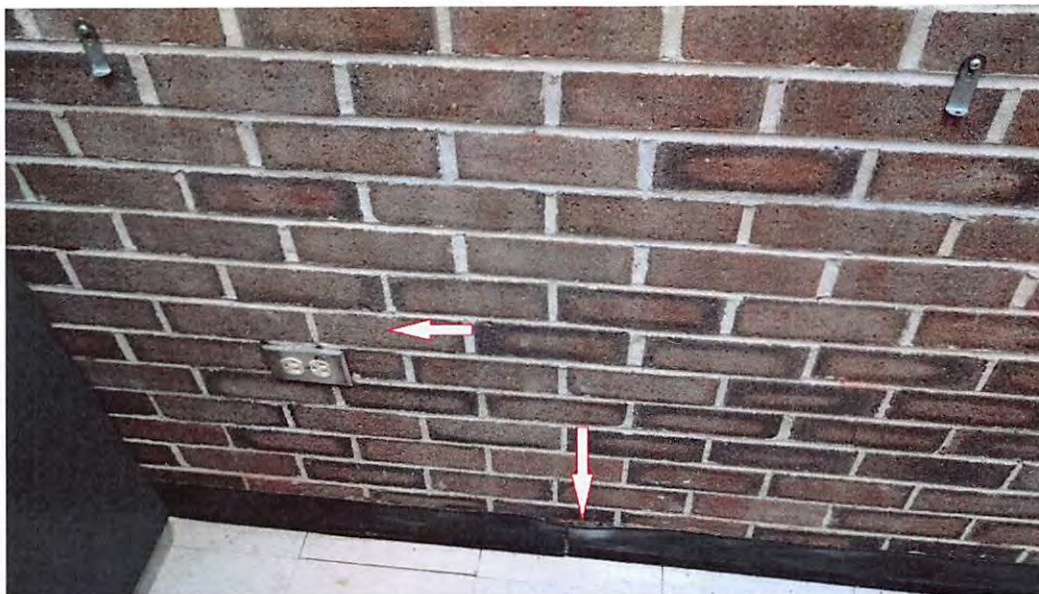
VIEW OF ANOTHER CRACK IN WALL OF POLICE CHIEF'S OFFICE. FLOOR IS SEPARATING FROM WALL. THIS IS AN EXTERIOR WALL.

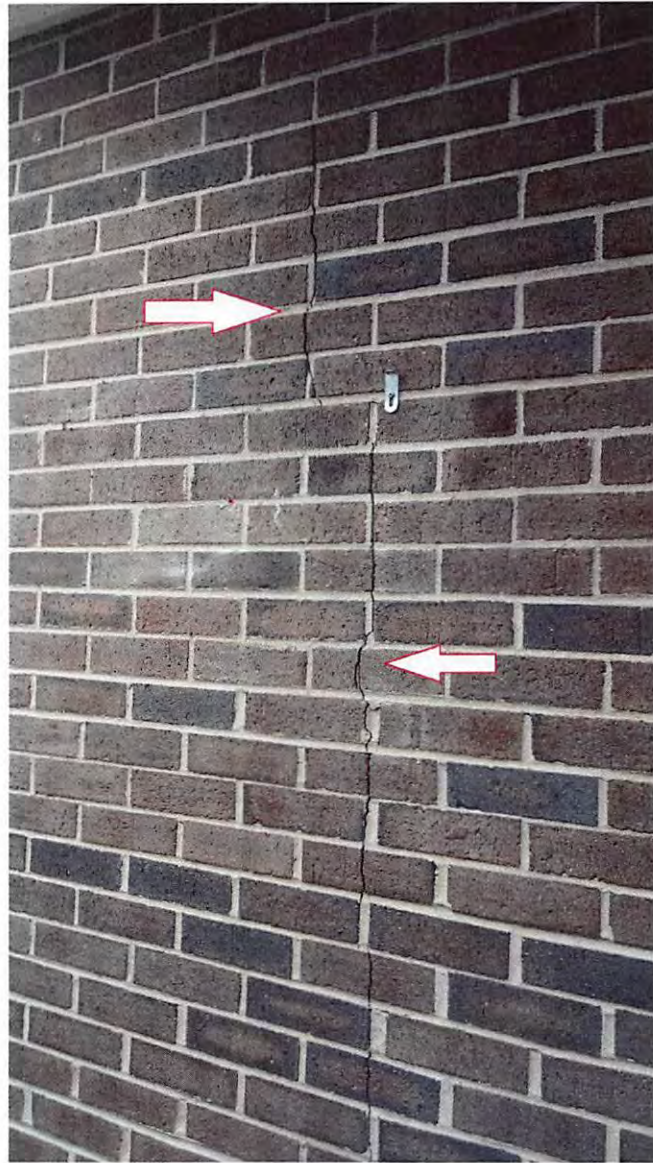
VERTICAL CRACK IN WALL OF POLICE CHIEF'S OFFICE. THIS CRACK EXTENDS FROM FLOOR TO CEILING. THIS IS AN EXTERIOR WALL.

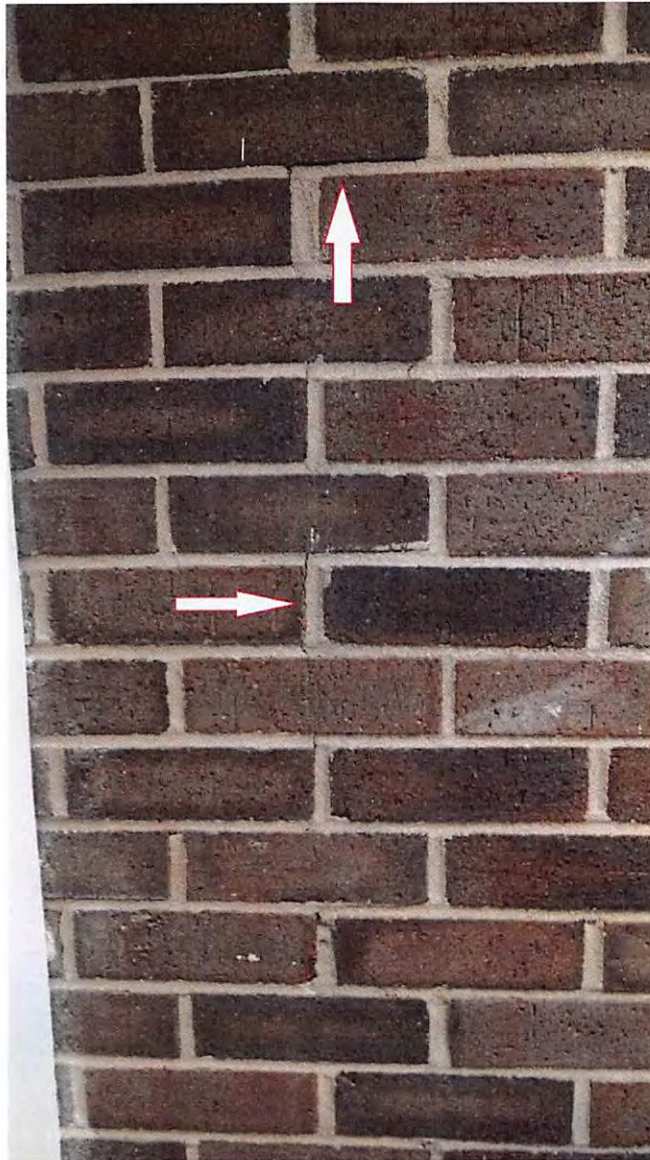
HORIZONTAL AND VERTICAL CRACK IN MEN'S RESTROOM IN LOBBY.

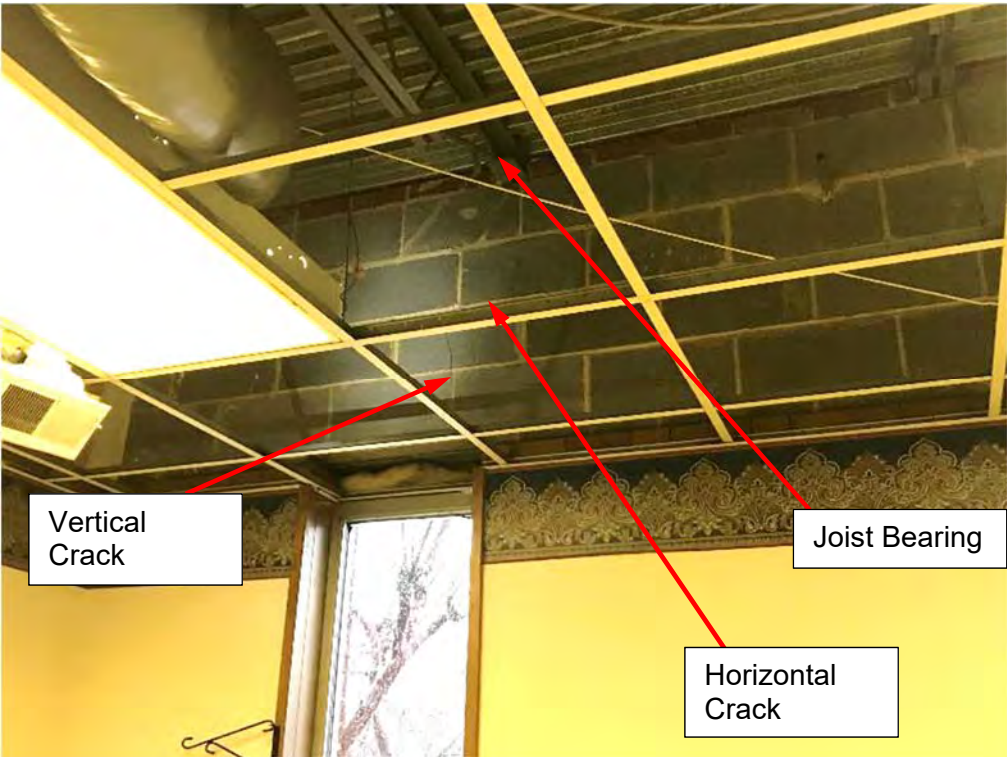
Photo 1 Town Hall – West Wall – Horizontal and Vertical Cracks

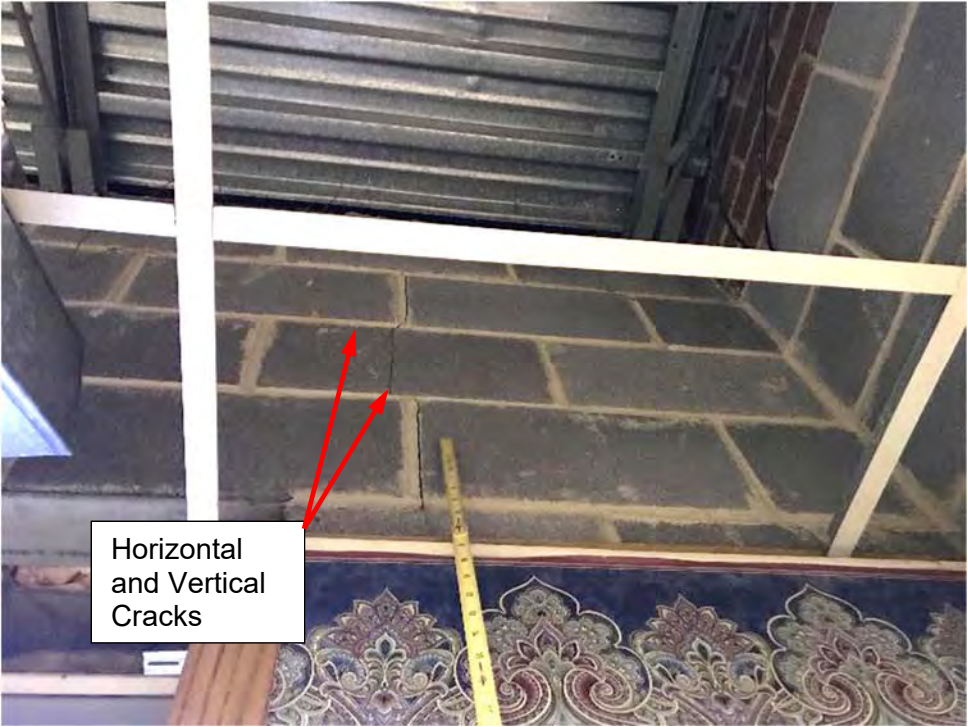
Vertical cracks are located at approximately 10 feet on center in the rear room of the building along the east exterior wall and part of the north wall. The cracks generally extend from floor to near the ceiling, but do not appear to extend above the reinforced bond beam at the top of the cmu interior wythe. It is reasonably obvious that the reason this is so is because the grouted and reinforced bond beam is restrained against cracking relative to the hollow unreinforced interior cmu wythe immediately below. Typical vertical cracks are depicted in Photos 2, 3, 4, and 5.

Photo 2 Town Hall – West Wall – Horizontal and Vertical Cracks

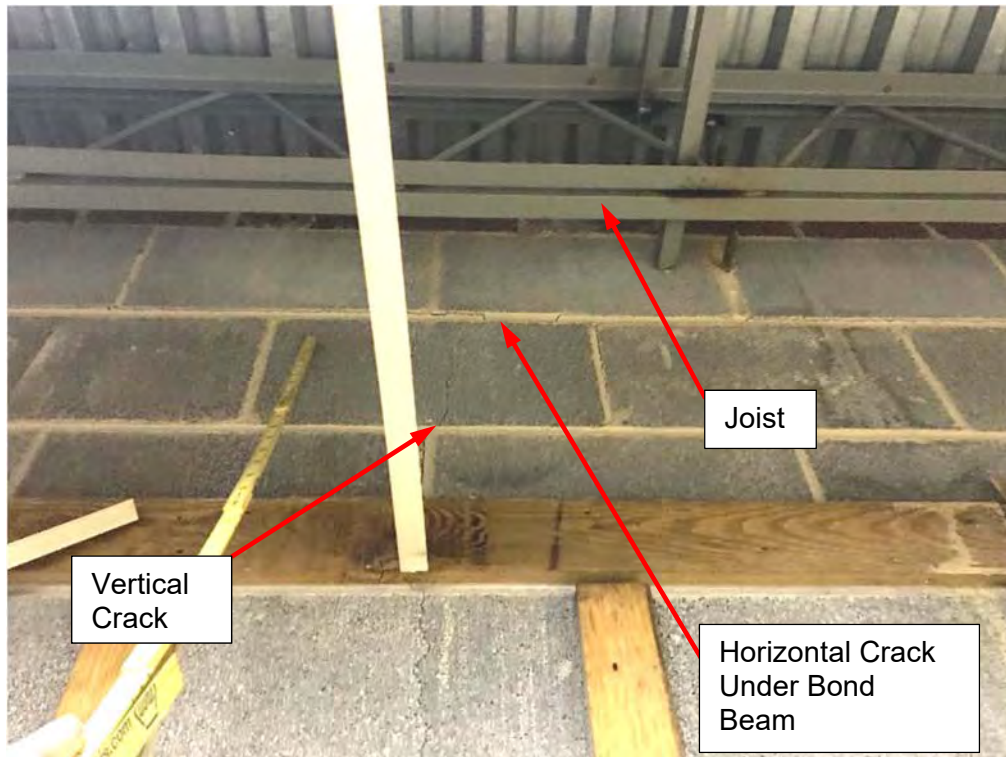
The horizontal cracks are typically located at the approximate elevation of the bottom of the steel reinforced Bond Beam, see Photo 3 and 4 and Figure 7. This condition persists along the north exterior wall and east exterior wall. Per Figure 7 from the Town Hall record drawings, the joint at the bottom of the bond beam is located at the crack elevation. In addition, the presumed horizontal joint reinforcing elevation is at the joint at the bottom of the bond beam. Horizontal joint reinforcing and the infilled bond beam appear to create a stress concentration at that elevation with respect out of plane loading.

The reason for the horizontal cracks appears to be out of plane loading induced at the roof elevation. Effectively the roof is pushing the top of the walls away from the center of the building which creates a crack on the inside face at the point of least resistance. This point is obviously the joint immediately below or near the bond beam. The exact reason for the out of plane loading in excess of the walls inherent strength is difficult to determine with the limited observation conducted to date. However, it stands to reason that the loading is attributable to differential expansion or contraction of the roof and/or wall footprint respectively. In the roof expansion case, the roof would have expanded under thermal load and pushed the walls outward. In the latter contraction case, the interior fill of the building would have contracted due to drying of the soil underneath or shrinkage of the interior floor slab. This contraction would tend to pull the walls inward creating the outward pressure on the walls from the roof. In either case, the inherent lack of strength in tension for masonry is why the wall cracked from the induced out of plane bending. Once cracks like these open, it is often the case that they never fully close even if the expansive force is later reversed due to change in season or otherwise.

Photo 3 Town Hall – South Wall – Horizontal and Vertical Cracks

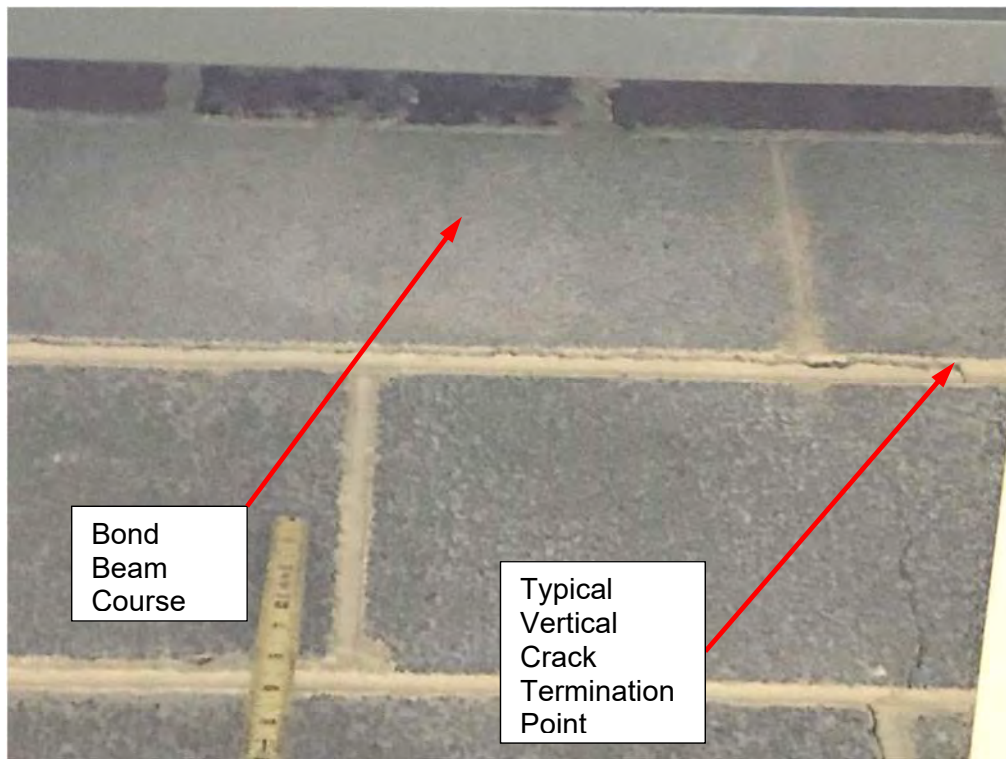
Photo 4 Town Hall – South Wall – Horizontal and Vertical Cracks

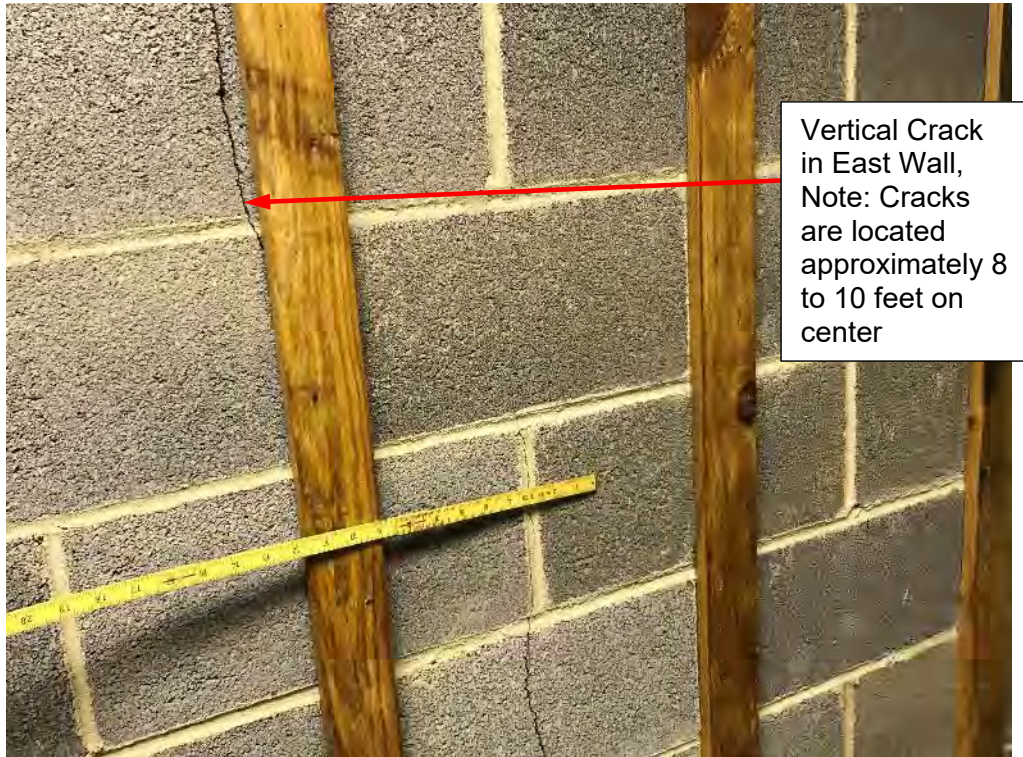
Photo 5 Town Hall – East Wall – Vertical Cracks

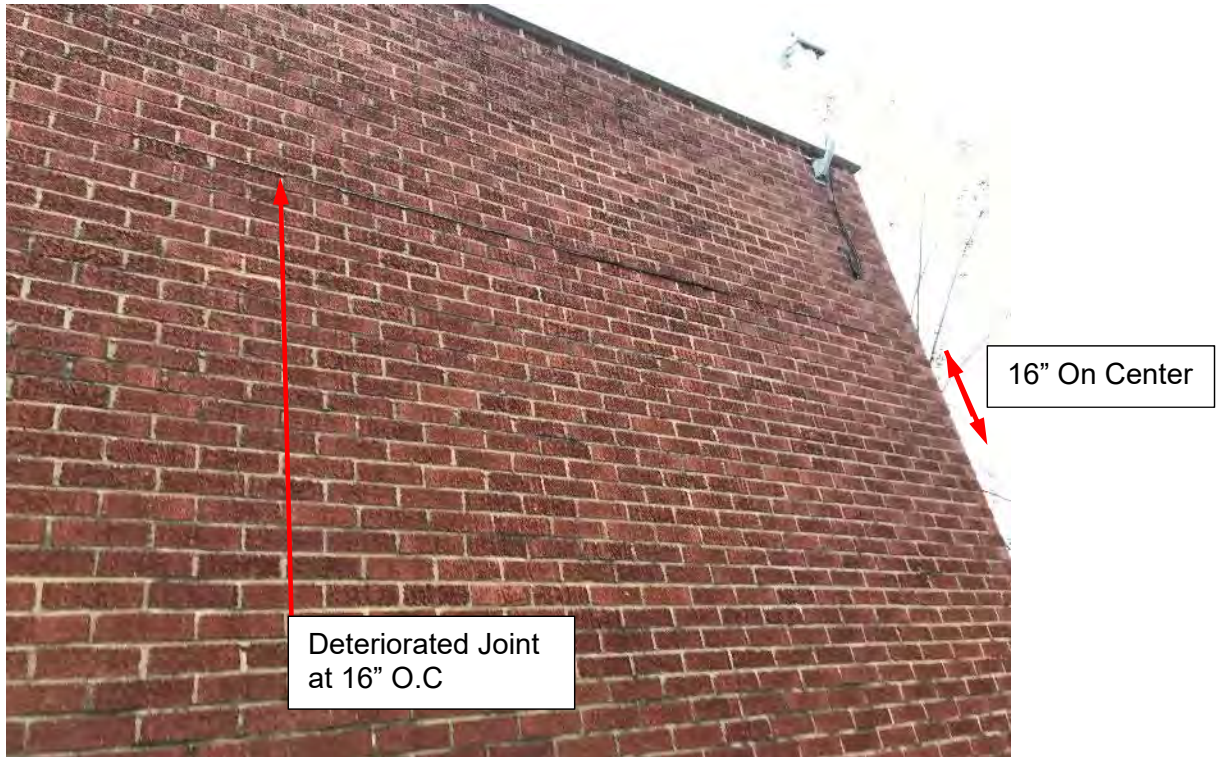
Photo 6 Town Hall – South Wall – Deteriorated Joints

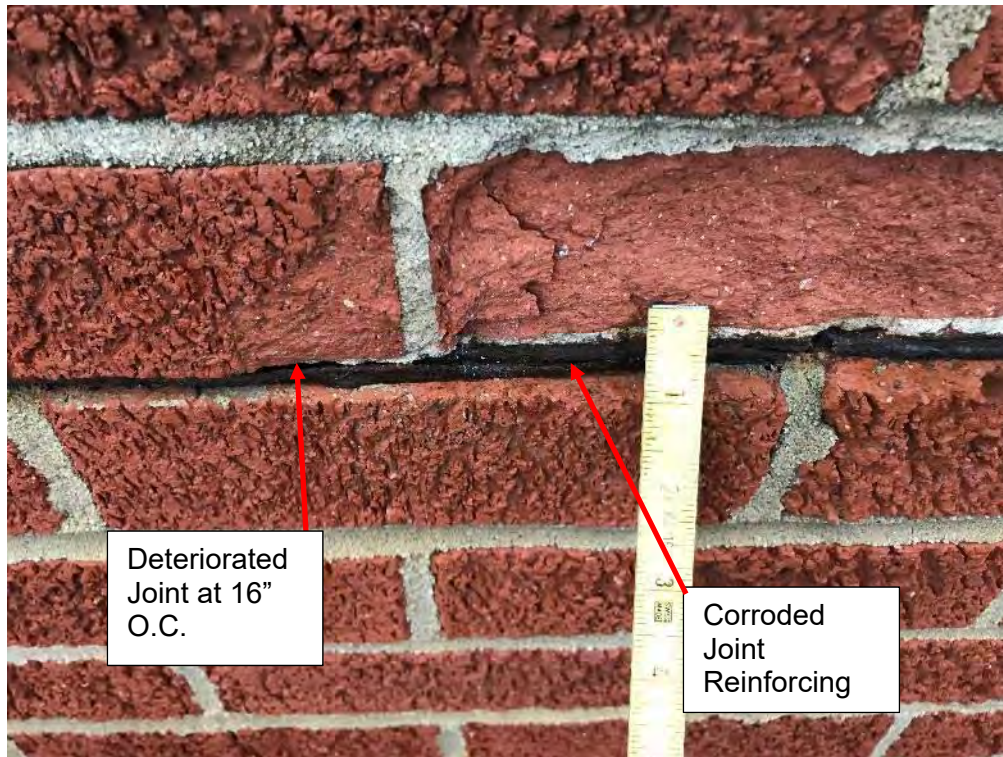
Photo 7 Town Hall – South Wall – Deteriorated Joints

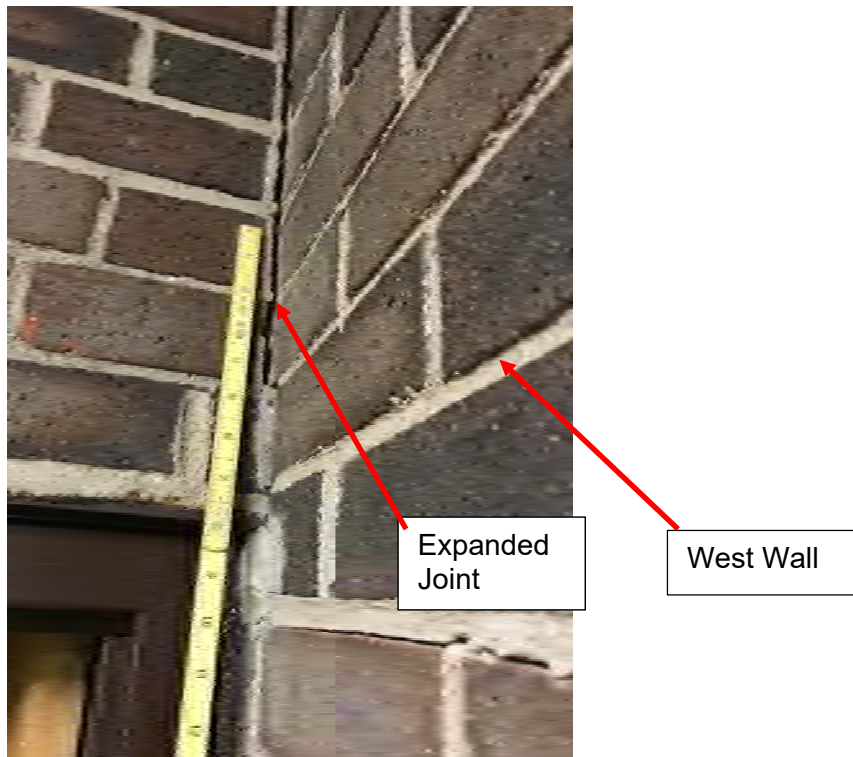
Photo 8 Public Safety Building – West Wall – Expanded Joint/Crack

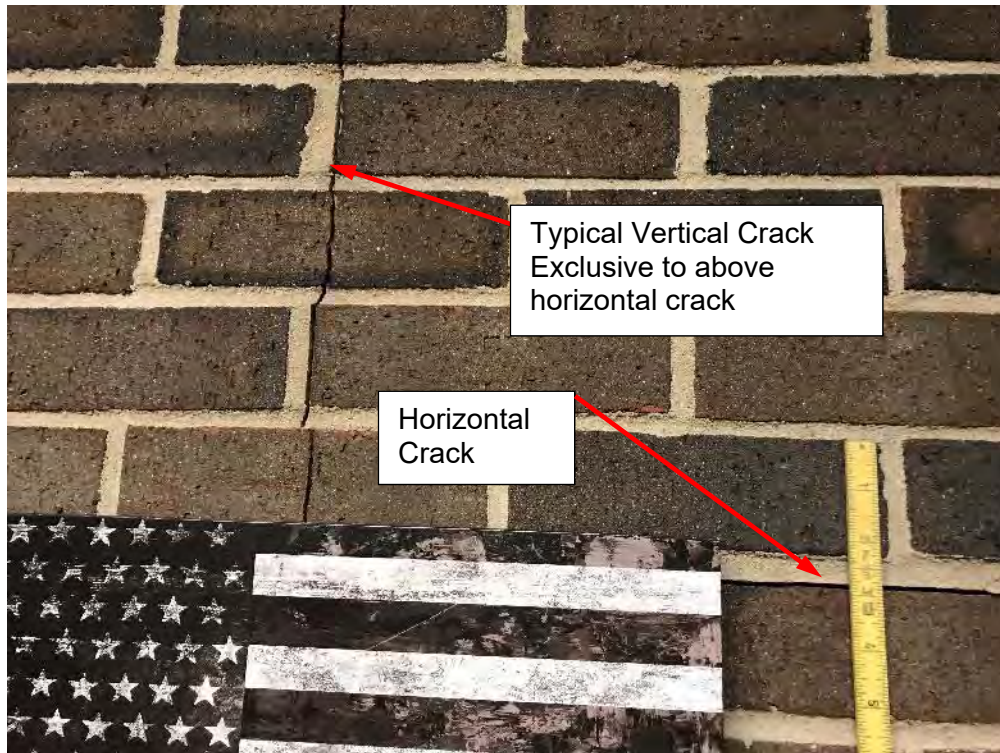
Photo 9 Public Safety Building – West Wall – Horiz./ Vertical Cracks

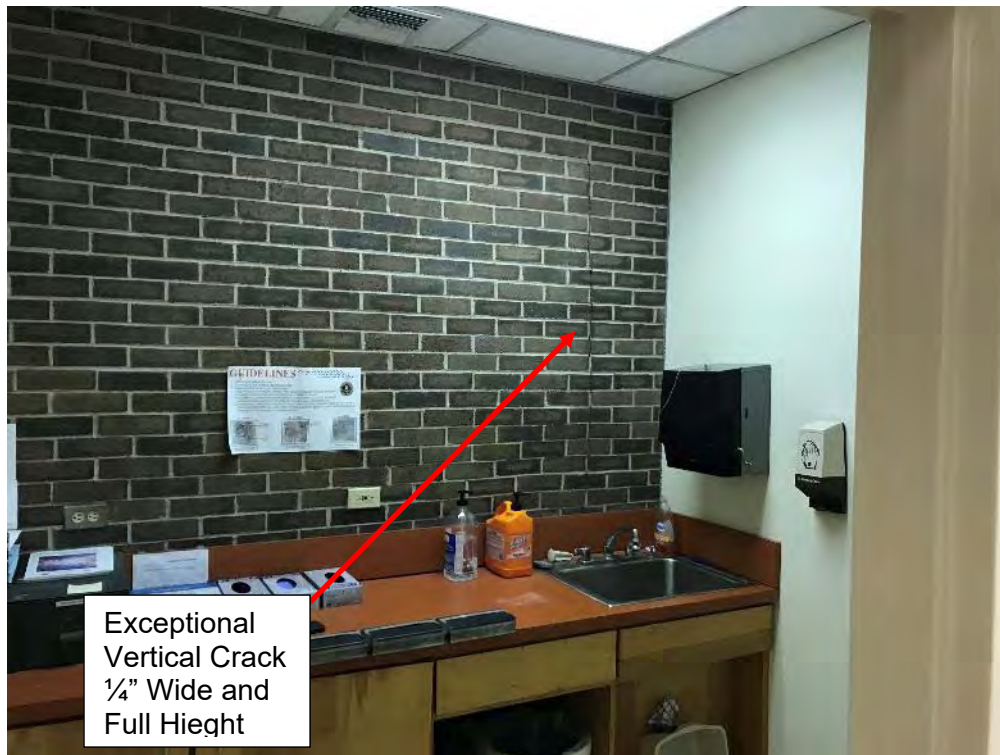
Photo 10 Public Safety Building – East Wall –Vertical Crack

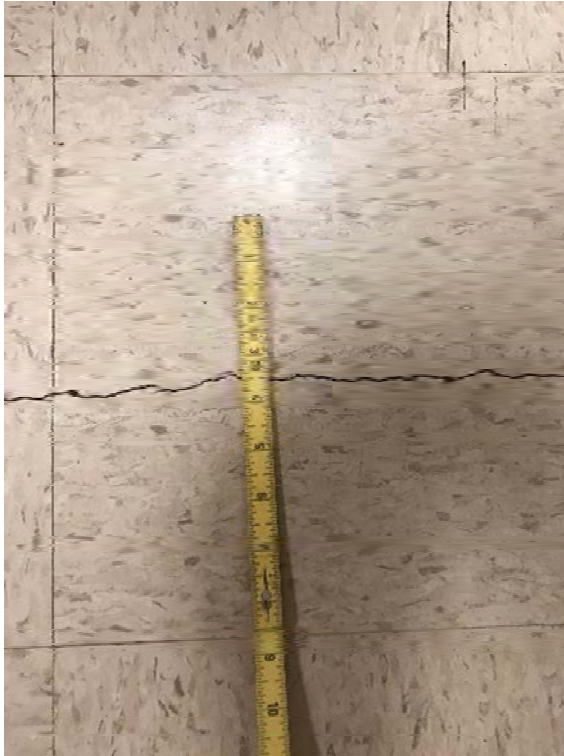
Photo 11 Public Safety Building – Interior Slab – Crack
