Town of Valdese
Public Safety Building Report
2021

Re: Inspection of Cracks in Building for
Fire Department and Police Department

VALDESE FIRE DEPARTMENT
Public Safety Buidling Inspection

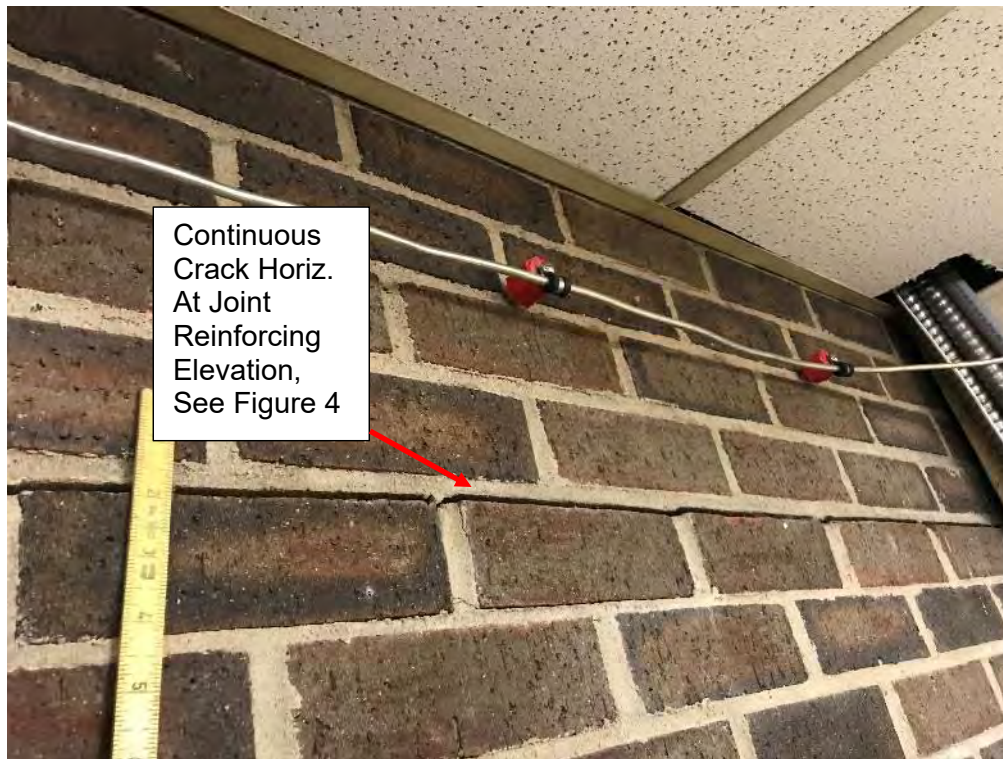
Photo 12 Public Safety Building – South Wall – Horizontal Crack

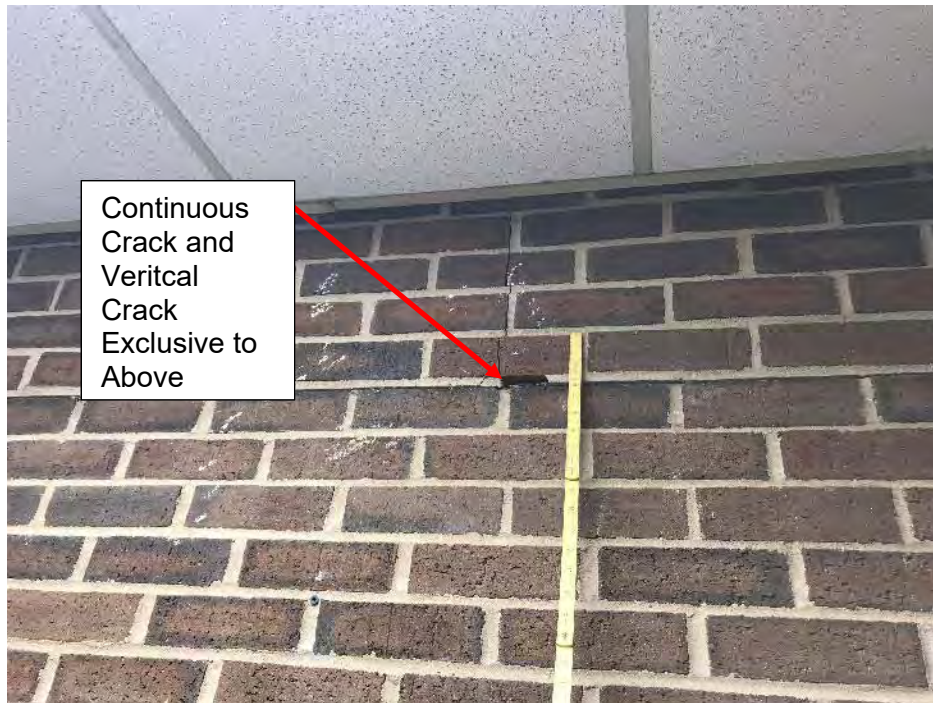
Photo 13 Public Safety Building – South Wall – Horizontal Crack

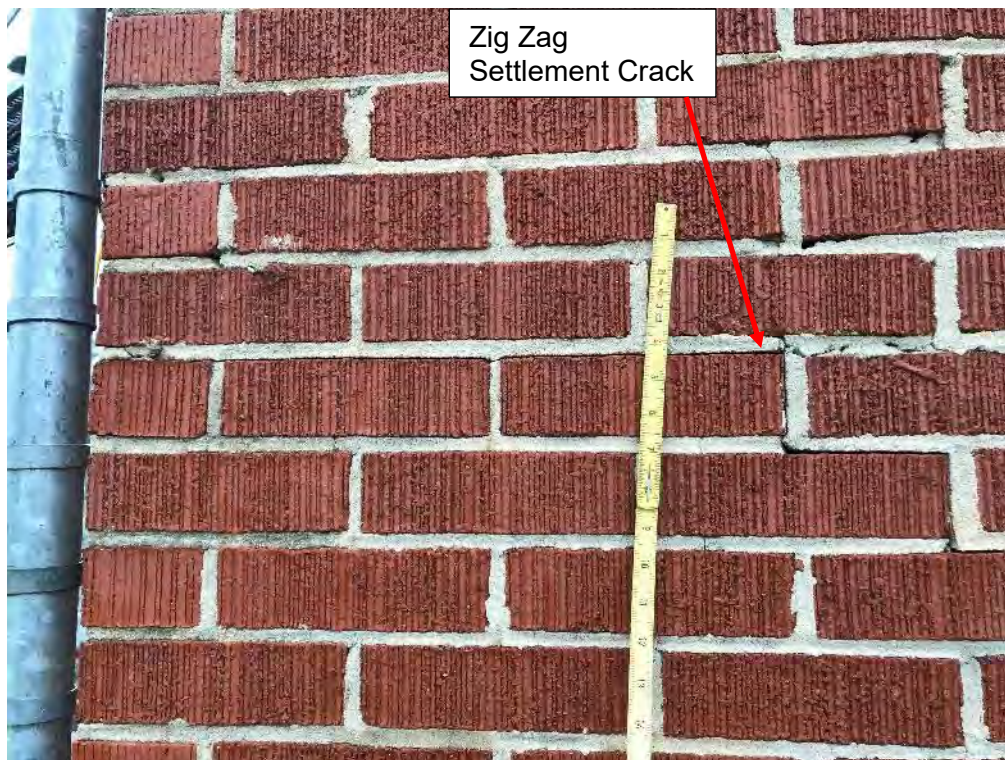
Photo 14 Public Safety Building – Southeast Corner – Zig Zag Crack

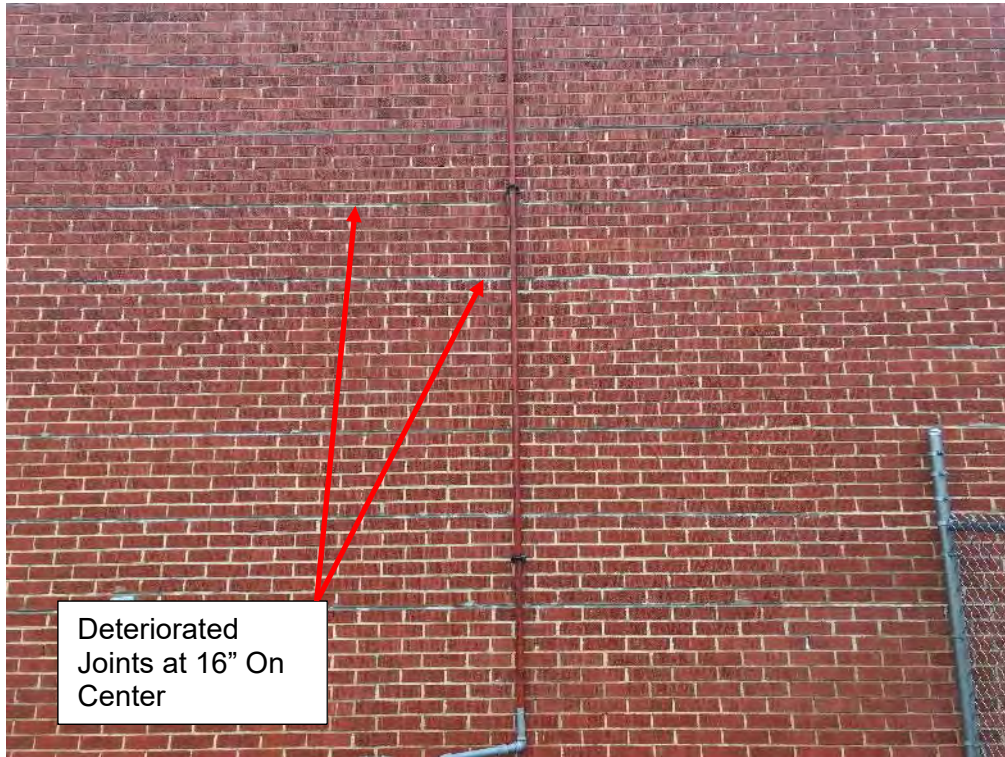
Photo 15 Public Safety Building – South Wall – Deteriorated Joints

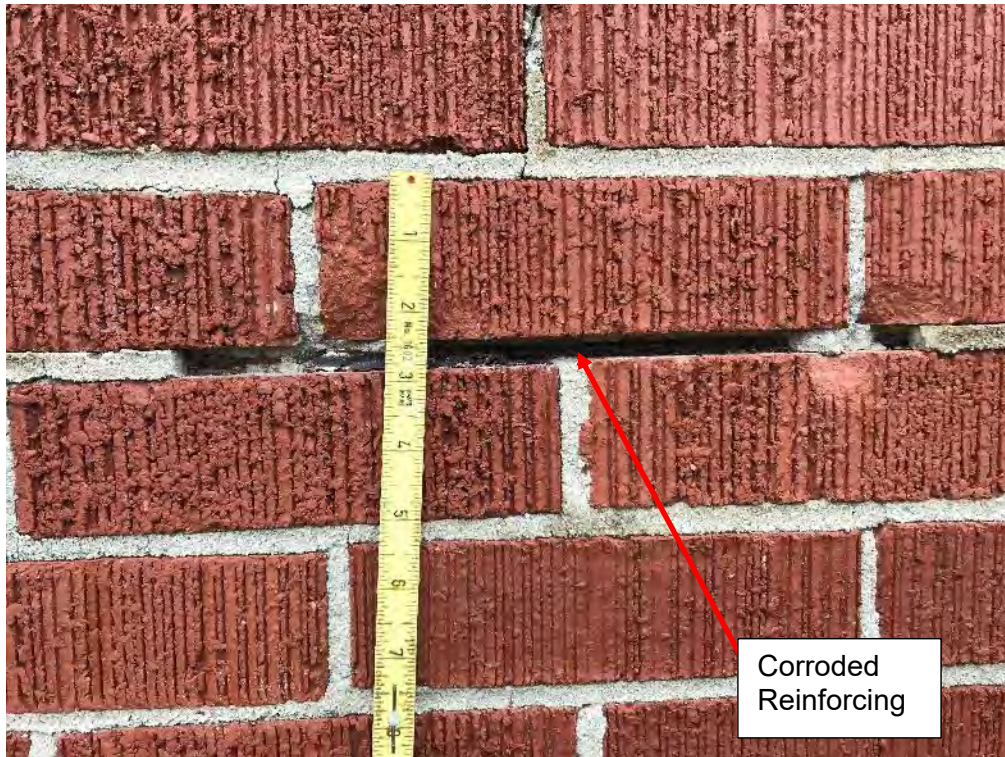
Photo 16 Public Safety Building – South Wall – Deteriorated Joints

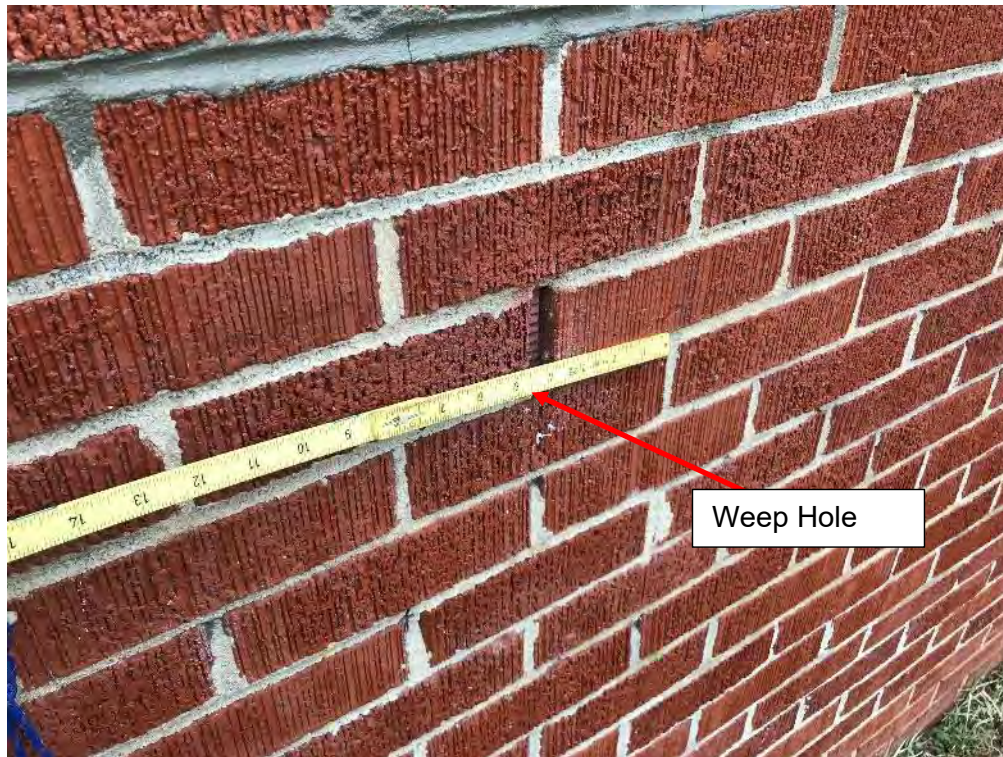
Photo 17 Public Safety Building – South Wall – Repaired Joint and Weep

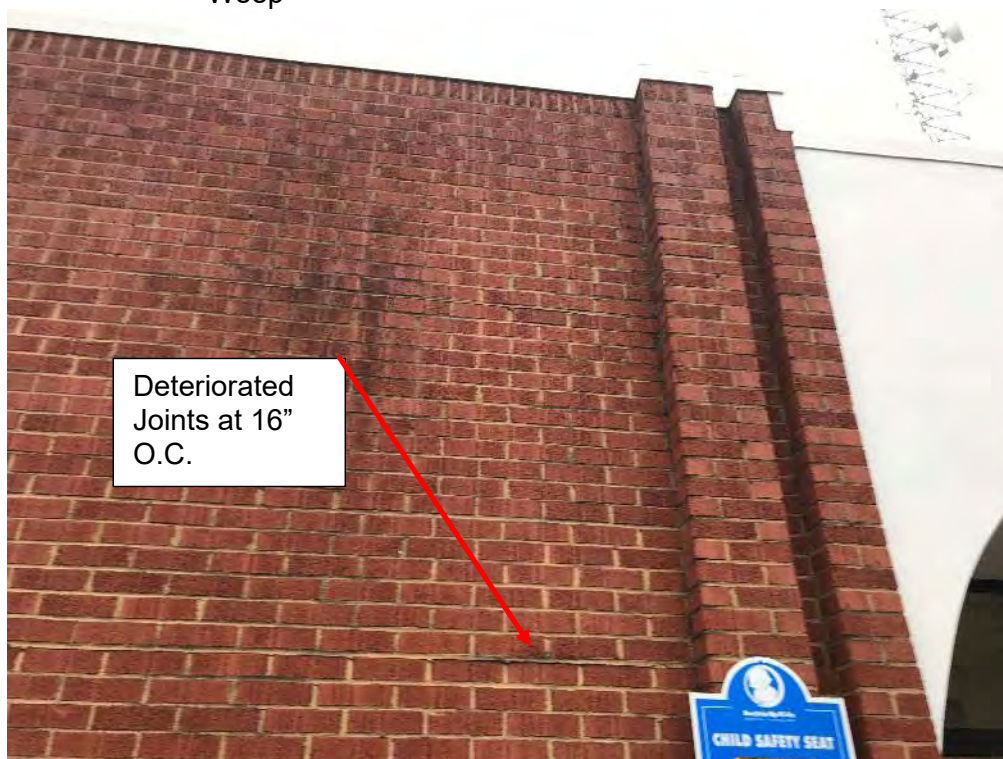
Photo 18 Public Safety Building – West Wall – Deteriorated Joints

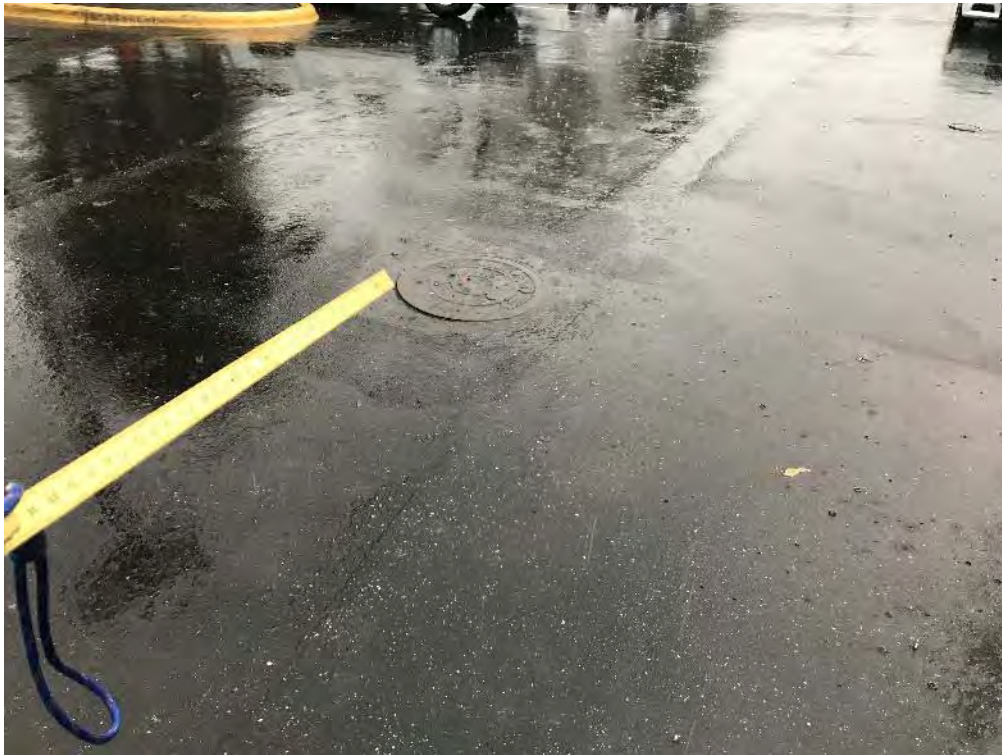
Photo 19 Public Safety Building – East Side – Manhole

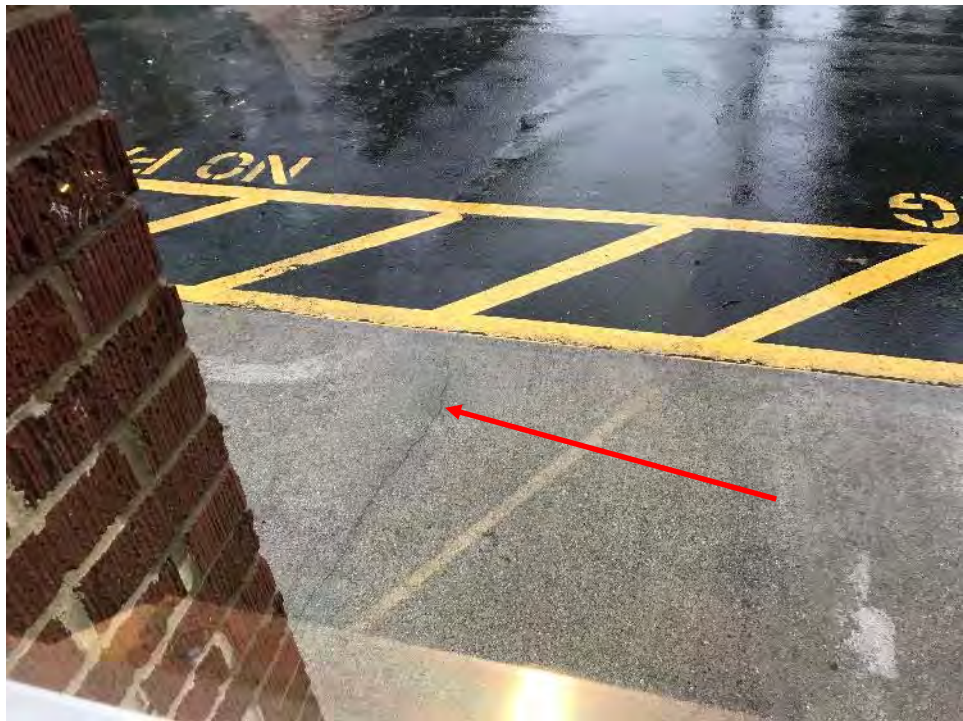
Photo 21 Public Safety Building – East Side – Cracked Slab

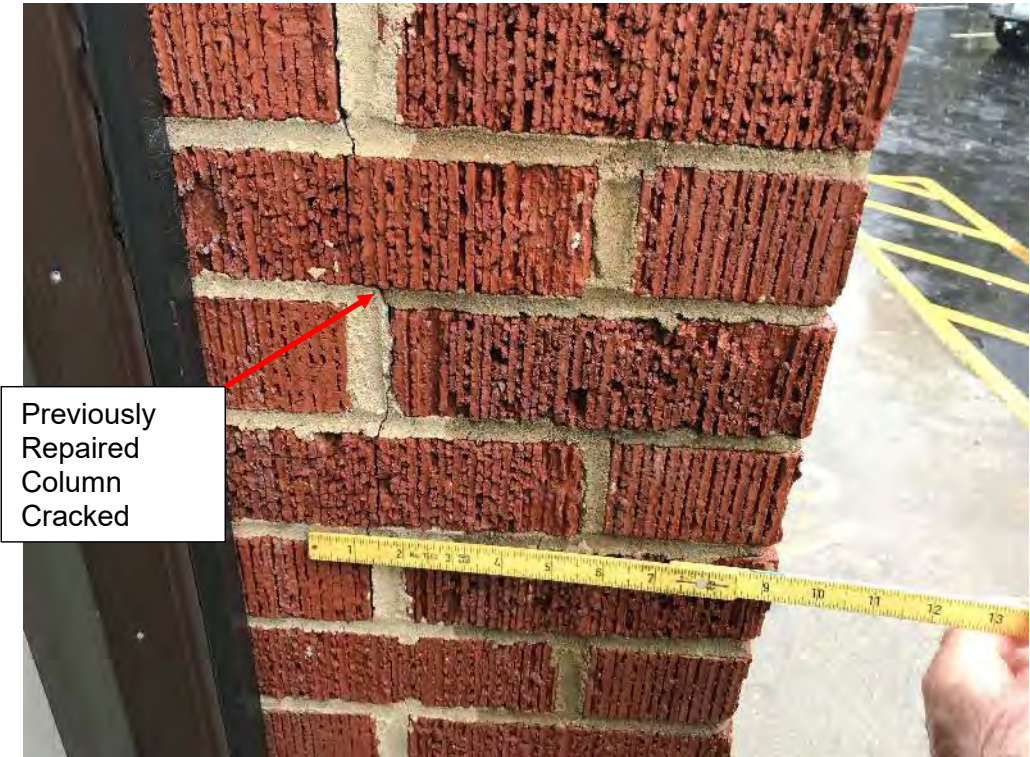
Photo 22 Public Safety Building – East Side – Cracked Column

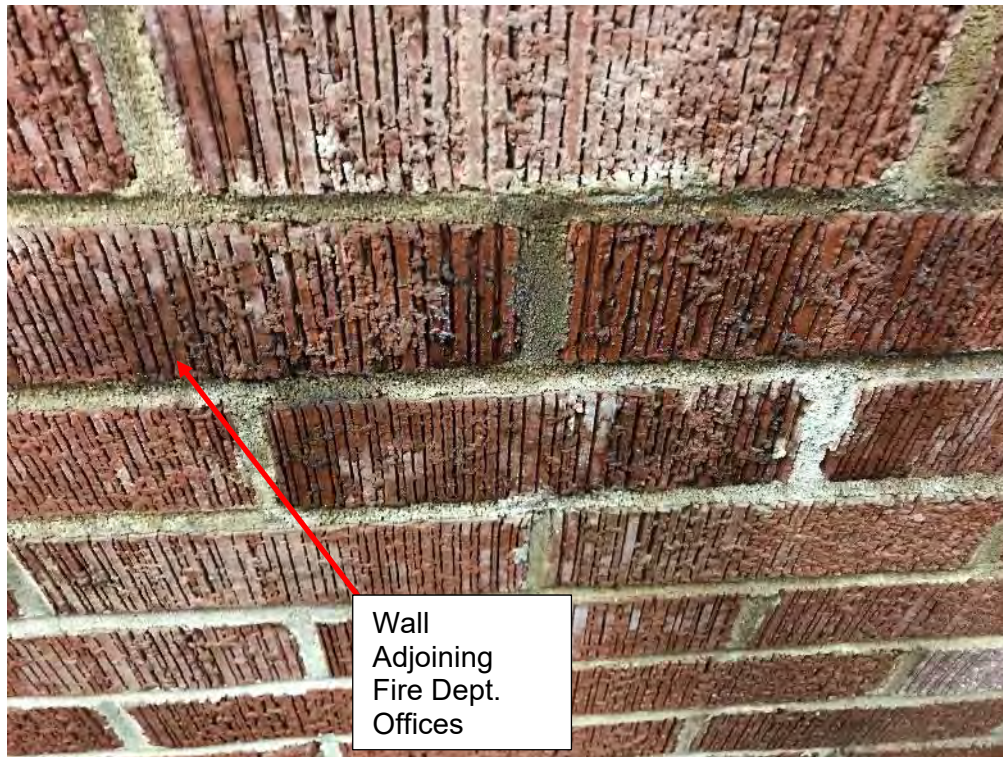
Wall
Adjoining
Fire Dept.
Offices

Photo 23 Public Safety Building – Engine Bay – Efflorescence

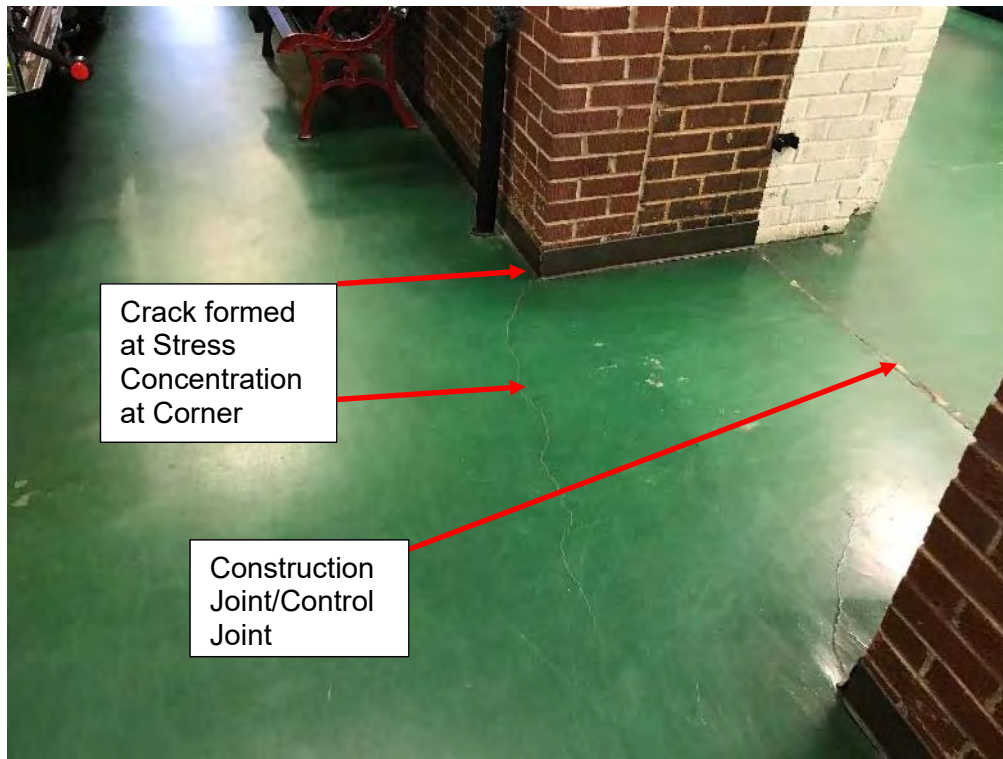
Crack formed
at Stress
Concentration
at Corner

Construction
Joint/Control
Joint

Photo 24 Public Safety Building – Engine Bay – Cracked Slab

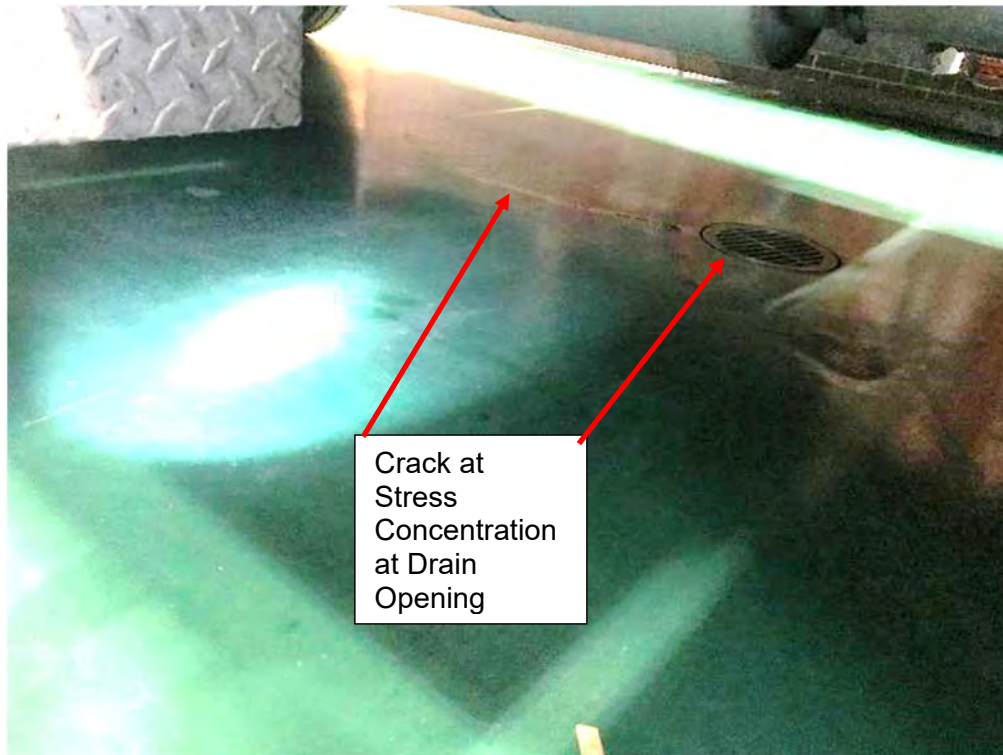
Crack at
Stress
Concentration
at Drain
Opening

Photo 25 Public Safety Building – Engine Bay – Cracked Slab

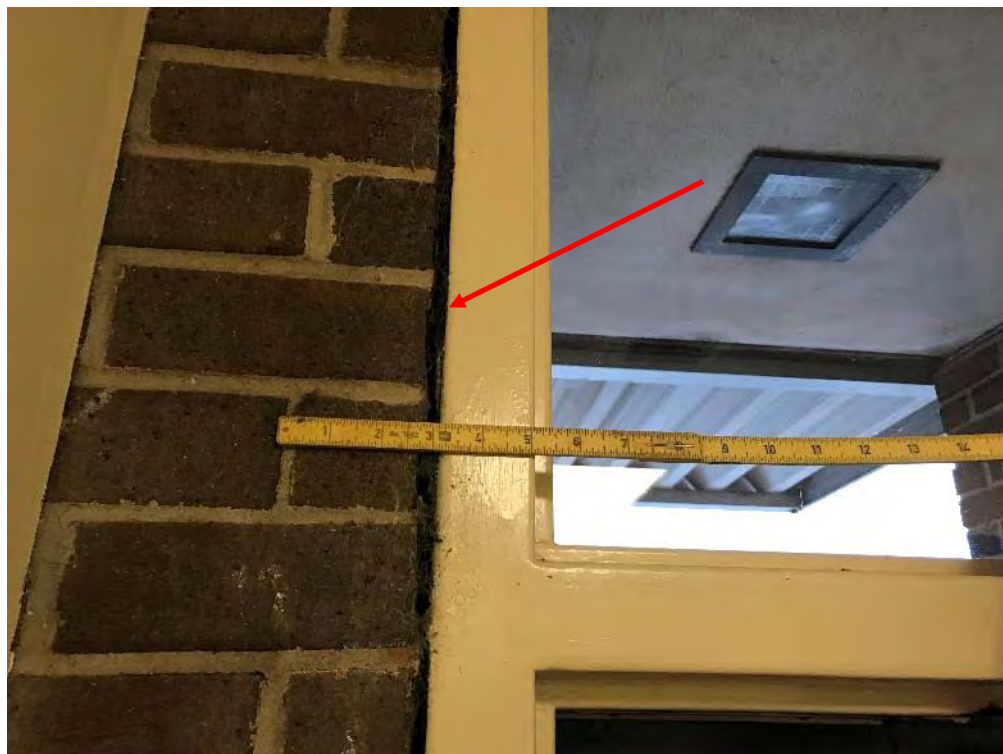
Photo 26 Public Safety Building – East Wall – Separation at Door
Frame

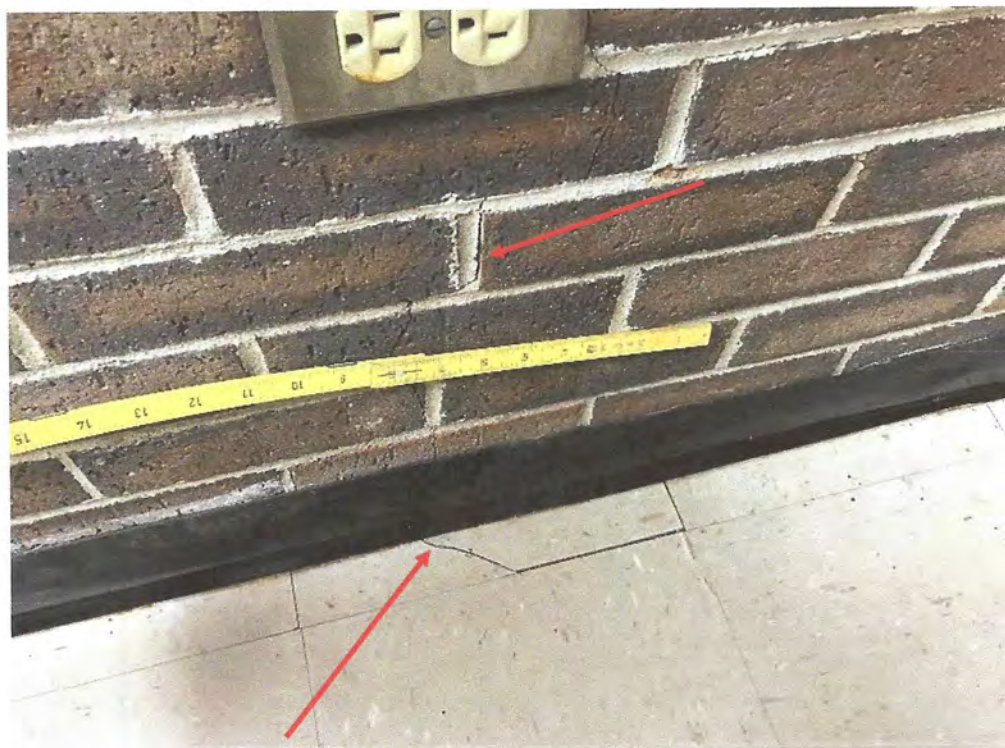
Photo 28 Public Safety Building – West Wall – Wall and Slab Crack

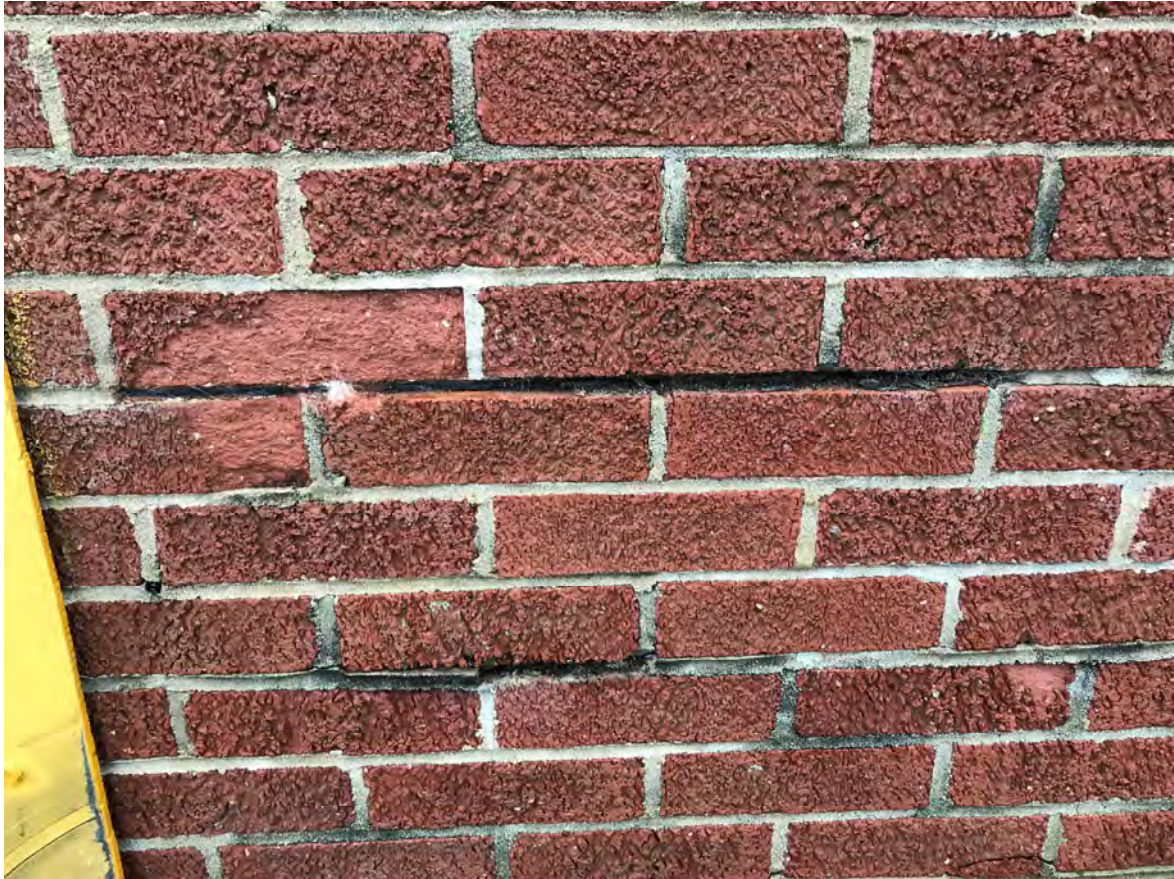
Photo 1 – Exterior Brick with Obvious Severe and often 100% Reinforcing Corrosion and Mortar Spalling

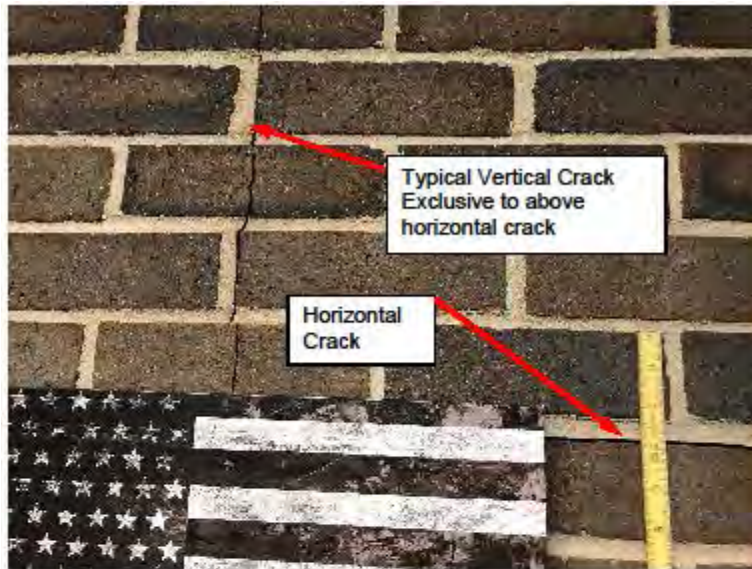
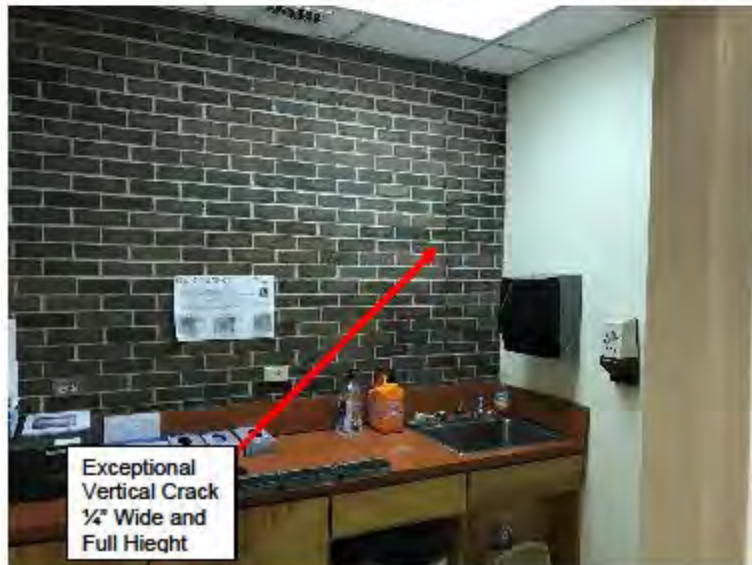
Vertical and horizontal cracks in load bearing double wythe brick wall.

Photo 9 Public Safety Building – West Wall – Horiz./ Vertical Cracks

Some vertical cracks run full height of wall on interior of building.

Photo 10 Public Safety Building – East Wall – Vertical Crack

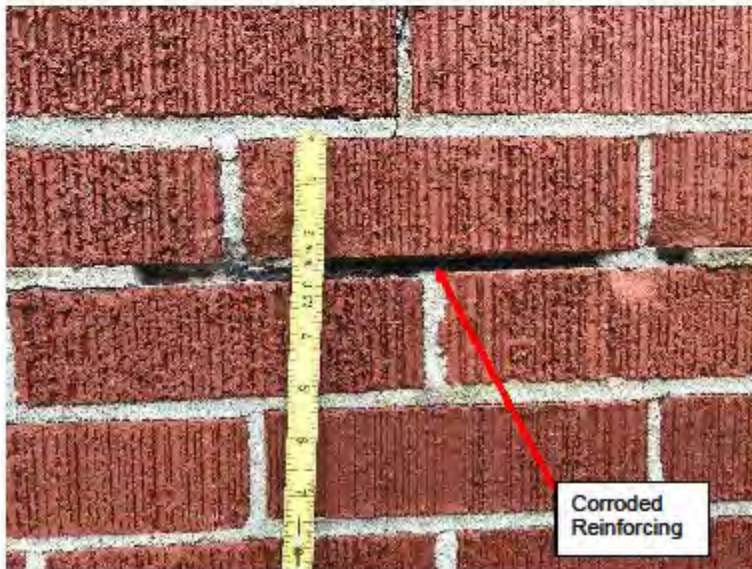
Exterior horizontal cracks at 16" on center at each band of steel ties.

Photo 15 Public Safety Building – South Wall – Deteriorated Joints

Photo 16 Public Safety Building – South Wall – Deteriorated Joints

Steel ties are rusting and pushing the mortar out. The deteriorated ties no longer hold the two wythes of brick together.

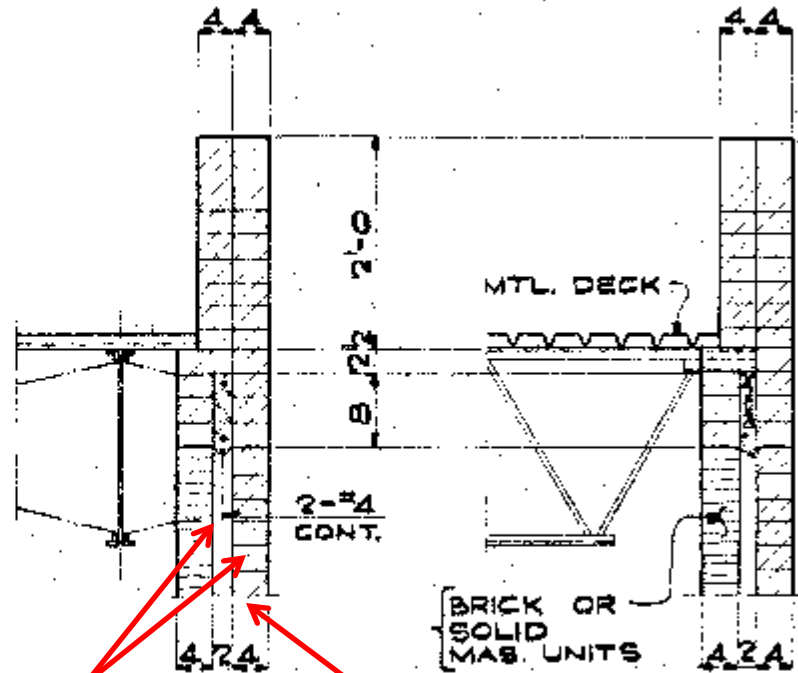
*Each wythe of wall
is bowing out away
from each other.*
