Town of Valdese
Public Safety Building Report
2021

Re: Inspection of Cracks in Building for
Fire Department and Police Department

VALDESE FIRE DEPARTMENT
Public Safety Building Inspection

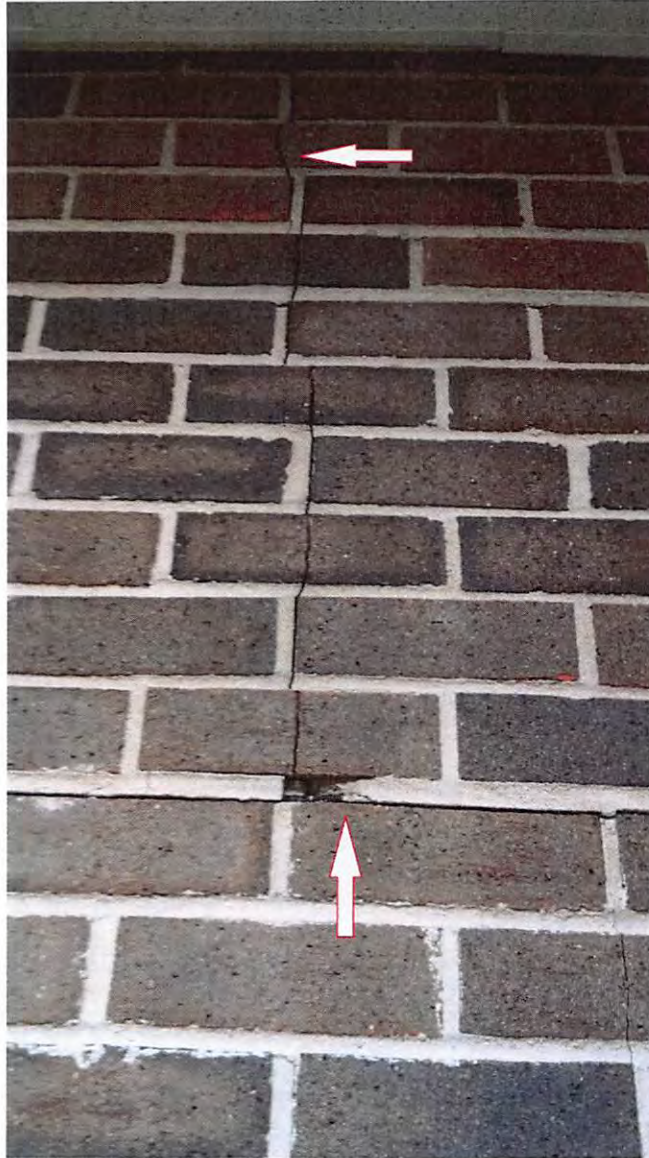
VERTICAL AND HORIZONTAL CRACKS IN WALL OF FIRE CHIEF'S OFFICE. VERTICAL CRACK EXTENDS FROM FLOOR TO CEILING. THIS WALL IS AN EXTERIOR WALL.

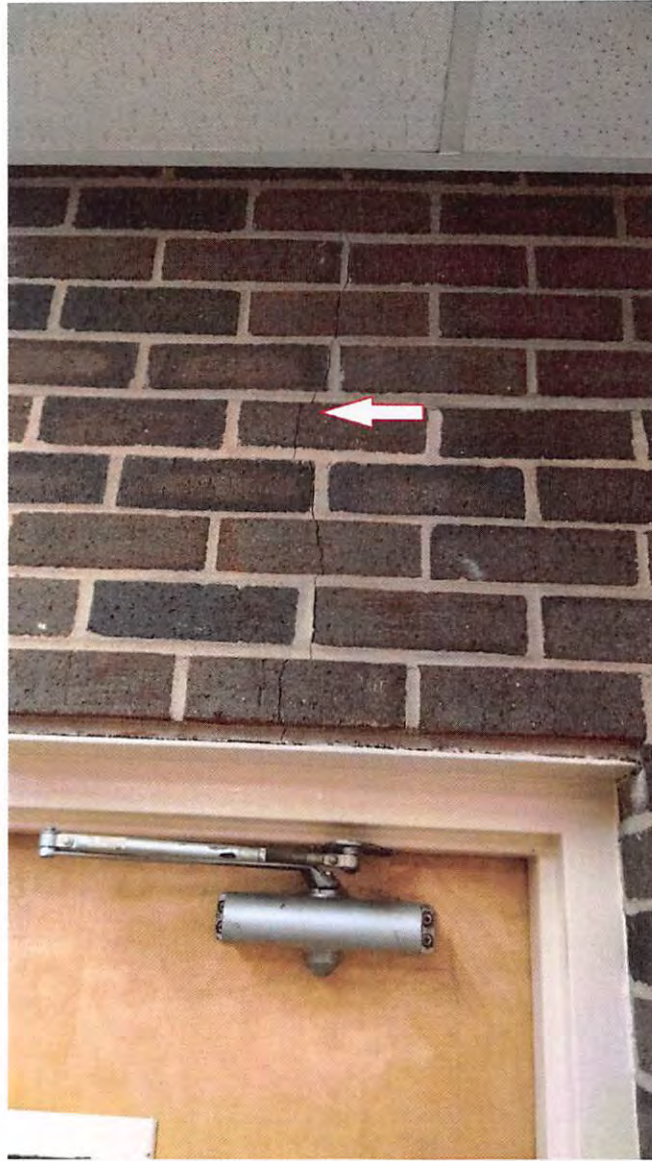
VERTICAL CRACK ABOVE DOOR NEAR FIRE CHIEF'S OFFICE.

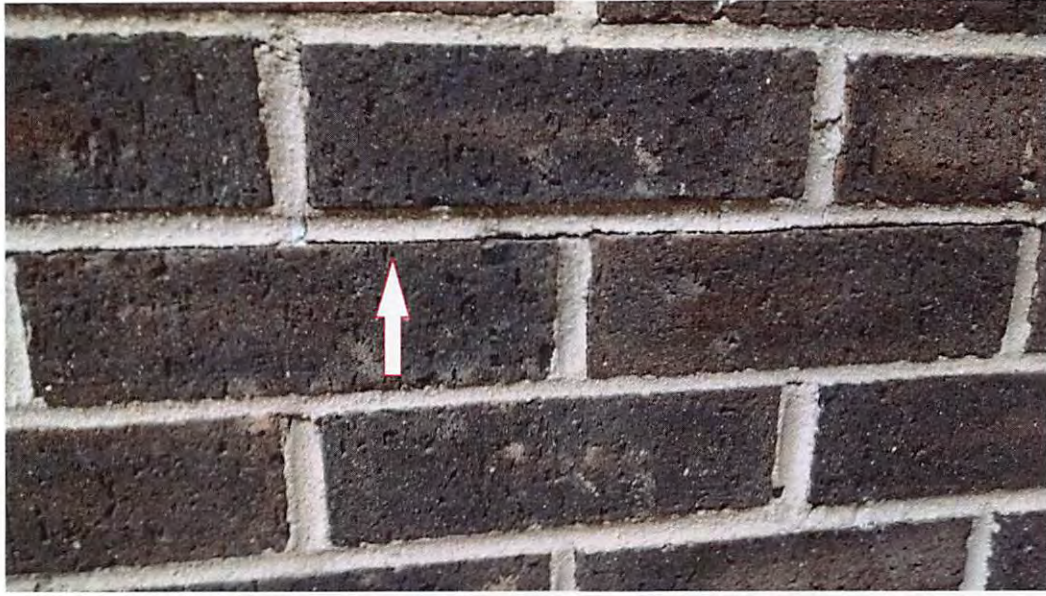
HORIZONTAL CRACK IN WALL IN LOUNGE AREA. THIS IS AN INTERIOR WALL.

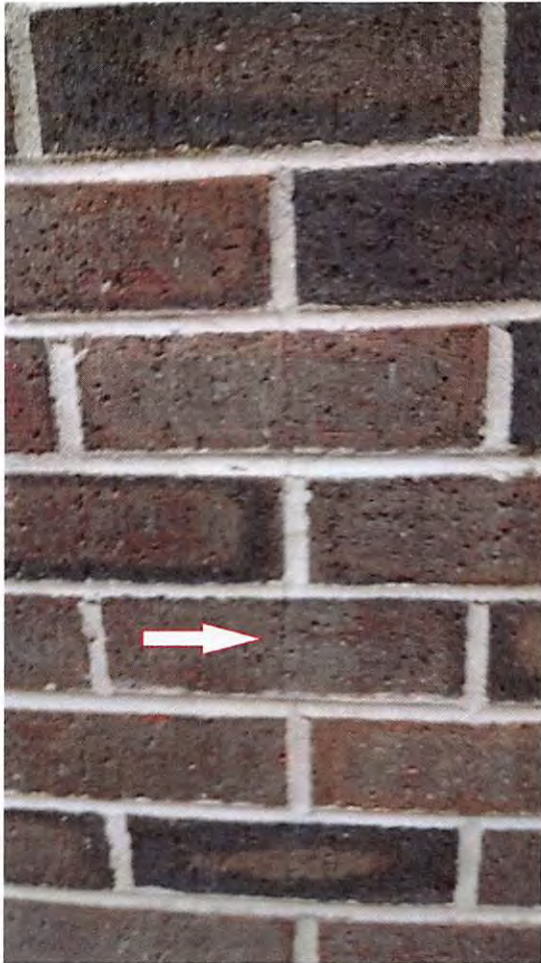
VERTICAL CRACK BEGINNING IN LOUNGE AREA WALL.

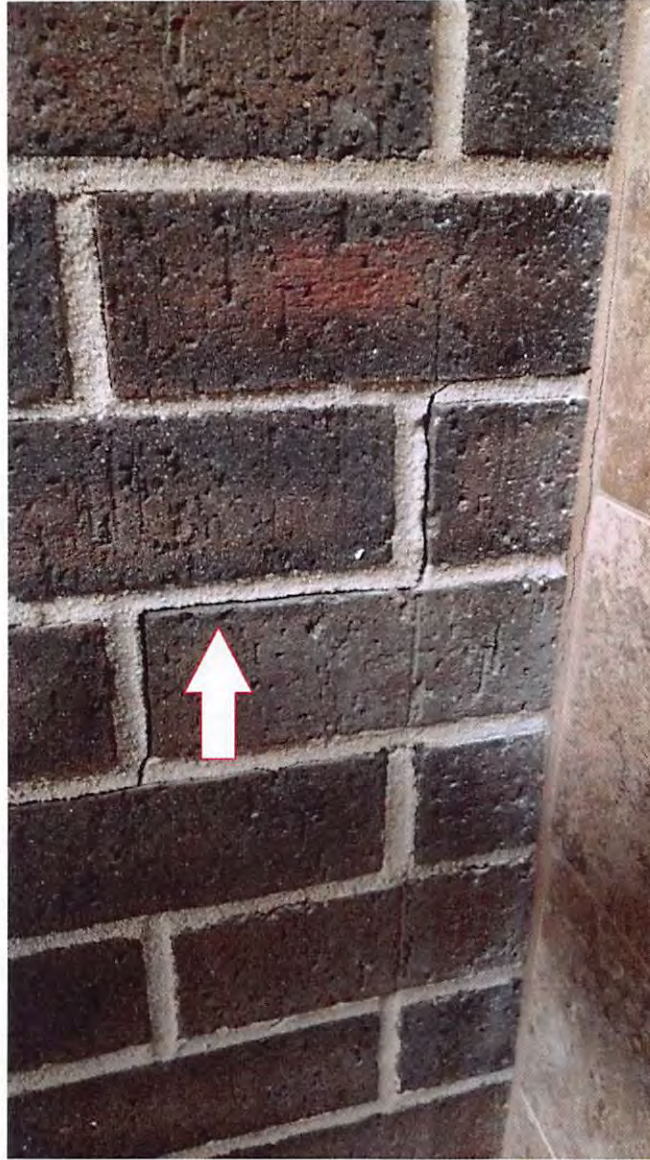
VERTICAL AND HORIZONTAL CRACK IN WALL OF WOMEN'S REST ROOM.

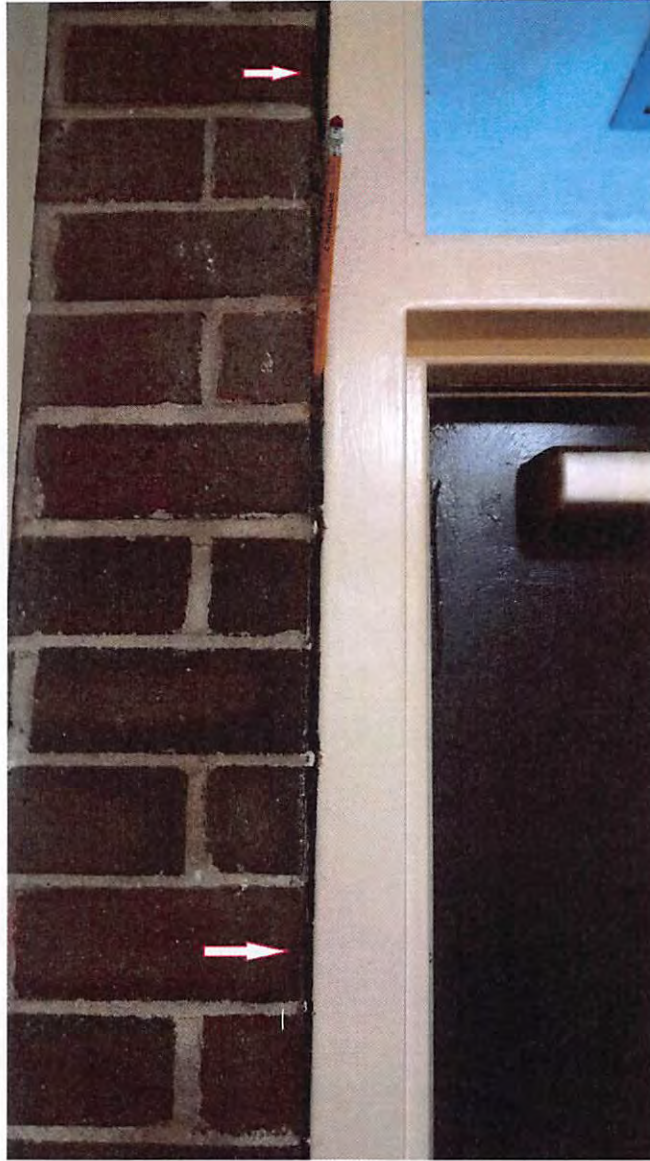
WALL SEPARATING FROM DOOR FRAME ON EXTERIOR DOOR ON EAST SIDE OF BUILDING. THIS IS AN EXTERIOR WALL.

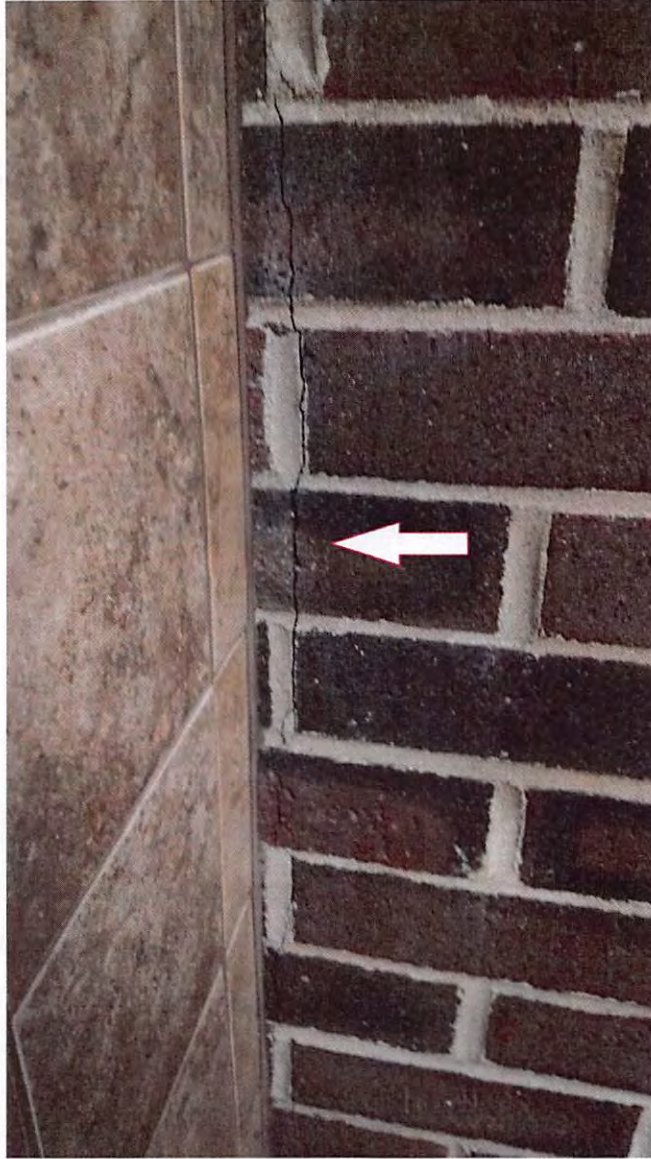
VERTICAL CRACK IN WALL IN MEN'S RESTROOM. THIS IS AN INTERIOR WALL.

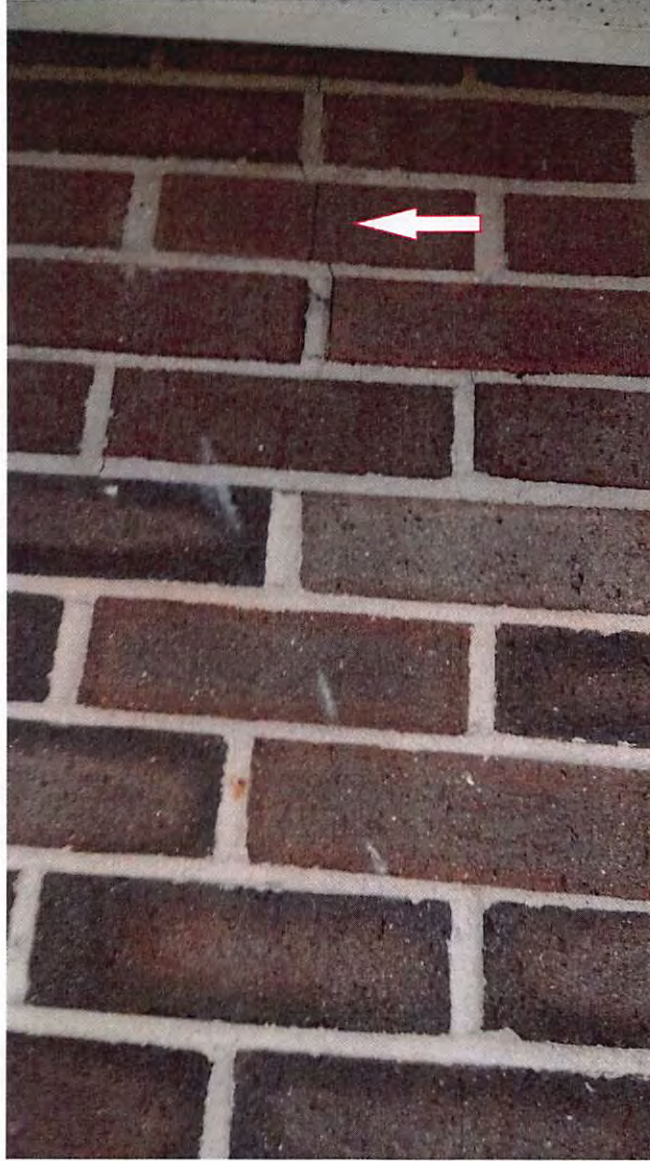
VERTICAL AND HORIZONTAL CRACKS IN INTERVIEW ROOM WALL. THIS WALL IS AN EXTERIOR WALL.

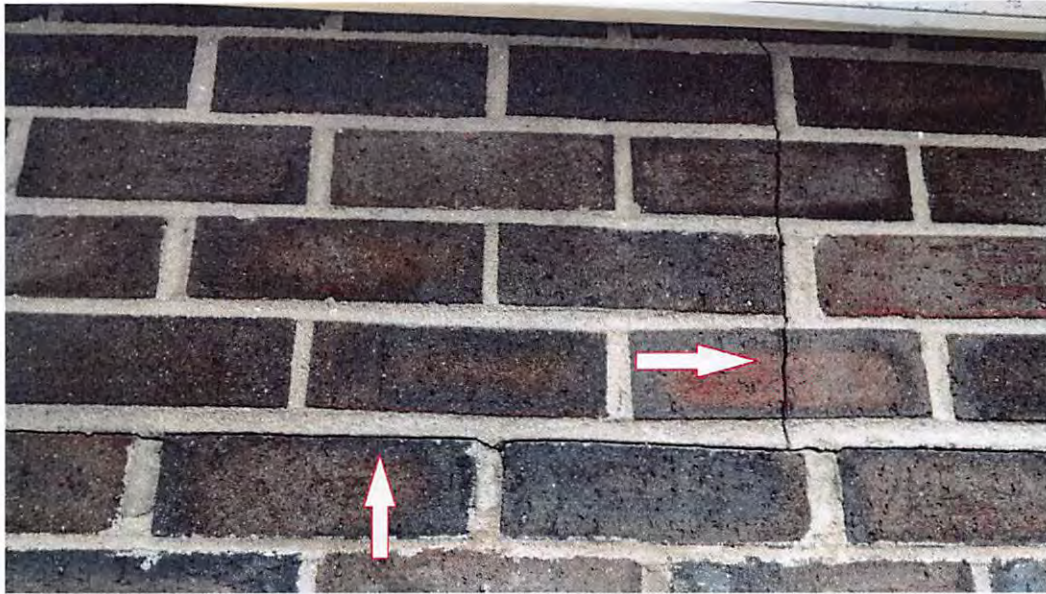
VERTICAL AND HORIZONTAL CRACK IN INTERVIEW ROOM WALL.

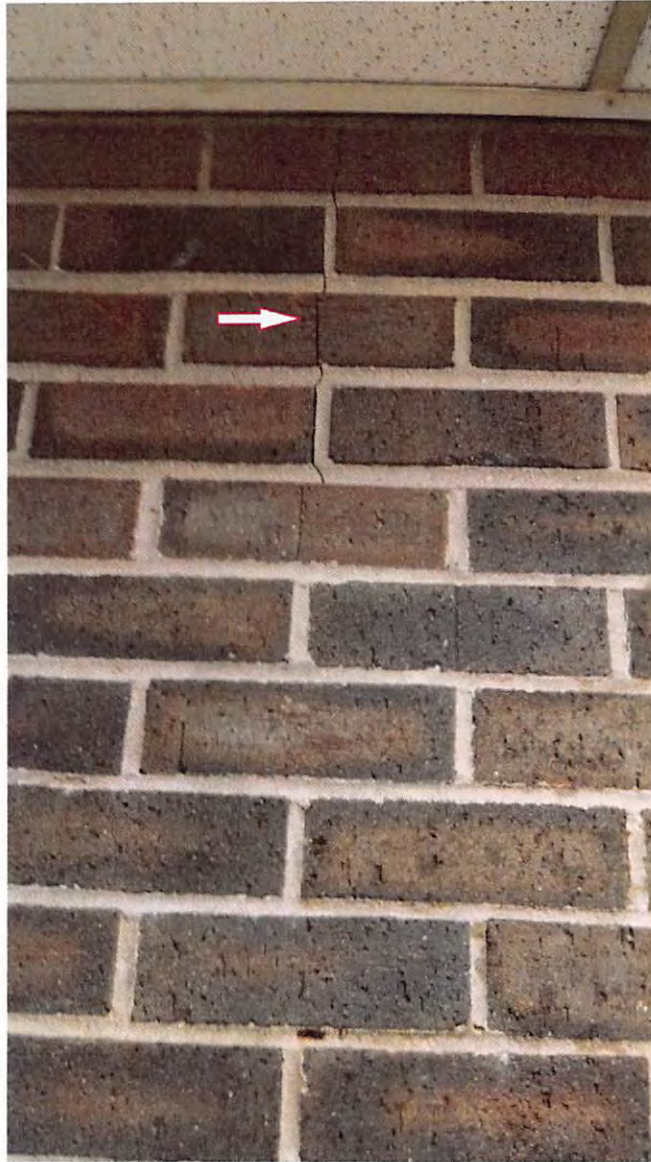
VERTICAL CRACK IN FINGERPRINTING ROOM WALL. THIS WALL IS AN EXTERIOR WALL.

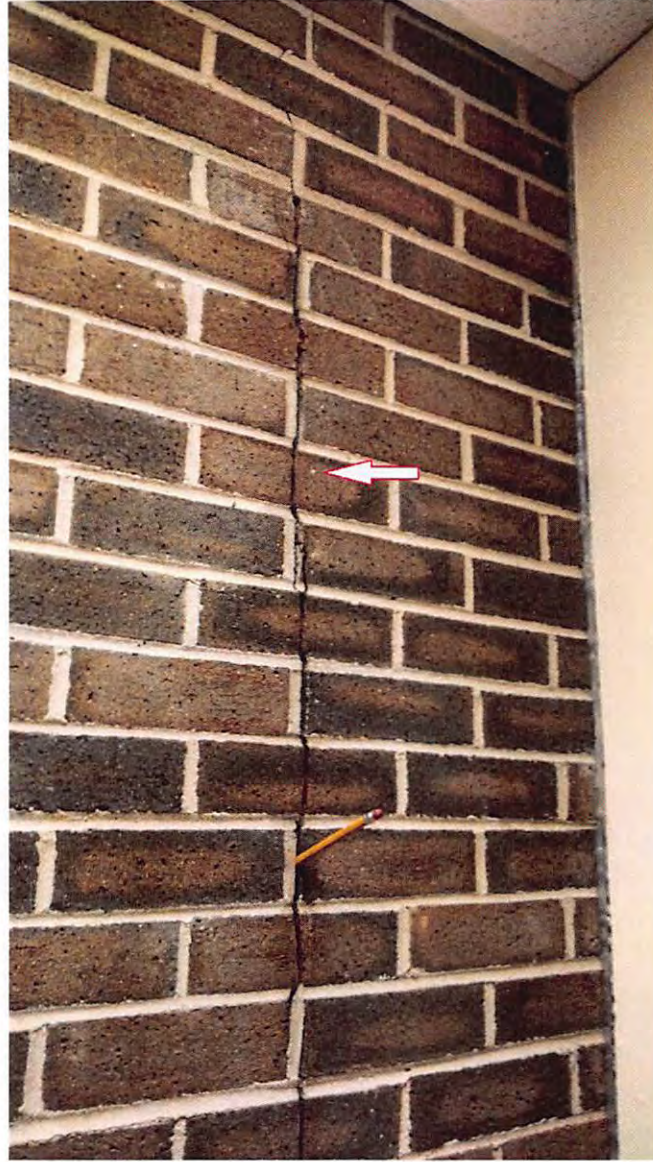
VERTICAL CRACK IN FINGERPRINTING ROOM WALL. THIS WALL IS AN EXTERIOR WALL.

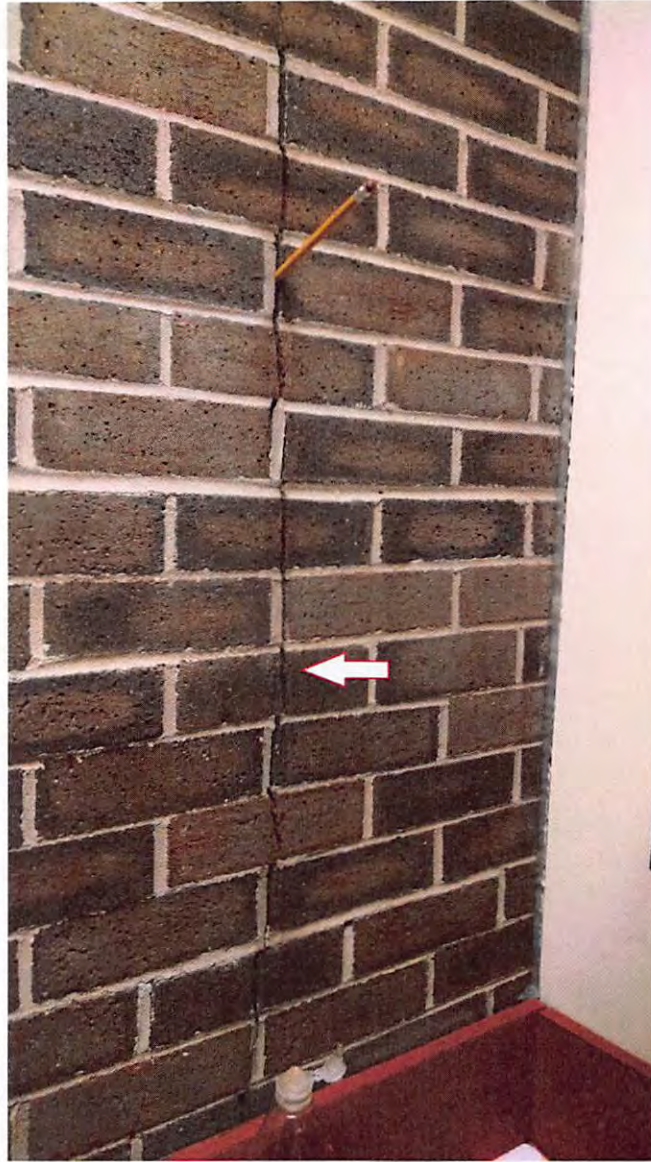
ANOTHER VIEW OF THE CRACK IN THE FINGERPRINTING ROOM WALL. THIS CRACK EXTENDS FROM THE FLOOR TO THE CEILING.

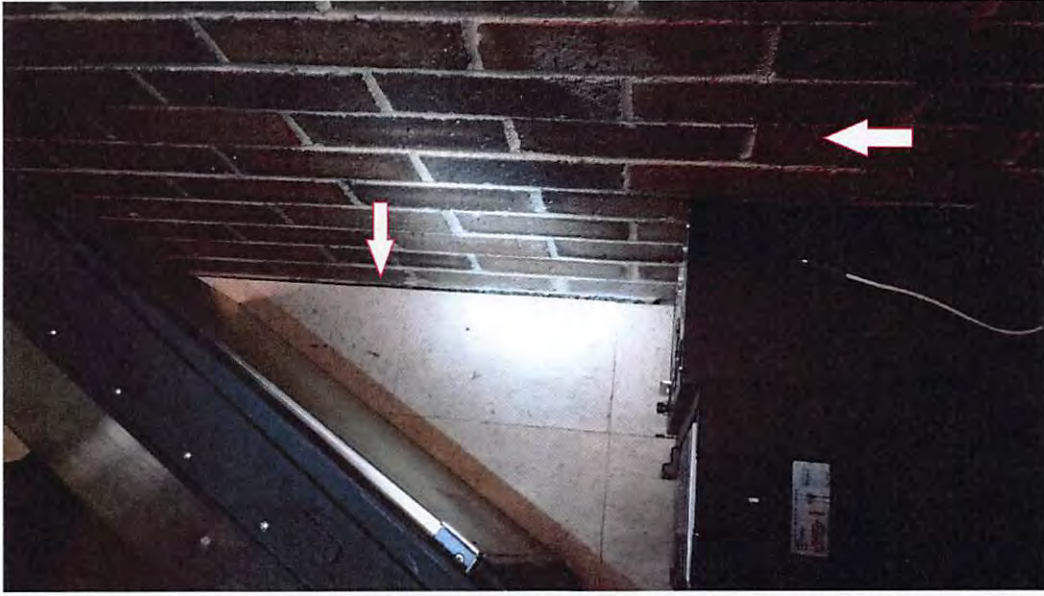
HORIZONTAL AND VERTICAL CRACK IN WALL IN SERVER ROOM. FLOOR HAS ALSO SUNKEN AND MOVED AWAY FROM WALL.

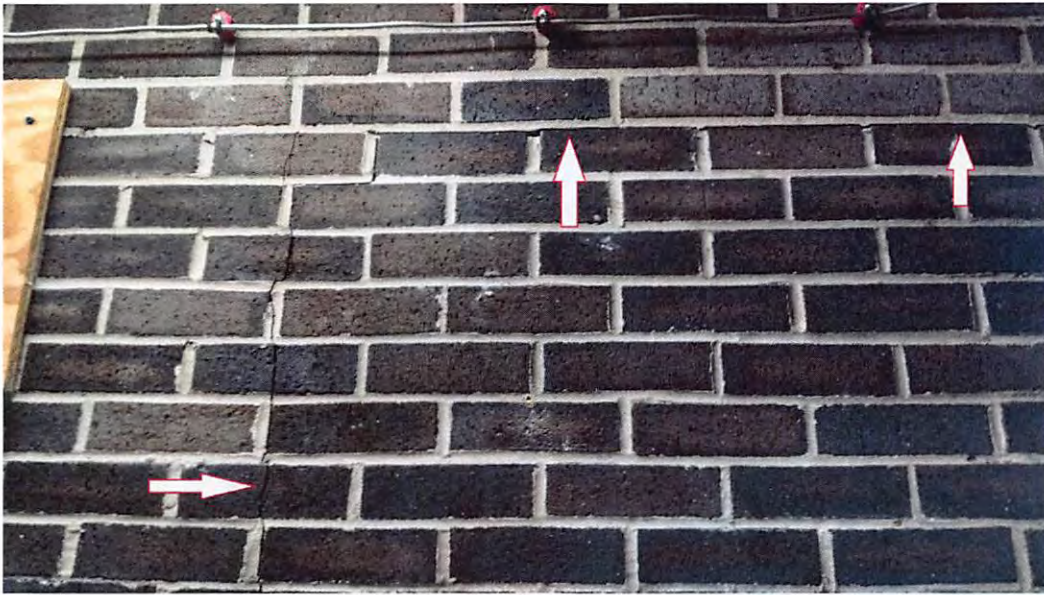
HORIZONTAL AND VERTICAL CRACK IN WALL IN SERVER ROOM.

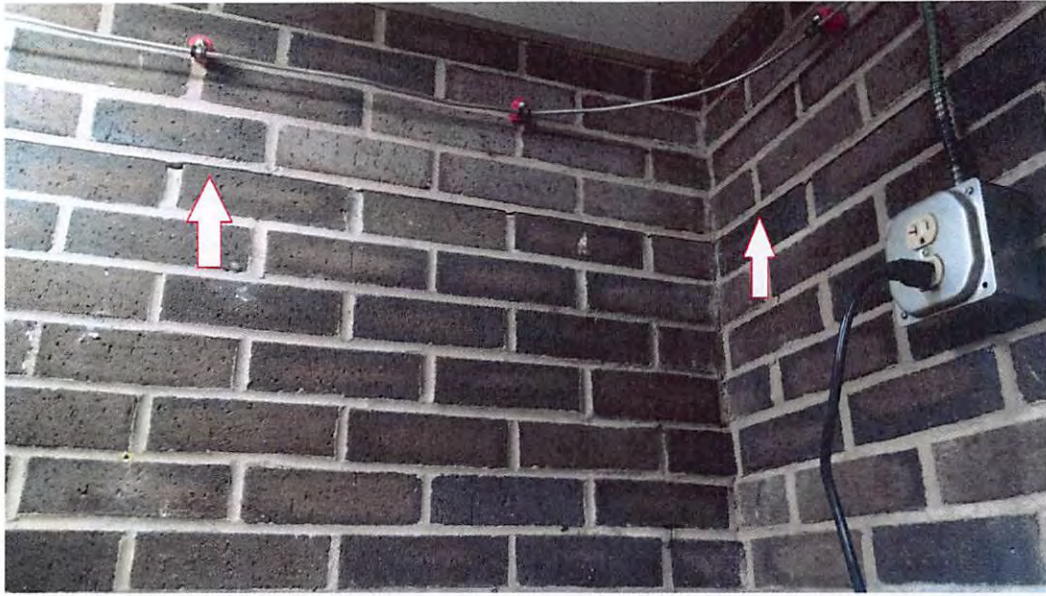
HORIZONTAL CRACK ALONG WALL IN SERVER ROOM.

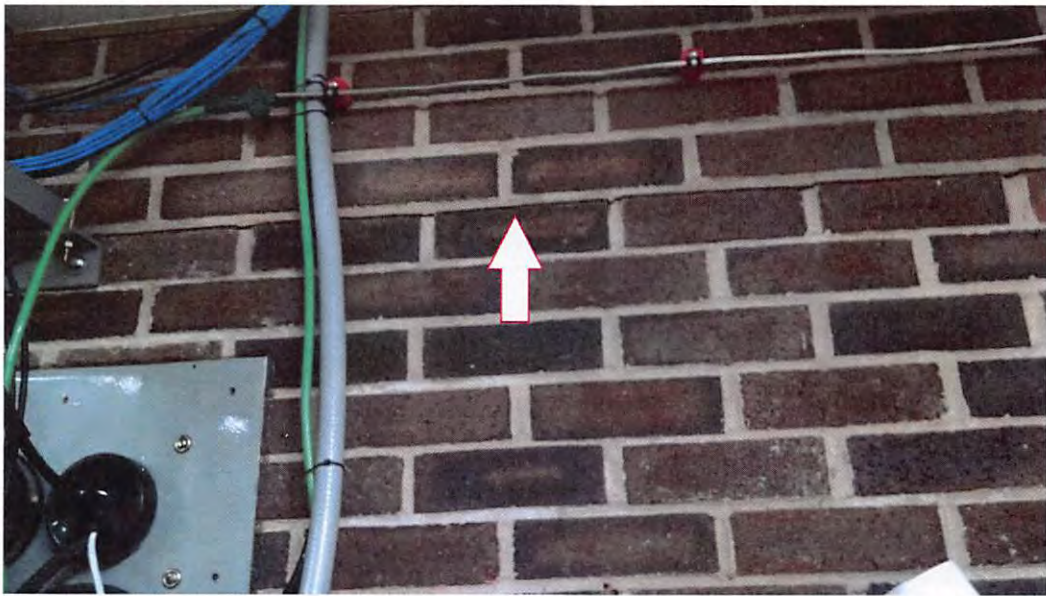
HORIZONTAL CRACK ALONG WALL IN SERVER ROOM.

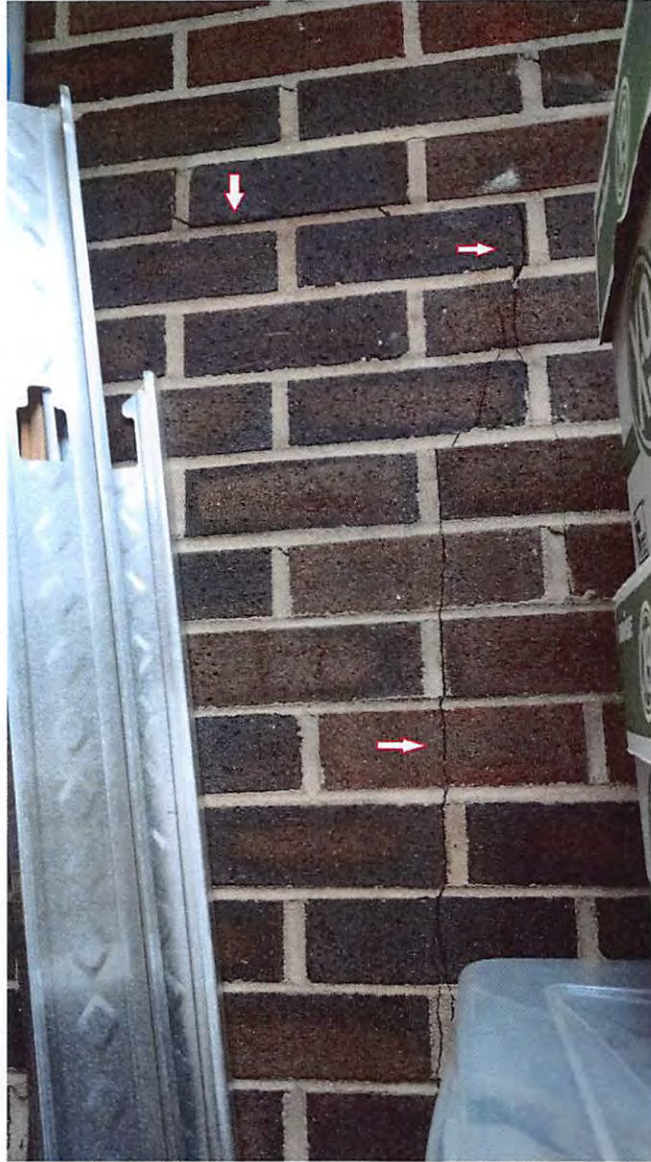
HORIZONTAL AND VERTICAL CRACK IN WALL IN ARMS ROOM.

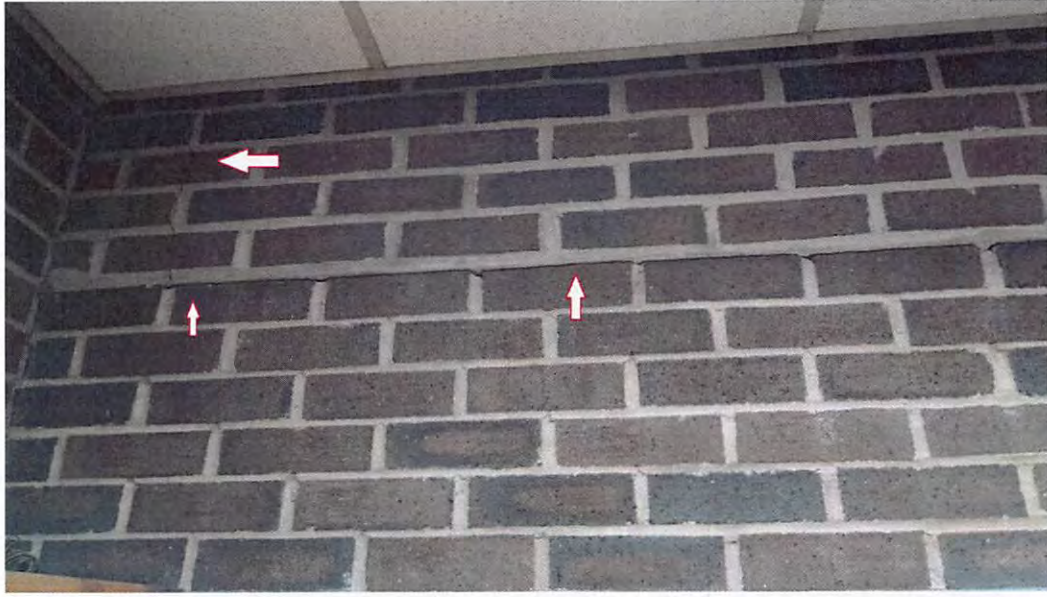
VIEW OF A DIFFERENT HORIZONTAL AND VERTICAL CRACK IN WALL OF ARMS ROOM.

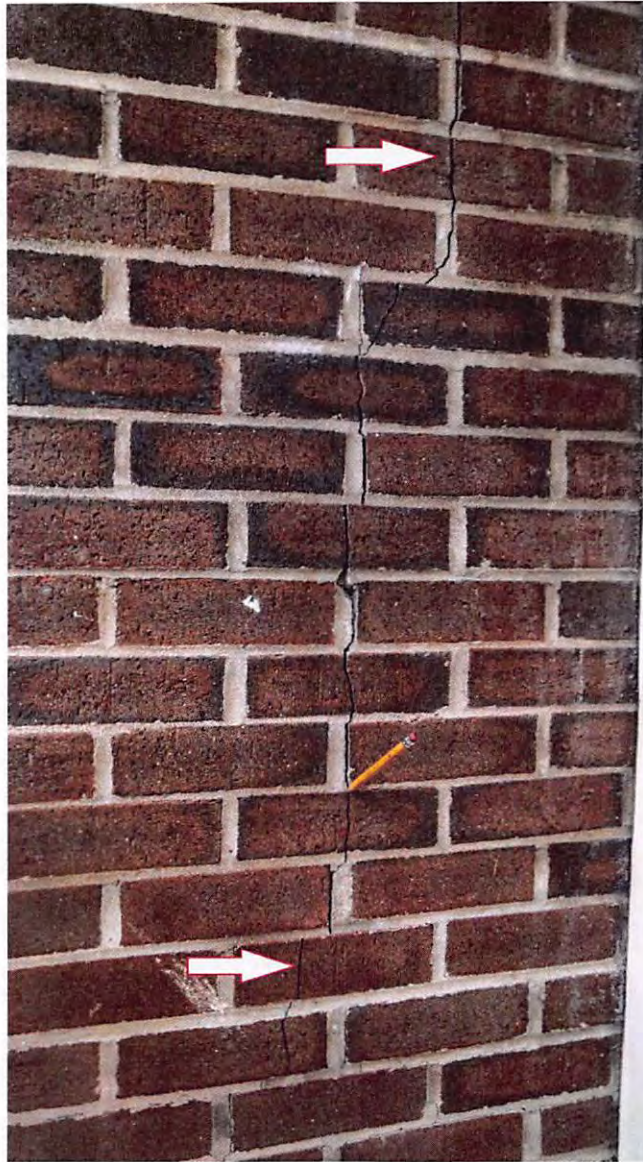
VERTICAL CRACK IN WALL IN WALL IN SQUAD ROOM. THIS IS AN EXTERIOR WALL.

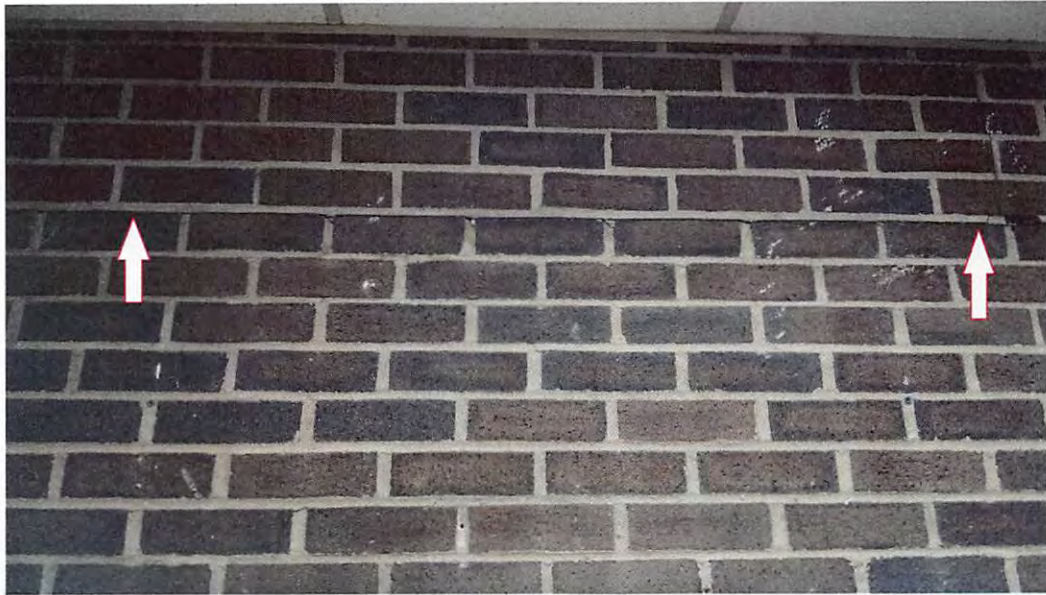
VIEW OF ANOTHER HORIZONTAL AND VERTICAL CRACK IN SQUAD ROOM.

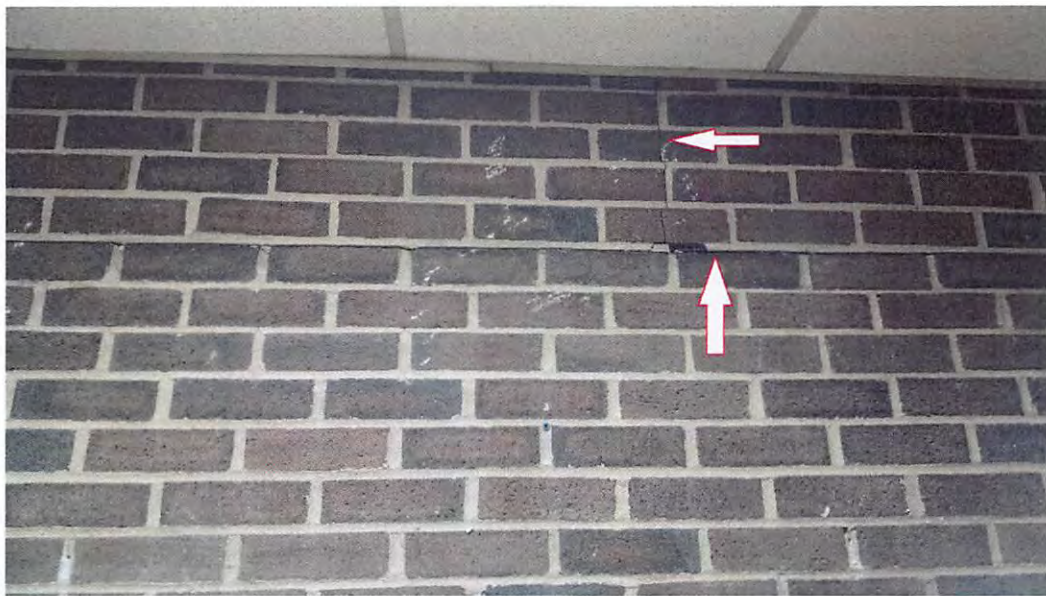
ANOTHER VIEW OF THE SAME CRACK IN SQUAD ROOM SHOWING VERTICAL PORTION OF CRACK.

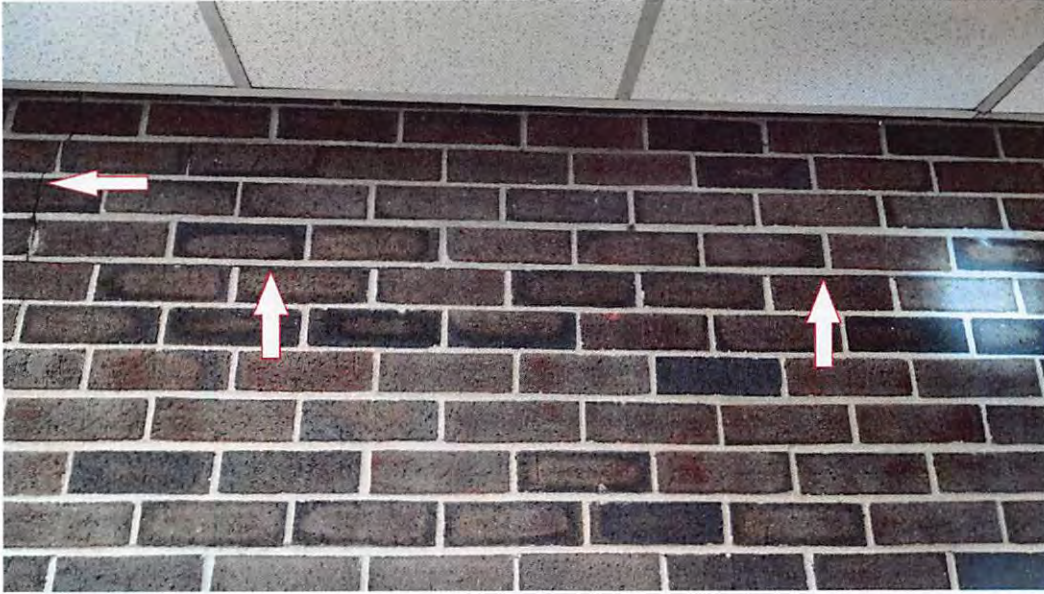
HORIZONTAL AND VERTICAL CRACK IN WALL OF POLICE CHIEF'S OFFICE. THIS IS AN EXTERIOR WALL.

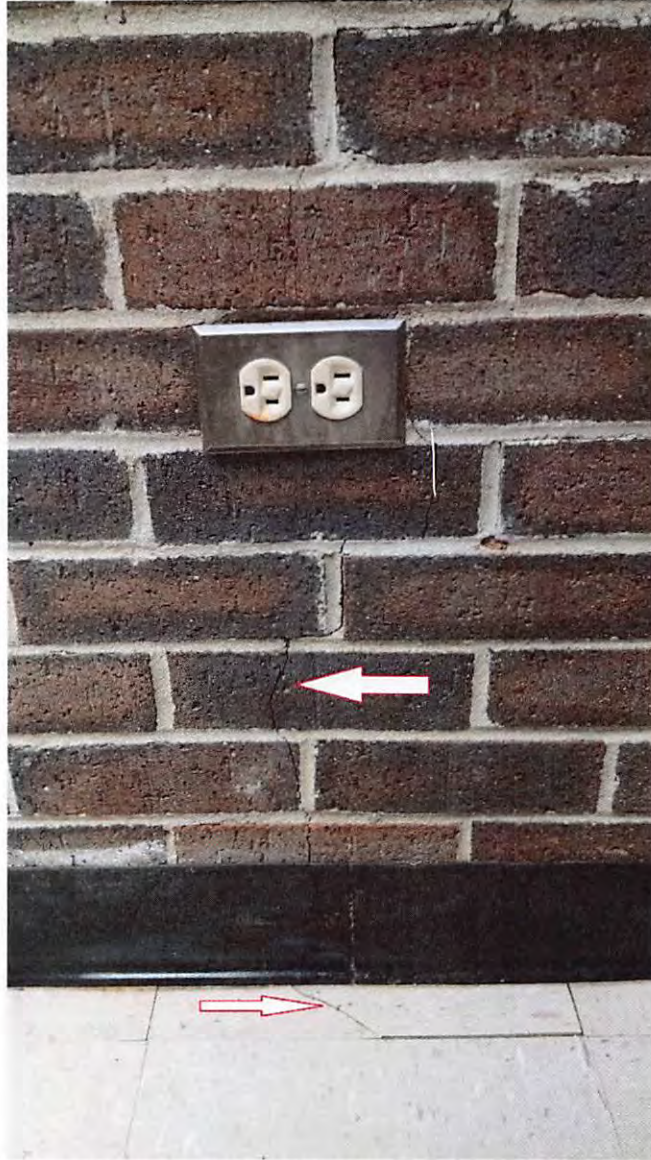
ANOTHER CRACK IN WALL IN POLICE CHIEF'S OFFICE. THIS IS AN EXTERIOR WALL.

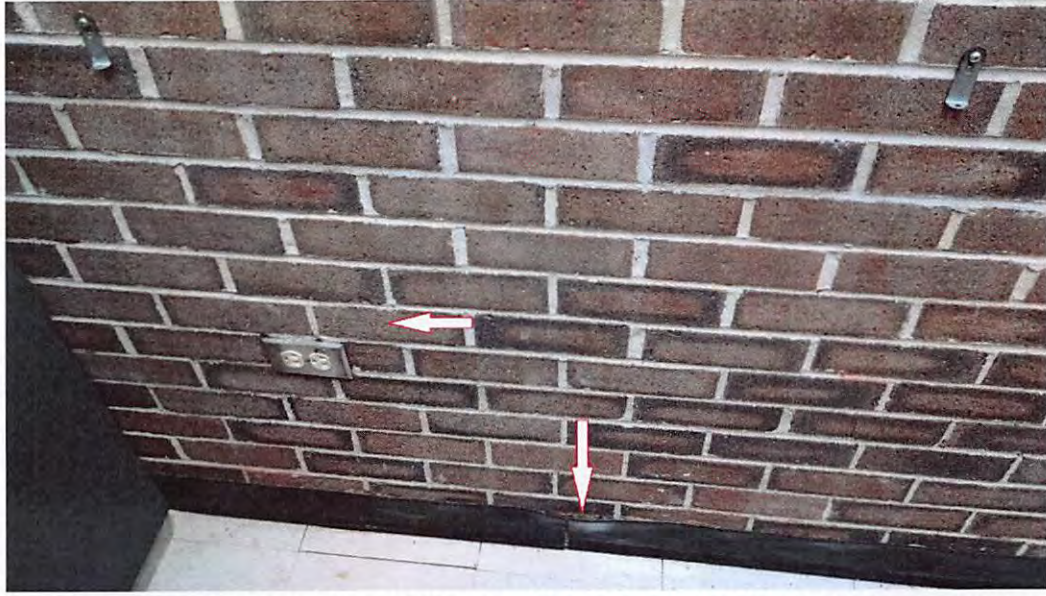
VIEW OF ANOTHER CRACK IN WALL OF POLICE CHIEF'S OFFICE. FLOOR IS SEPARATING FROM WALL. THIS IS AN EXTERIOR WALL.

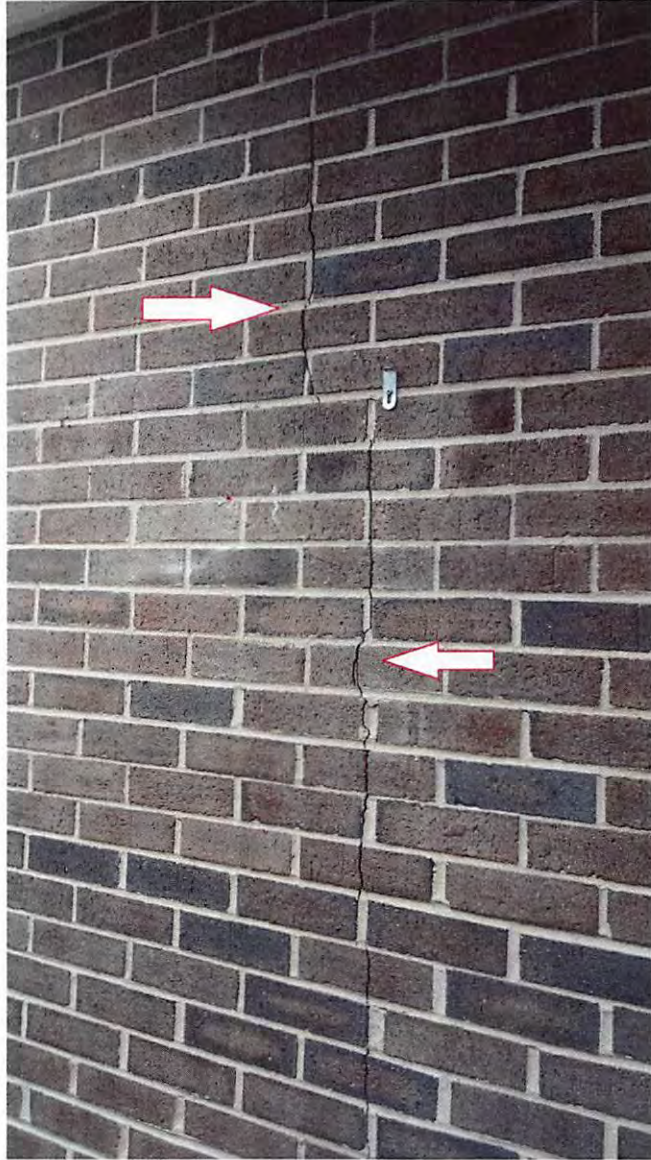
VERTICAL CRACK IN WALL OF POLICE CHIEF'S OFFICE. THIS CRACK EXTENDS FROM FLOOR TO CEILING. THIS IS AN EXTERIOR WALL.

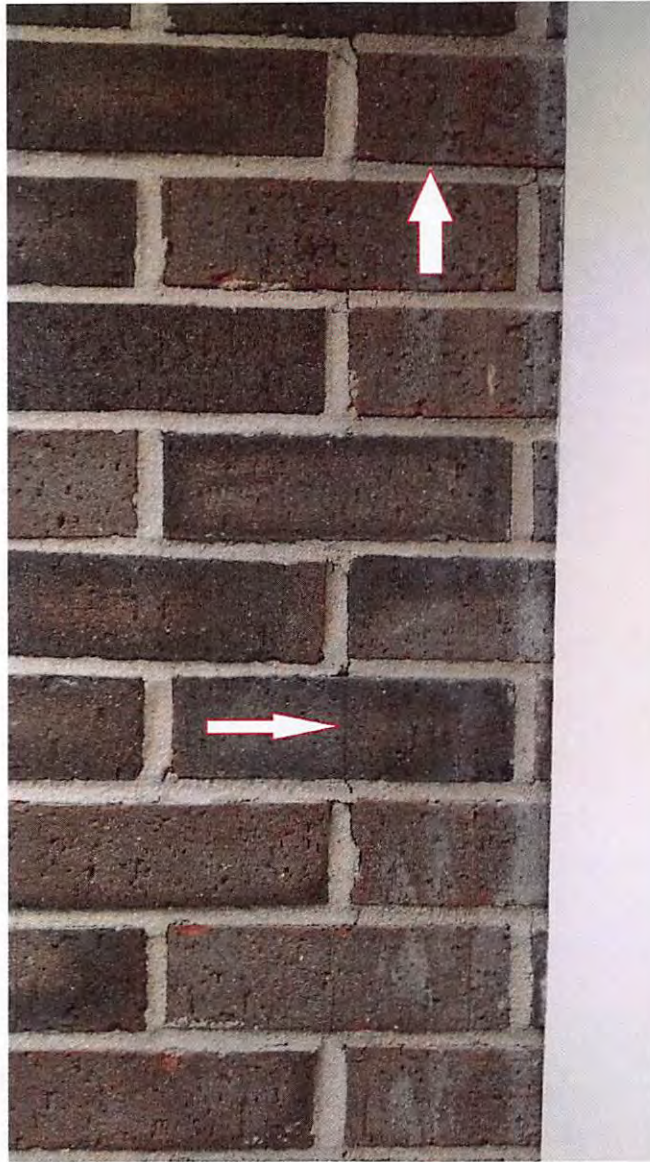
HORIZONTAL AND VERTICAL CRACK IN WALL OF WOMEN'S RESTROOM IN LOBBY.

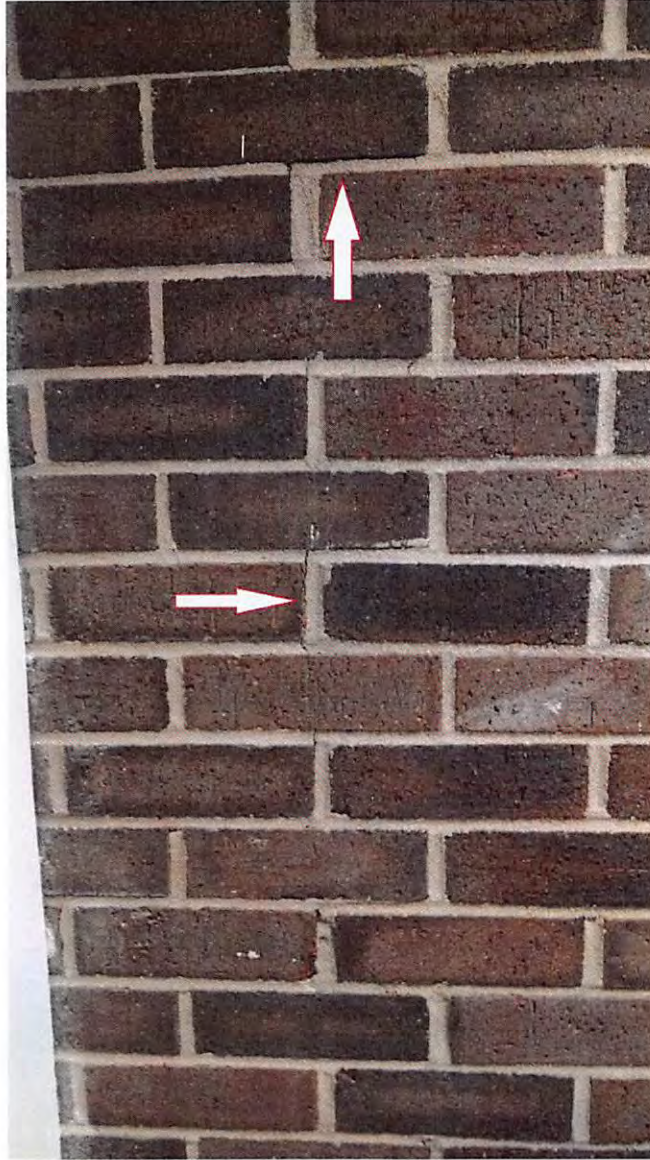
HORIZONTAL AND VERTICAL CRACK IN MEN'S RESTROOM IN LOBBY.

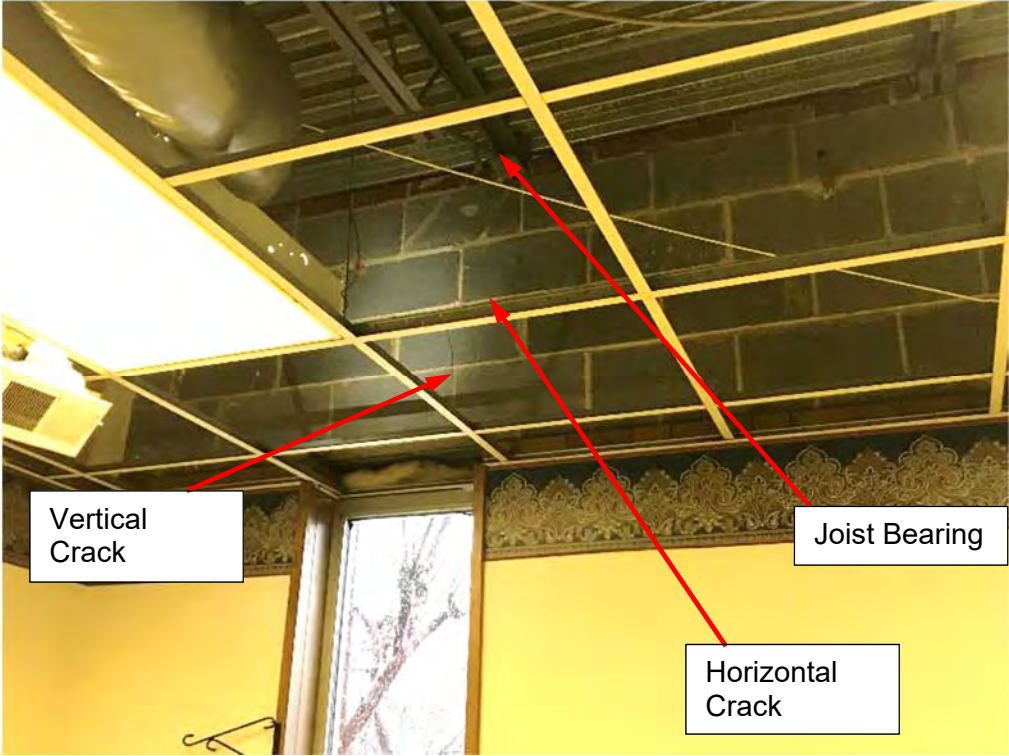
Photo 1 Town Hall – West Wall – Horizontal and Vertical Cracks

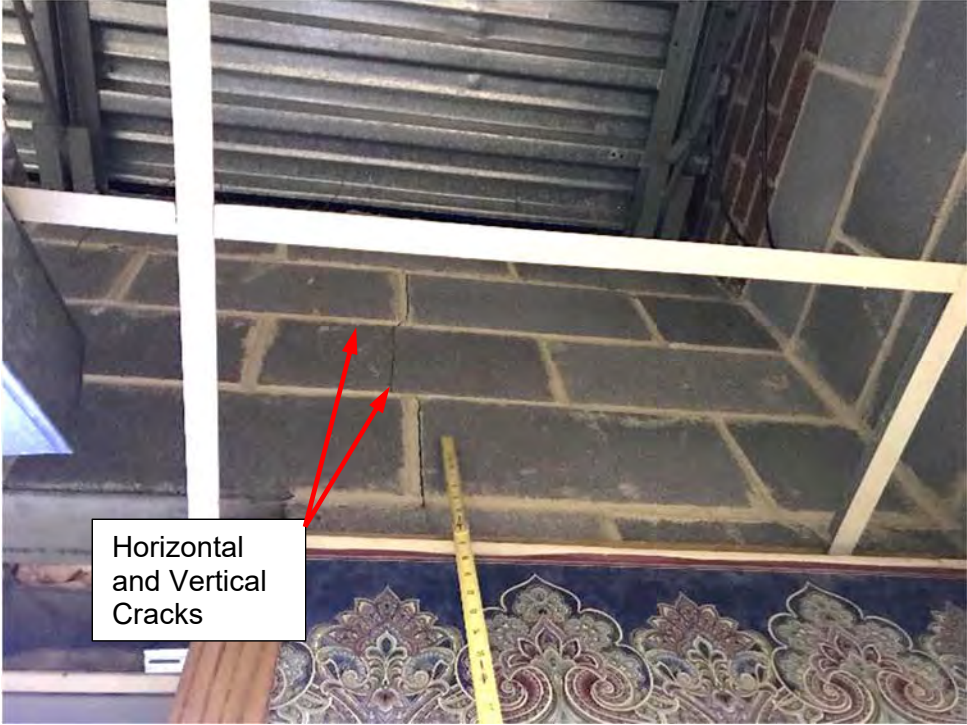
Vertical cracks are located at approximately 10 feet on center in the rear room of the building along the east exterior wall and part of the north wall. The cracks generally extend from floor to near the ceiling, but do not appear to extend above the reinforced bond beam at the top of the cmu interior wythe. It is reasonably obvious that the reason this is so is because the grouted and reinforced bond beam is restrained against cracking relative to the hollow unreinforced interior cmu wythe immediately below. Typical vertical cracks are depicted in Photos 2, 3, 4, and 5.

Photo 2 Town Hall – West Wall – Horizontal and Vertical Cracks

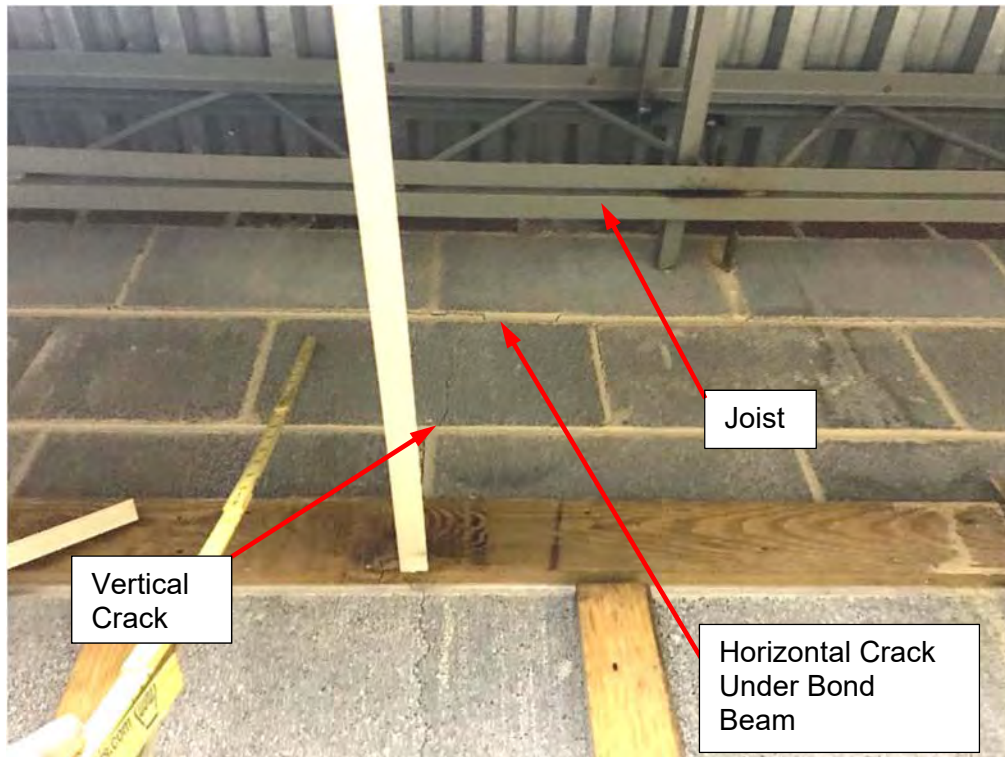
The horizontal cracks are typically located at the approximate elevation of the bottom of the steel reinforced Bond Beam, see Photo 3 and 4 and Figure 7. This condition persists along the north exterior wall and east exterior wall. Per Figure 7 from the Town Hall record drawings, the joint at the bottom of the bond beam is located at the crack elevation. In addition, the presumed horizontal joint reinforcing elevation is at the joint at the bottom of the bond beam. Horizontal joint reinforcing and the infilled bond beam appear to create a stress concentration at that elevation with respect out of plane loading.

Photo 3 Town Hall – South Wall – Horizontal and Vertical Cracks

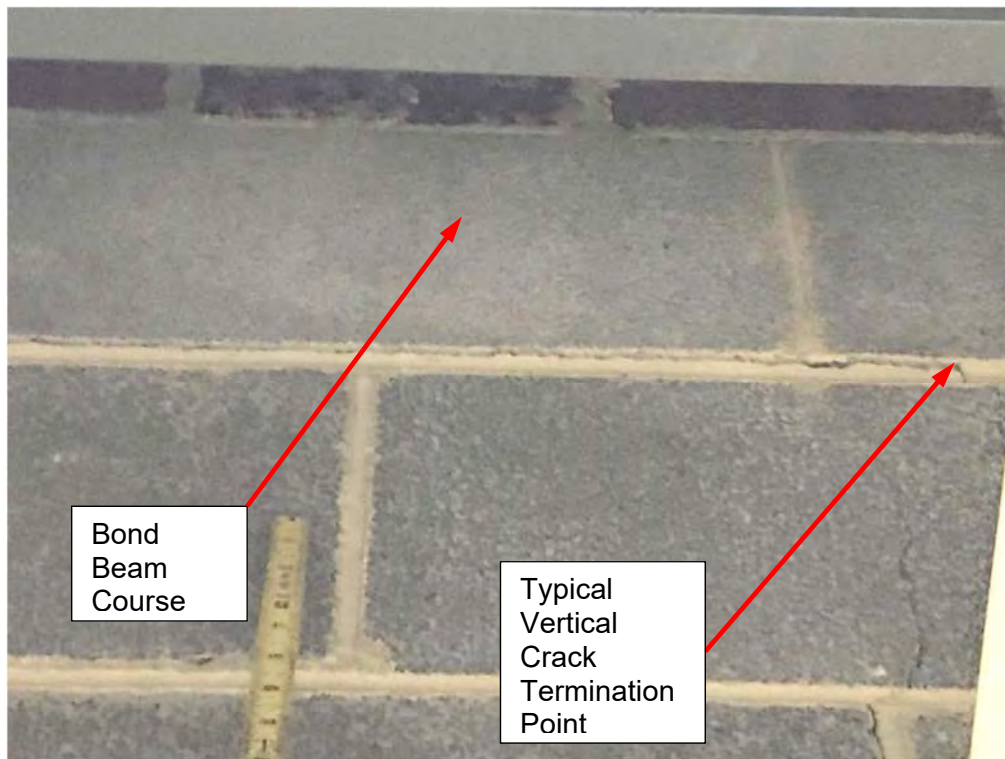
Photo 4 Town Hall – South Wall – Horizontal and Vertical Cracks
