Town of Valdese
Public Safety Building Report
2021

Re: Inspection of Cracks in Building for
Fire Department and Police Department

VALDESE FIRE DEPARTMENT
Public Safety Building Inspection

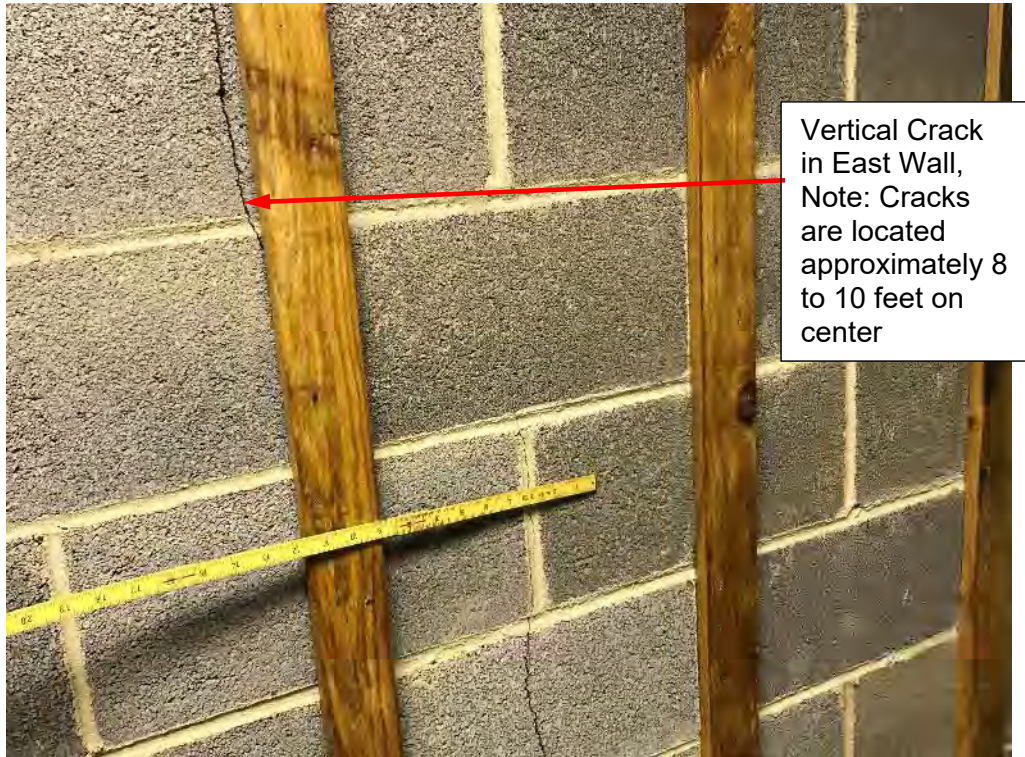
Vertical cracks are located at approximately 10 feet on center in the rear room of the building along the east exterior wall and part of the north wall. The cracks generally extend from floor to near the ceiling, but do not appear to extend above the reinforced bond beam at the top of the cmu interior wythe. It is reasonably obvious that the reason this is so is because the grouted and reinforced bond beam is restrained against cracking relative to the hollow unreinforced interior cmu wythe immediately below. Typical vertical cracks are depicted in Photos 2, 3, 4, and 5.

Vertical Crack
in East Wall,
Note: Cracks
are located
approximately 8
to 10 feet on
center

Photo 5 Town Hall – East Wall – Vertical Cracks

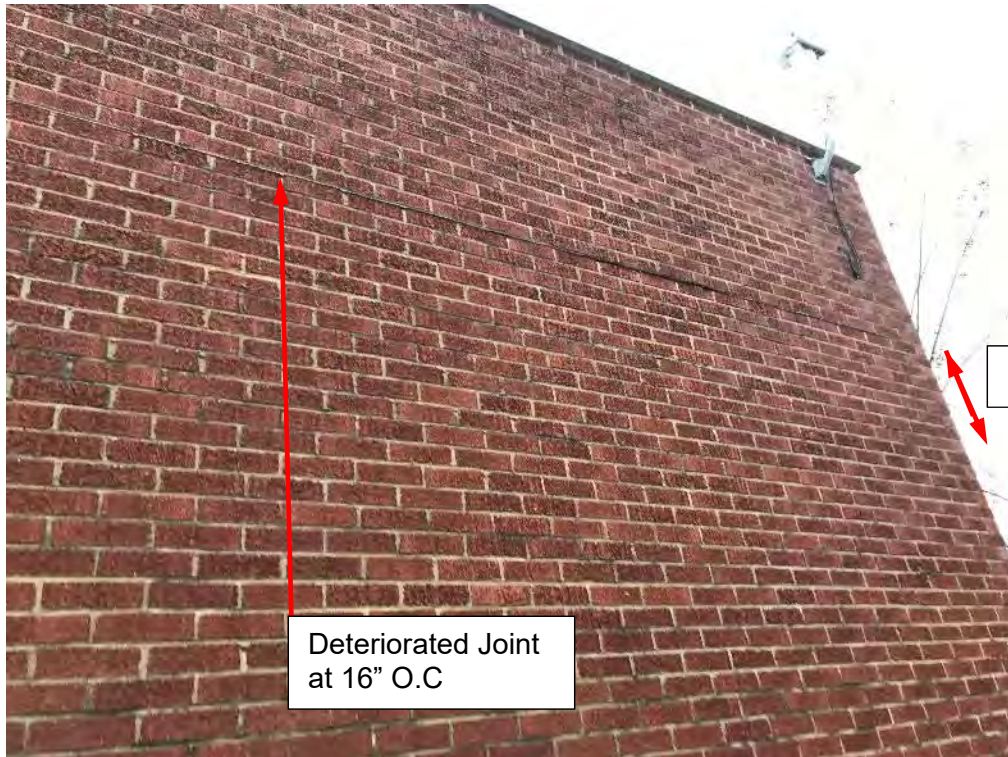
Deteriorated Joint
at 16" O.C

Photo 6 Town Hall – South Wall – Deteriorated Joints

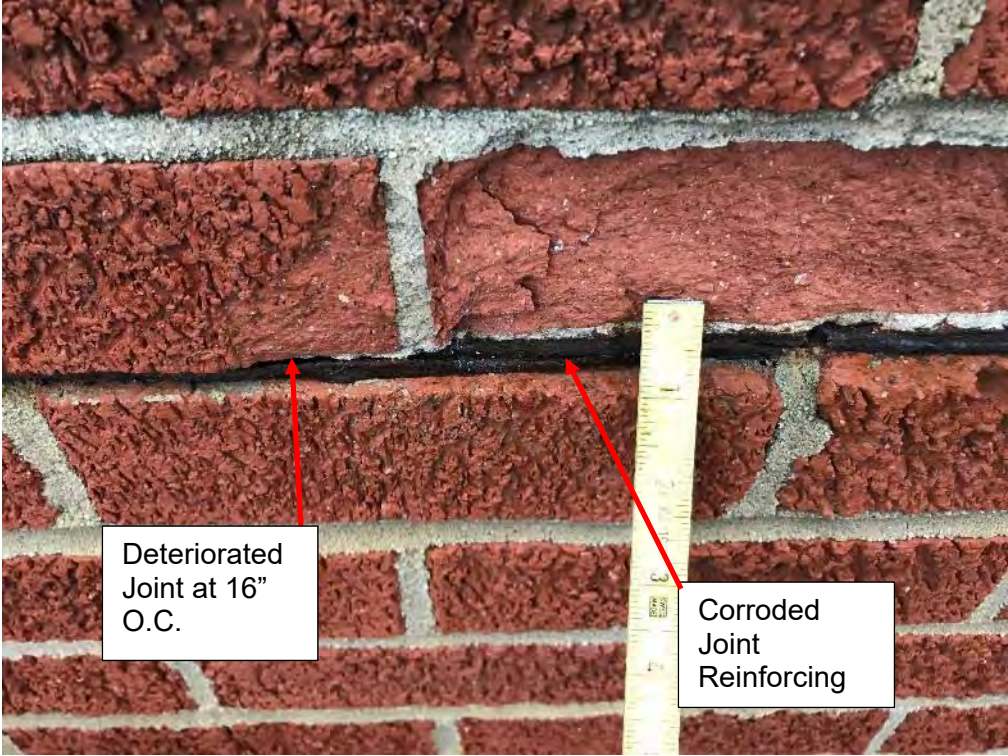
Photo 7 Town Hall – South Wall – Deteriorated Joints

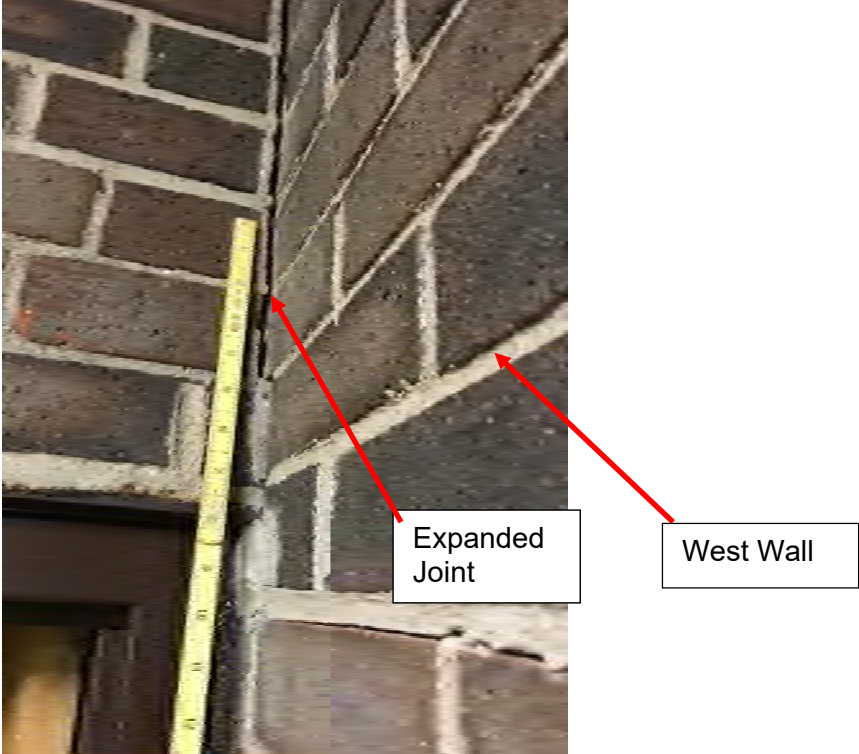
Photo 8 Public Safety Building – West Wall – Expanded Joint/Crack

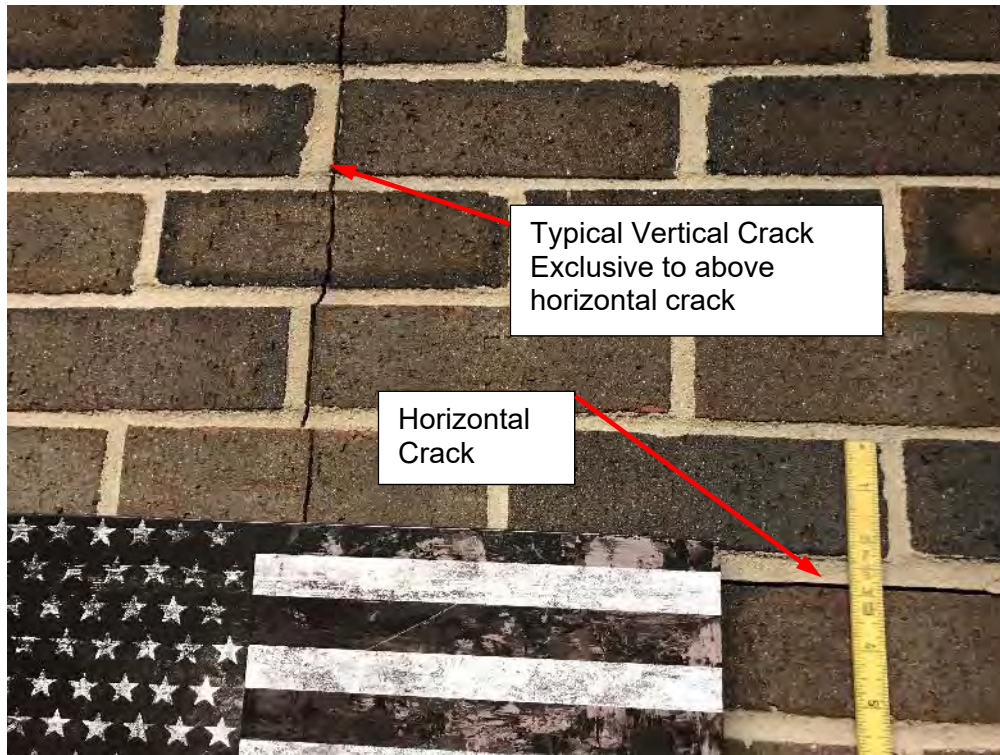
Photo 9 Public Safety Building – West Wall – Horiz./ Vertical Cracks

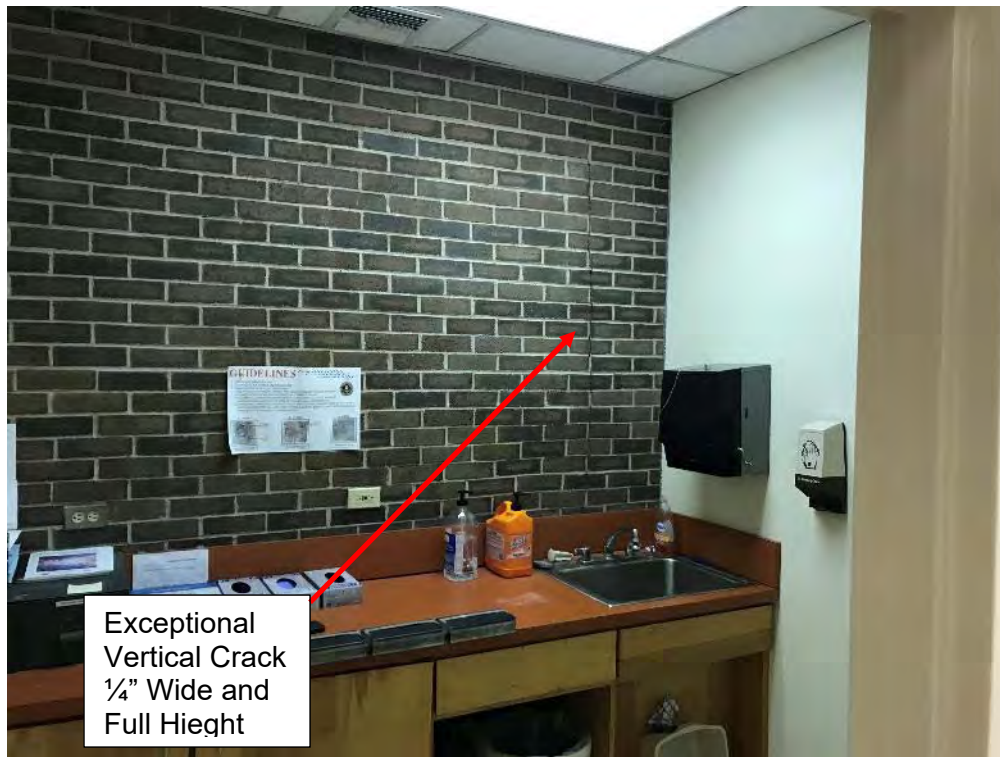
Photo 10 Public Safety Building – East Wall – Vertical Crack

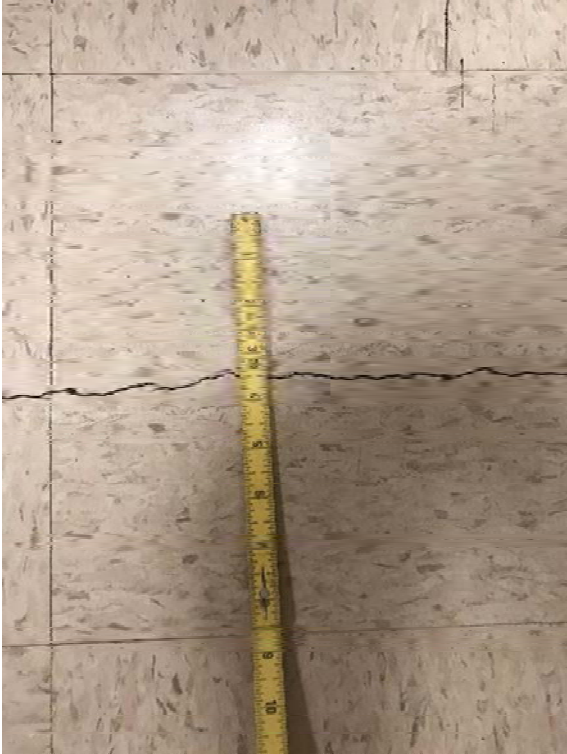
Photo 11 Public Safety Building – Interior Slab – Crack

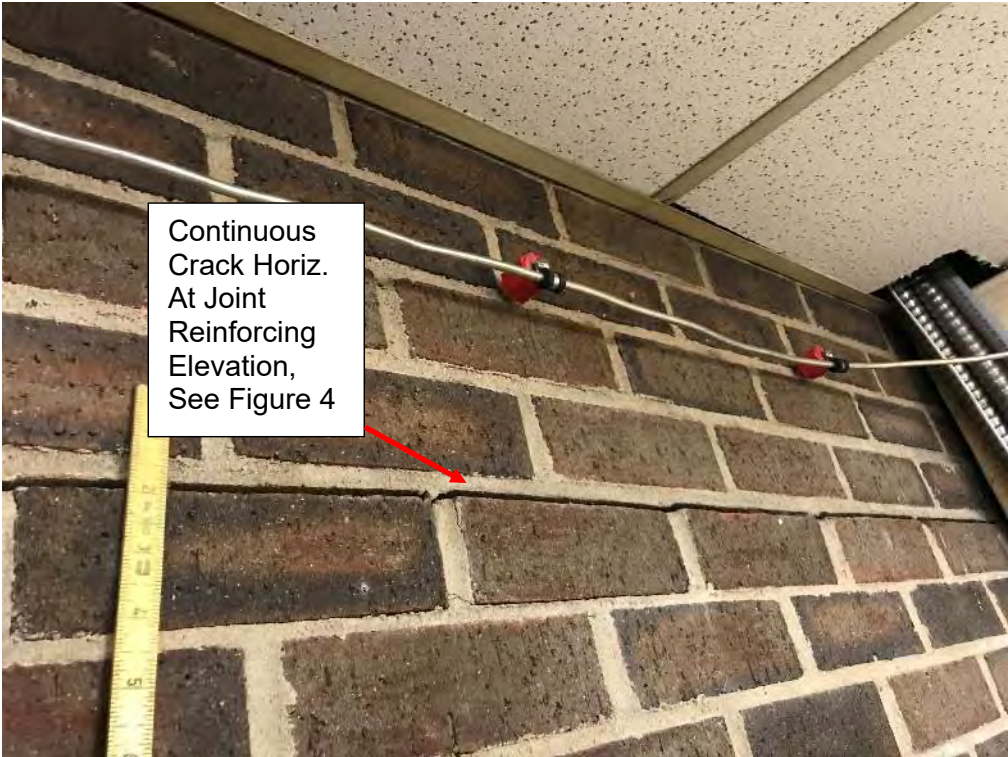
Photo 12 Public Safety Building – South Wall – Horizontal Crack

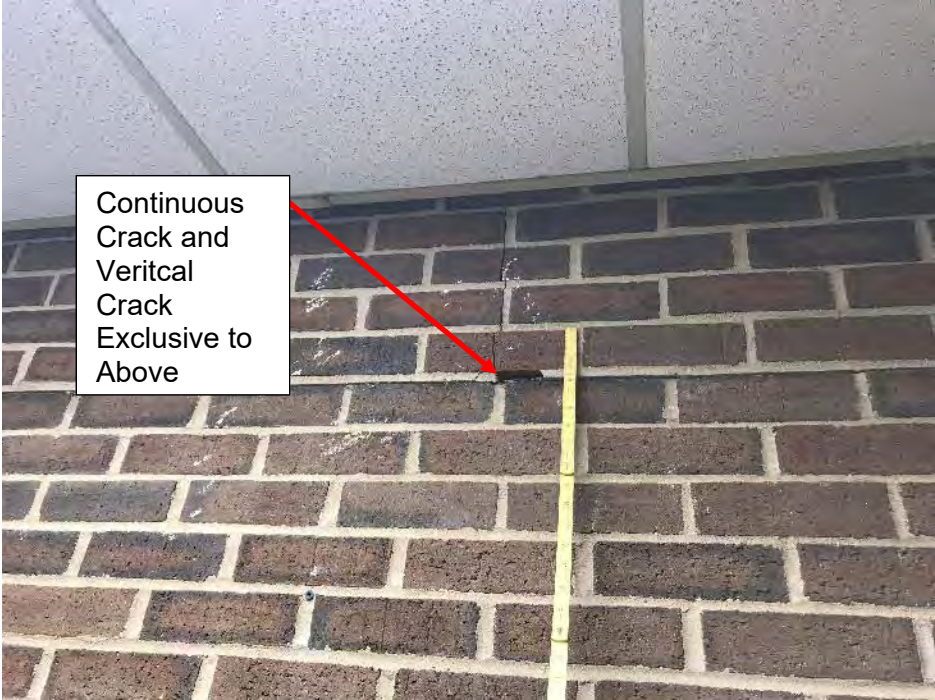
Photo 13 Public Safety Building – South Wall – Horizontal Crack

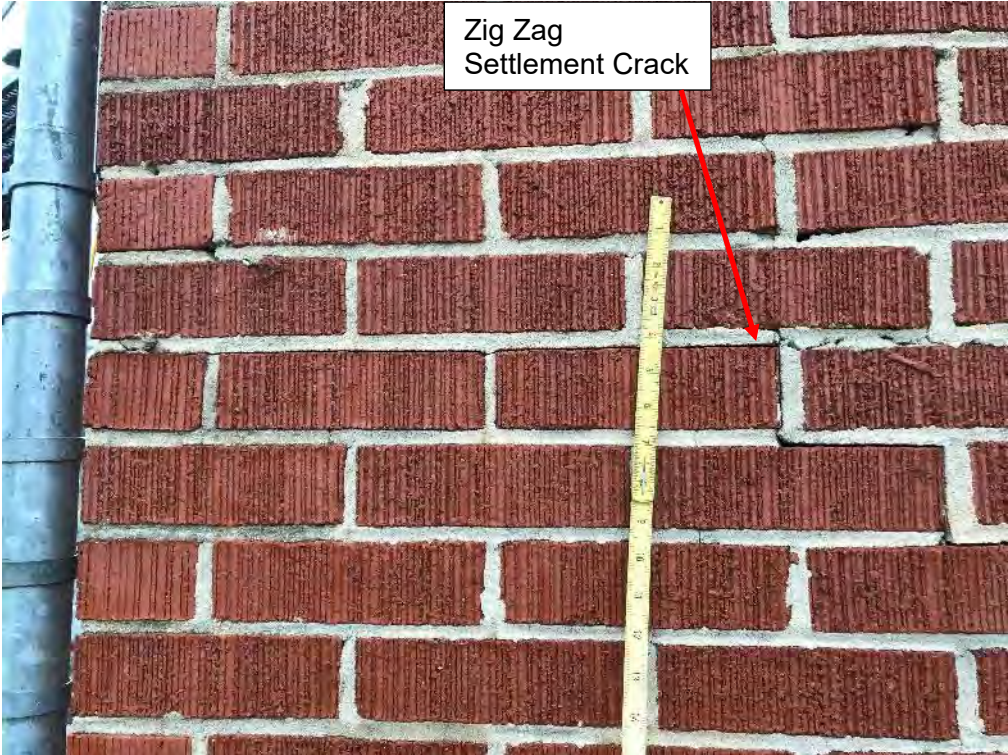
Photo 14 Public Safety Building – Southeast Corner – Zig Zag Crack

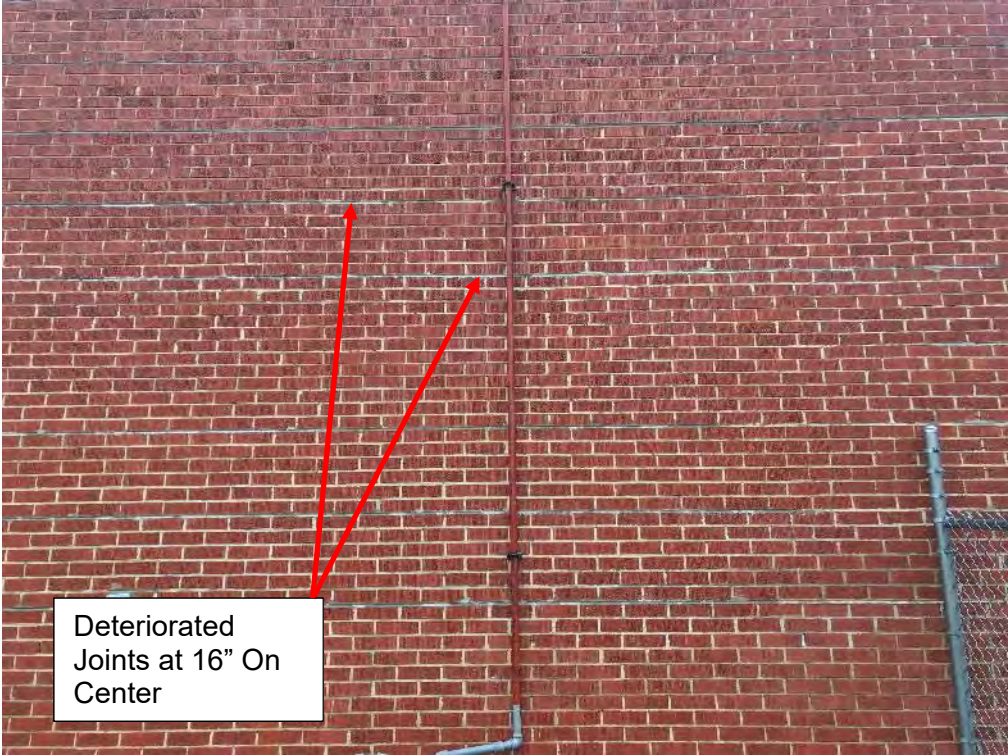
Photo 15 Public Safety Building – South Wall – Deteriorated Joints

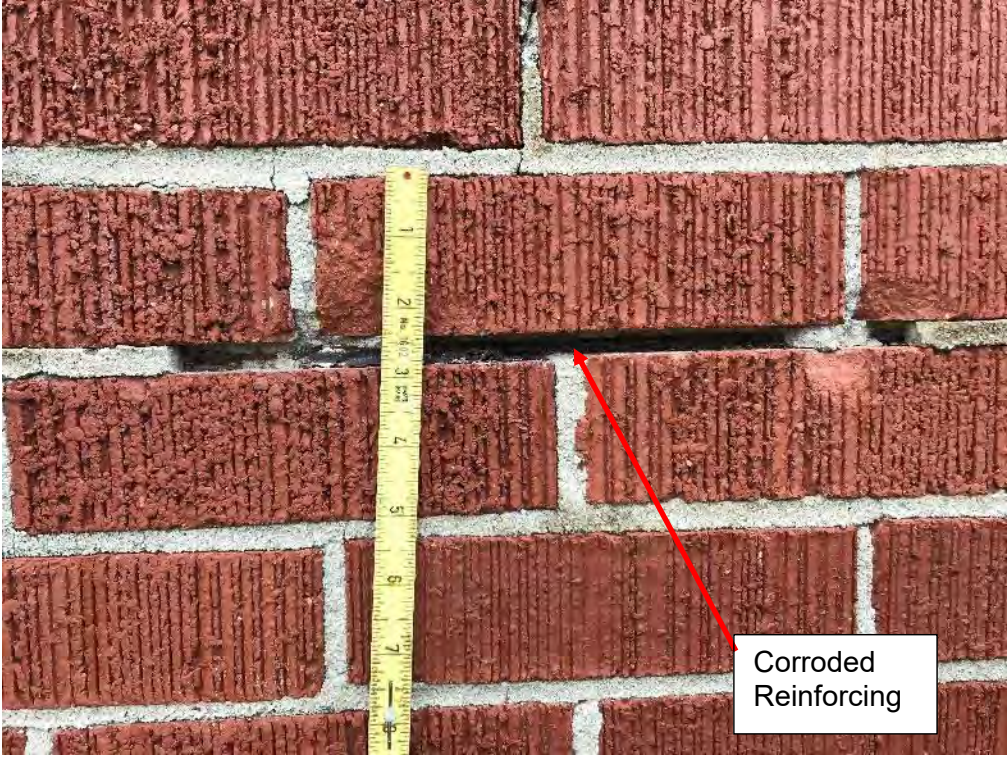
Photo 16 Public Safety Building – South Wall – Deteriorated Joints

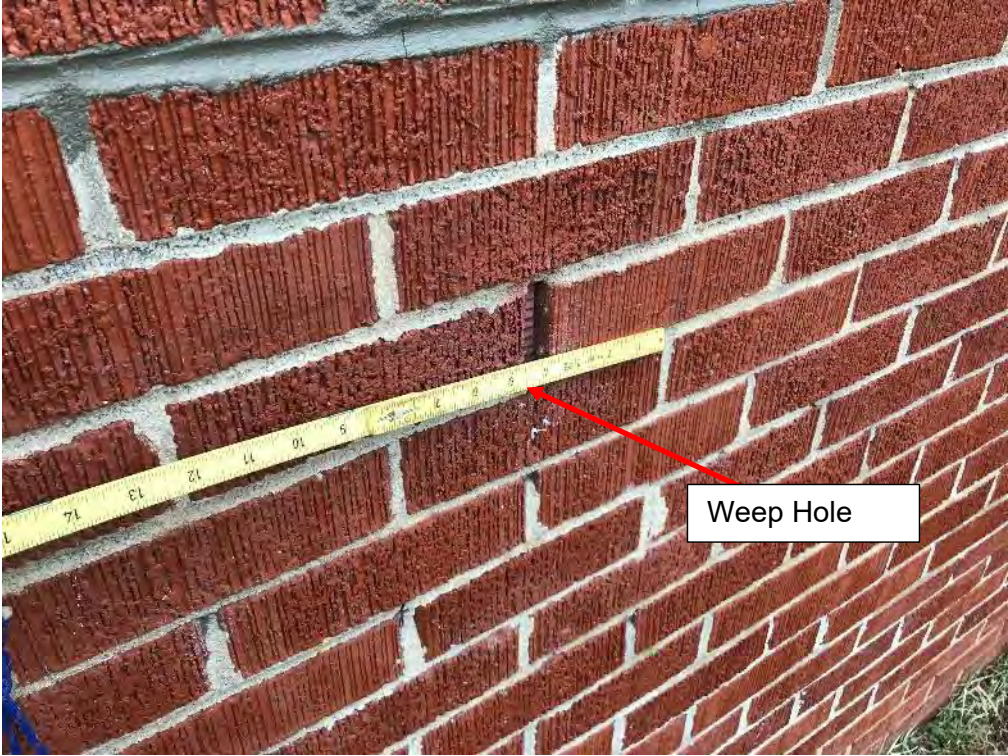
Photo 17 Public Safety Building – South Wall – Repaired Joint and Weep

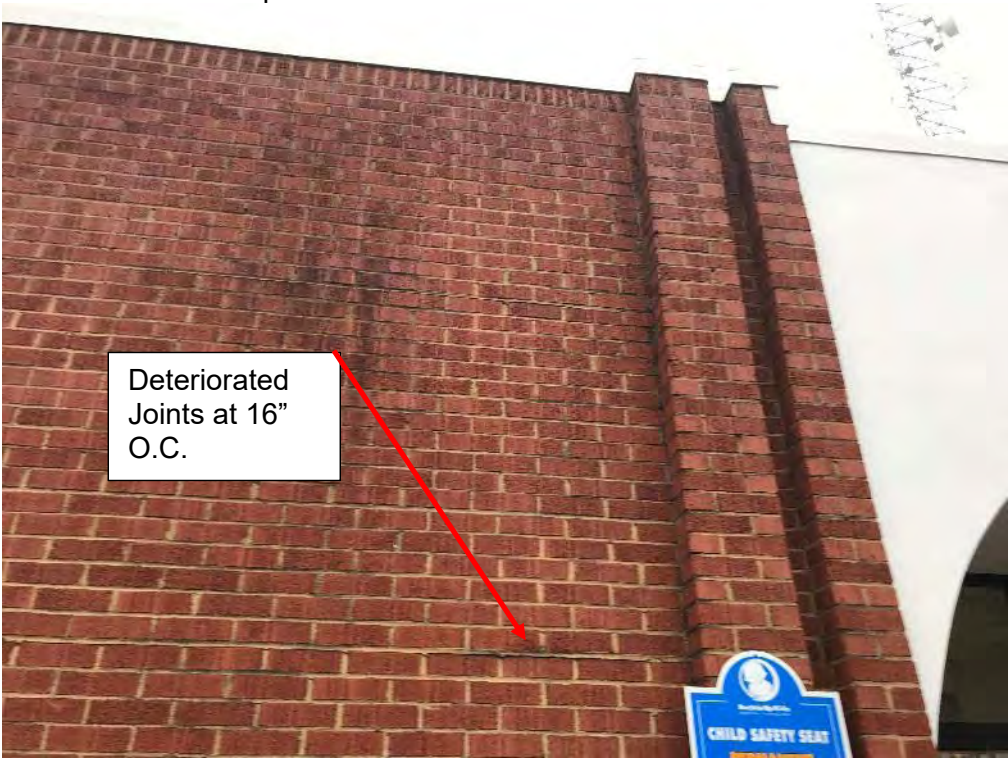
Photo 18 Public Safety Building – West Wall – Deteriorated Joints

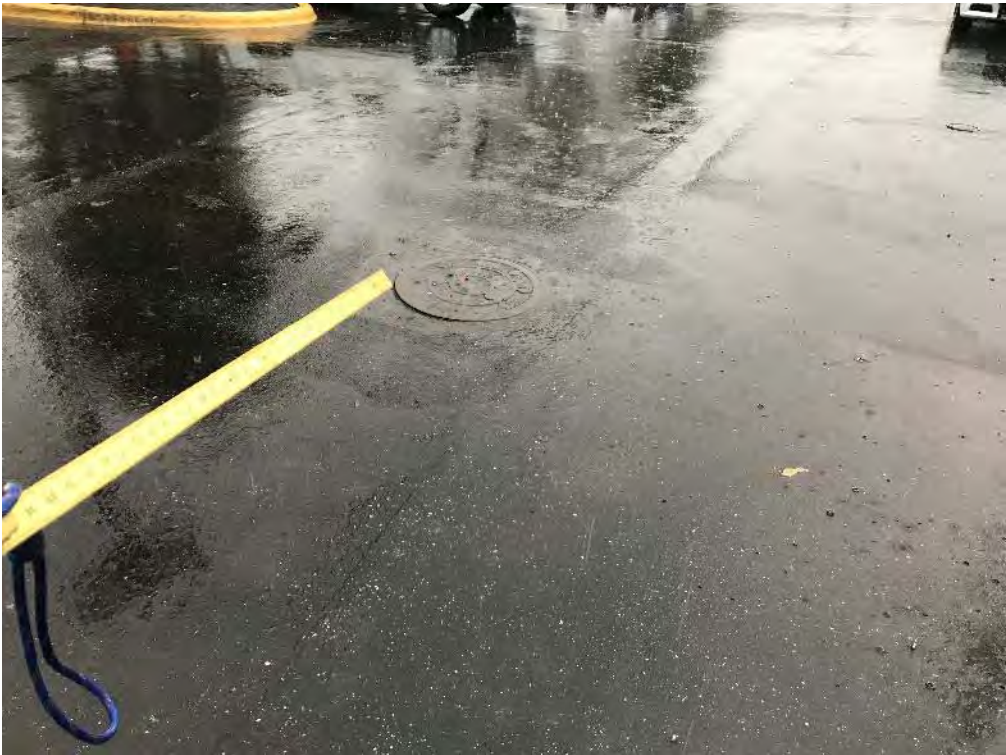
Photo 19 Public Safety Building – East Side – Manhole

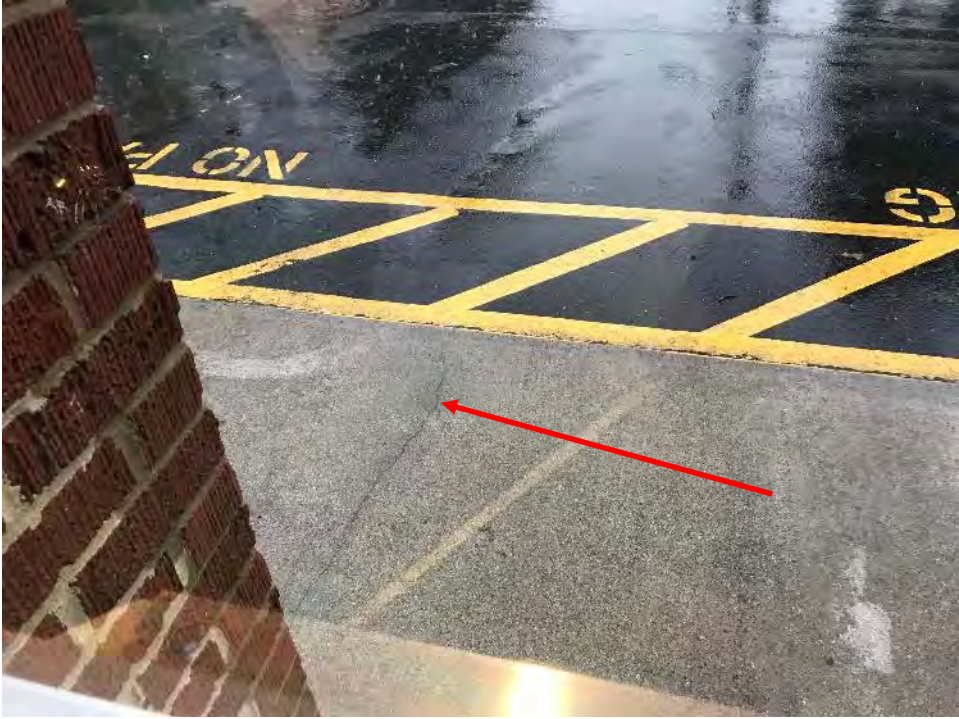
Photo 21 Public Safety Building – East Side – Cracked Slab

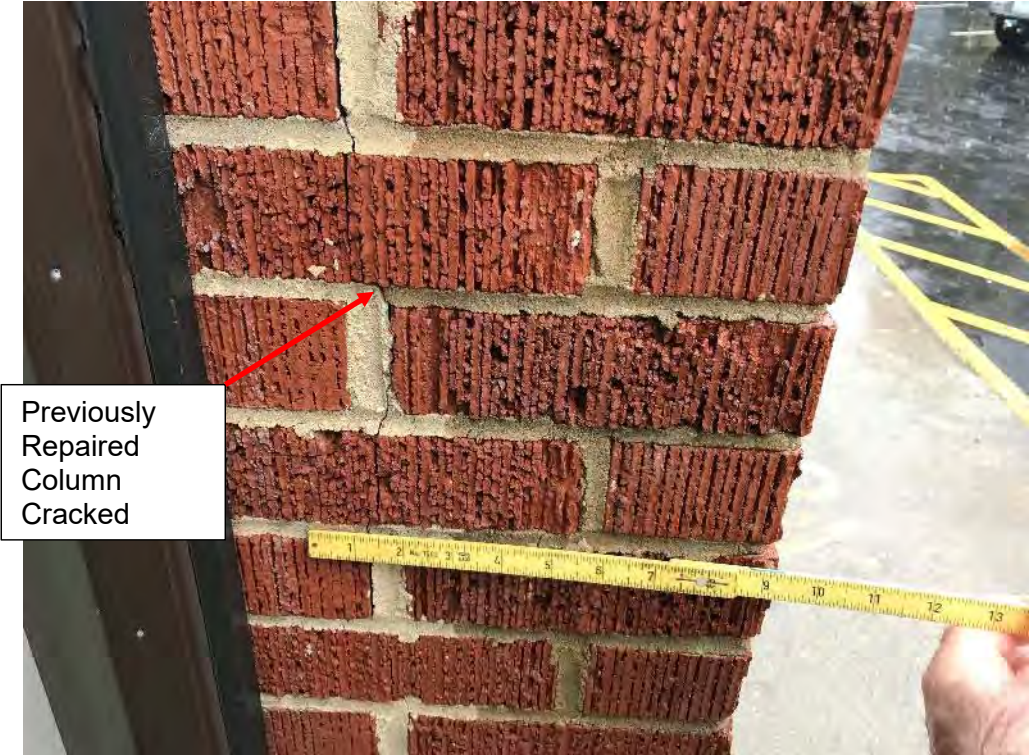
Photo 22 Public Safety Building – East Side – Cracked Column

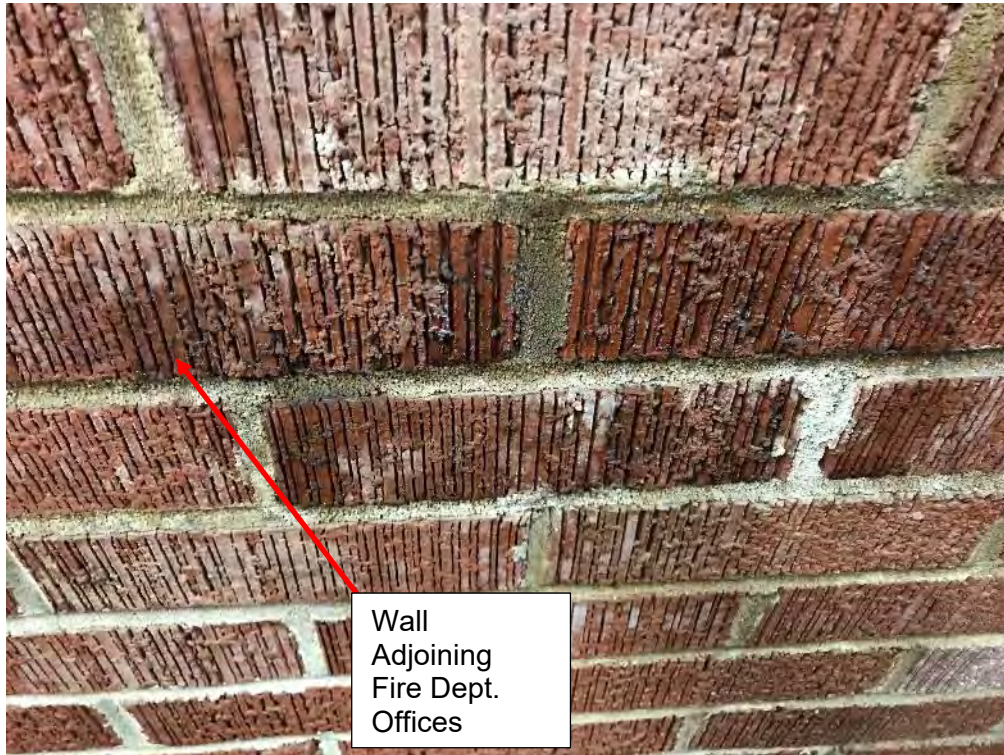
Photo 23 Public Safety Building – Engine Bay – Efflorescence

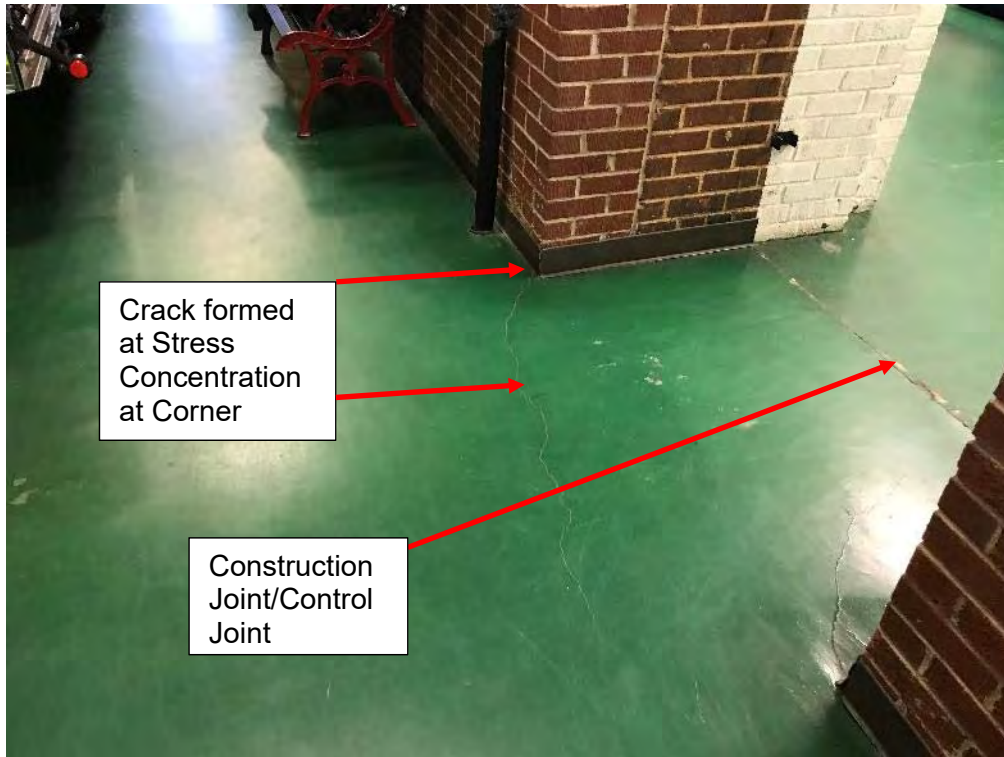
Photo 24 Public Safety Building – Engine Bay – Cracked Slab

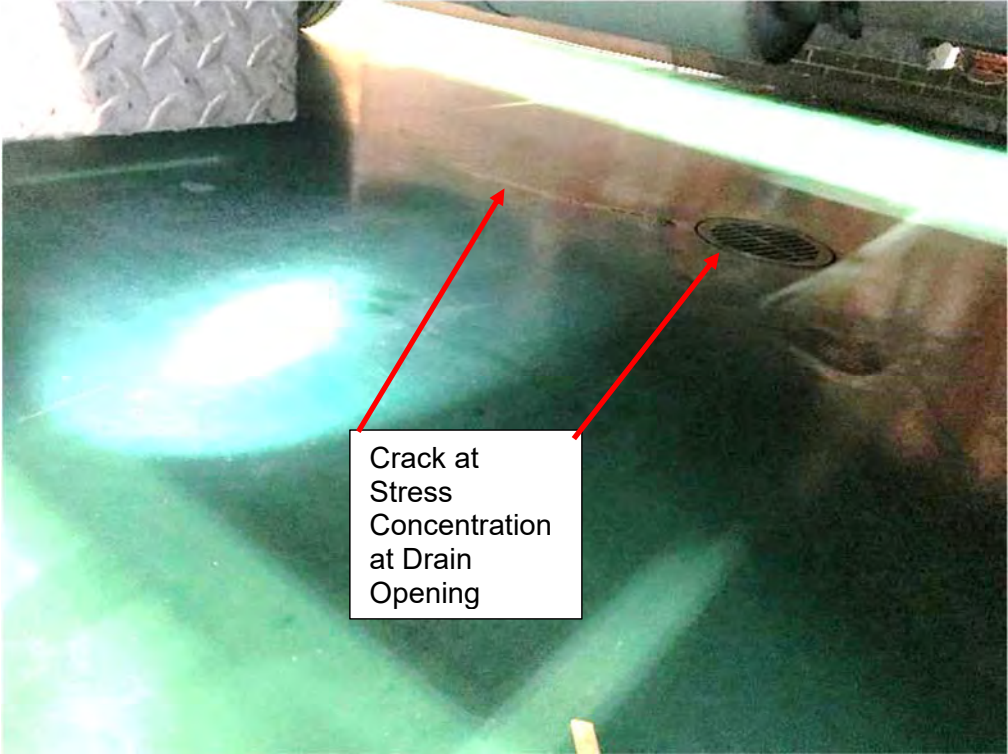
Photo 25 Public Safety Building – Engine Bay – Cracked Slab

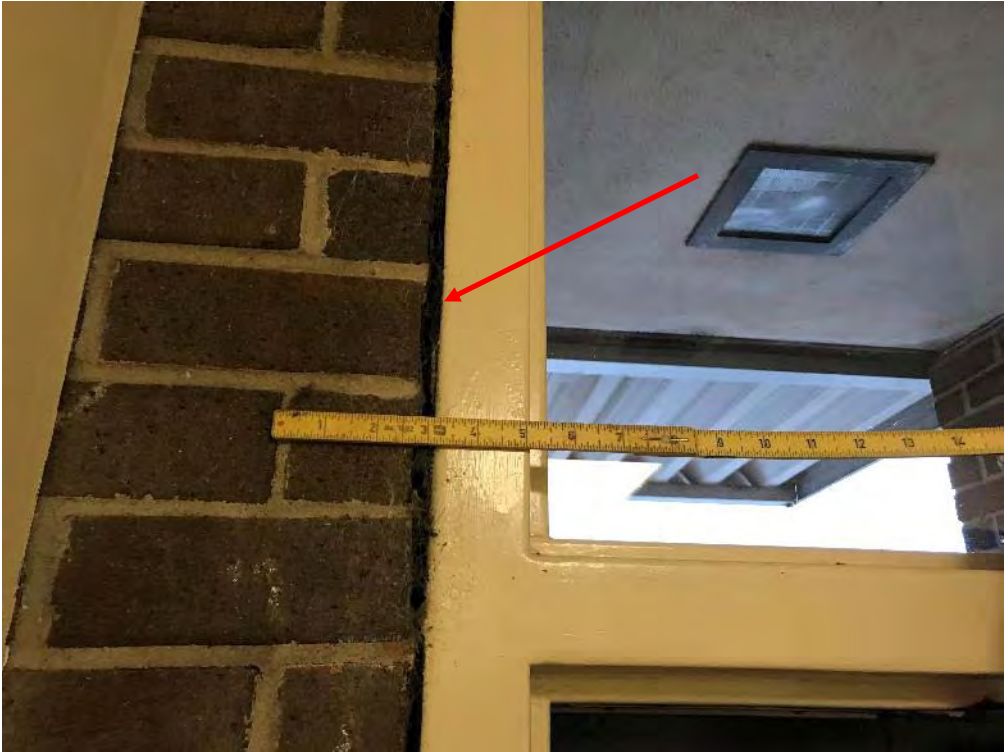
Photo 26 Public Safety Building – East Wall – Separation at Door Frame

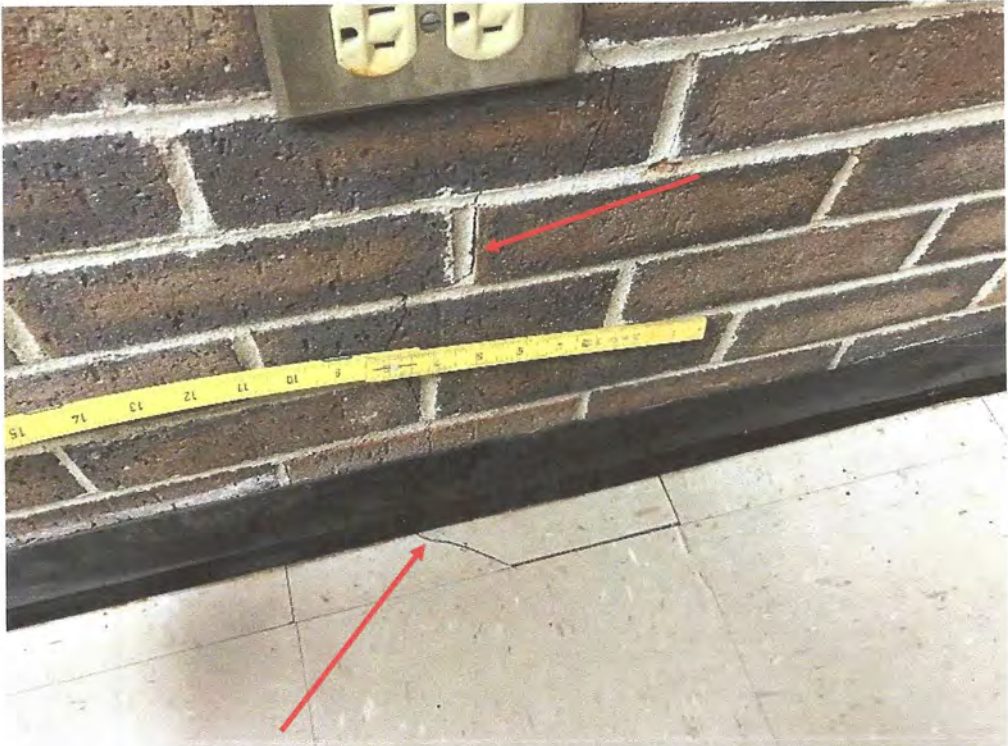
Photo 28 Public Safety Building – West Wall – Wall and Slab Crack

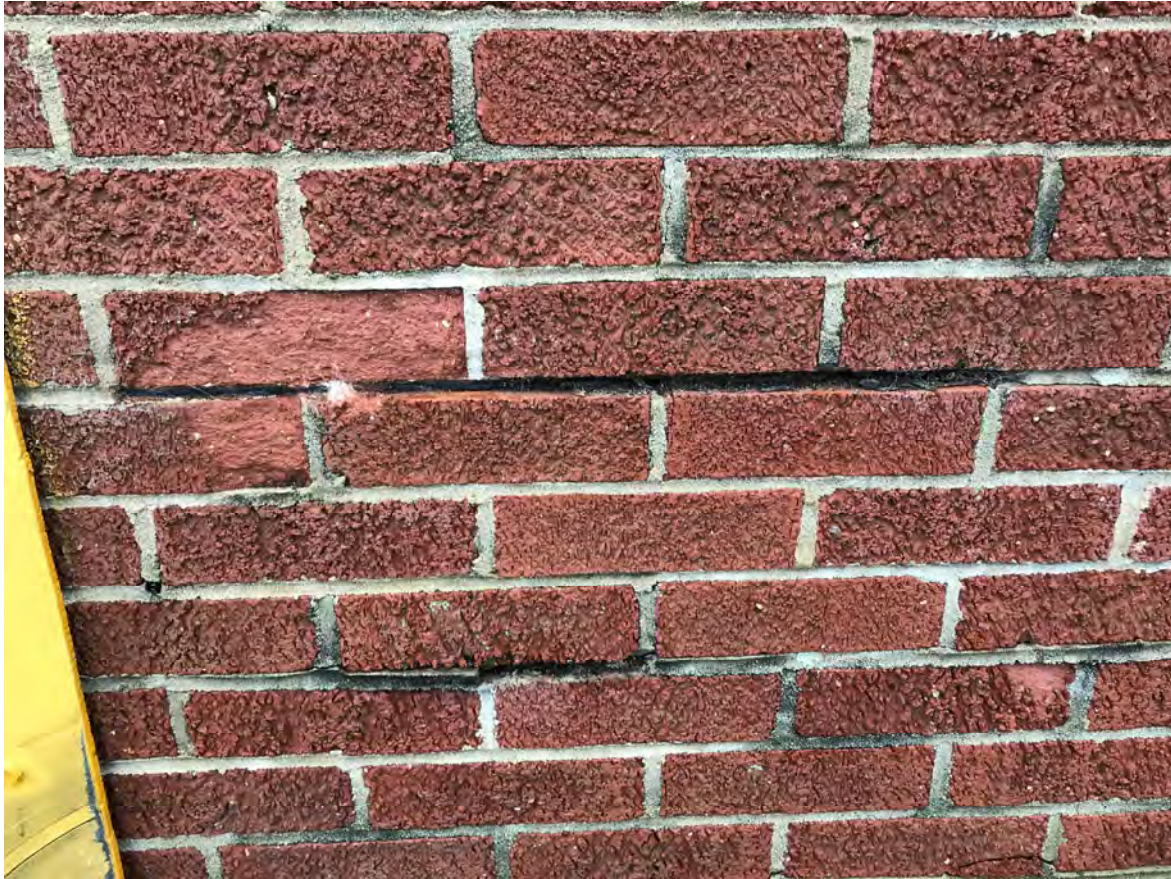
Photo 1 – Exterior Brick with Obvious Severe and often 100% Reinforcing Corrosion and Mortar Spalling

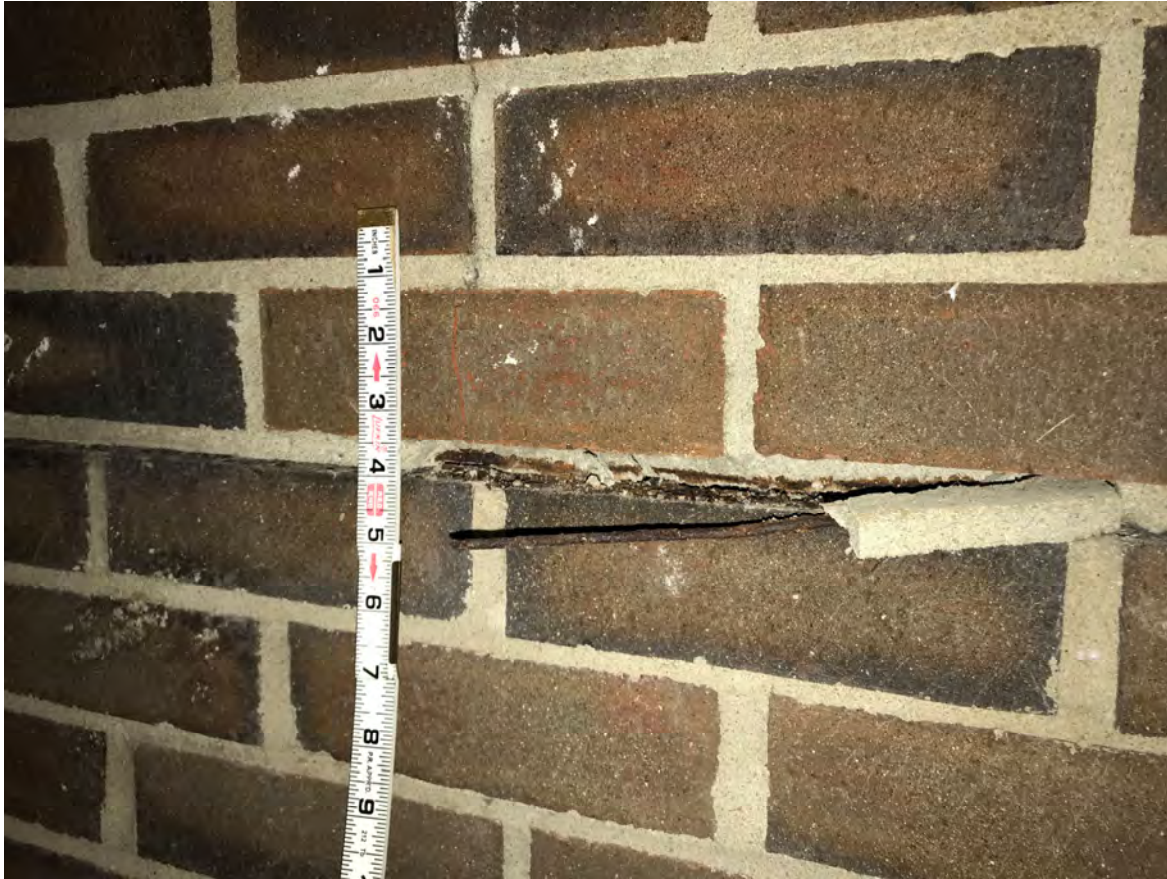
Photo 2 – 100% corroded wire reinforcing (examples were discovered in both Chief Watts office and the room adjacent to Chief Moss's office in December 2018)

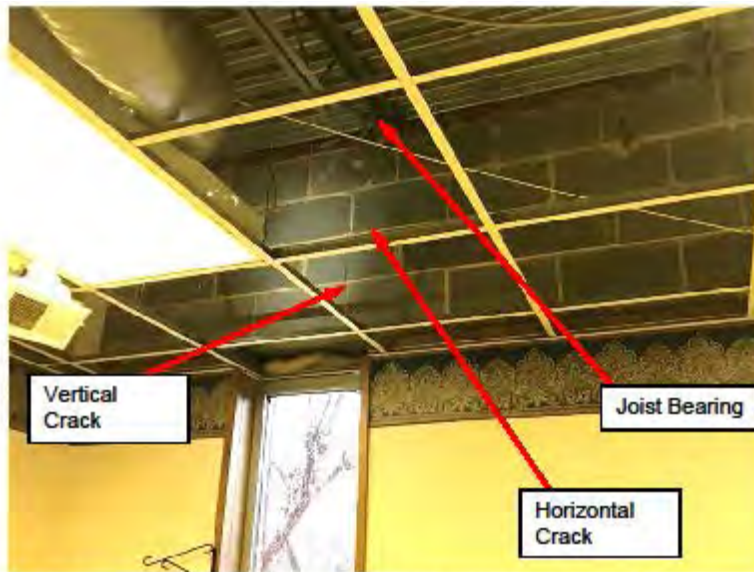
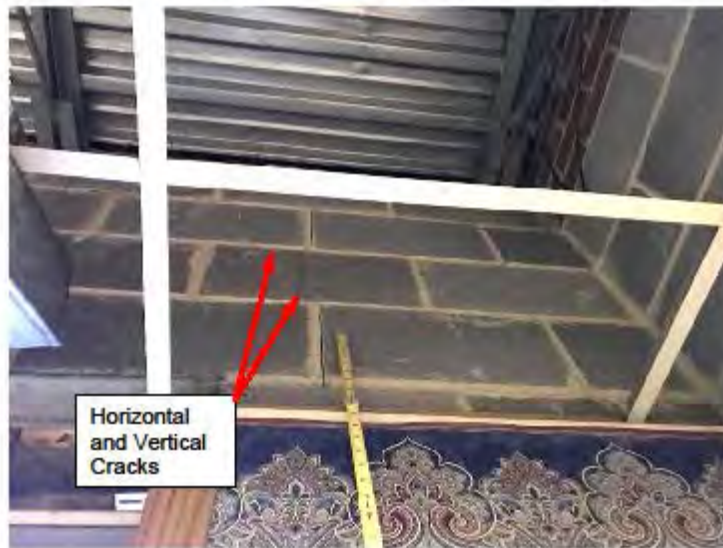
Cracks in load bearing masonry block walls.

Photo 1 Town Hall – West Wall – Horizontal and Vertical Cracks

Photo 2 Town Hall – West Wall – Horizontal and Vertical Cracks

Vertical cracks in mortar joints and through middle of block.

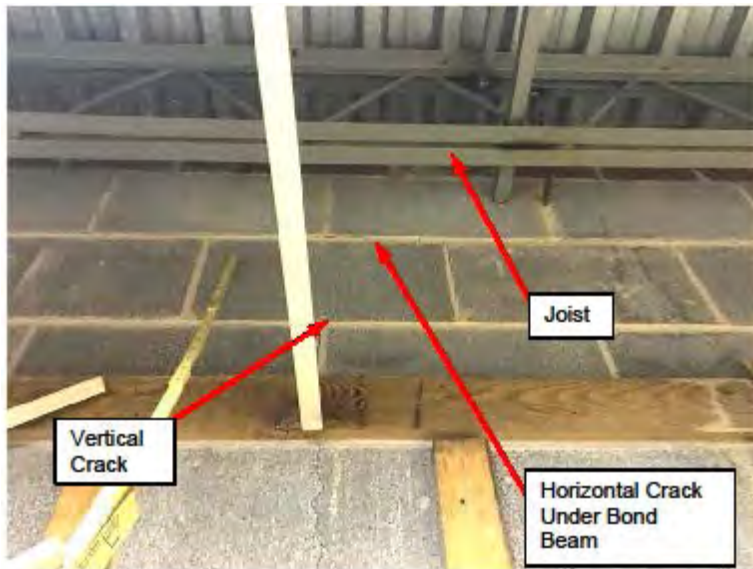
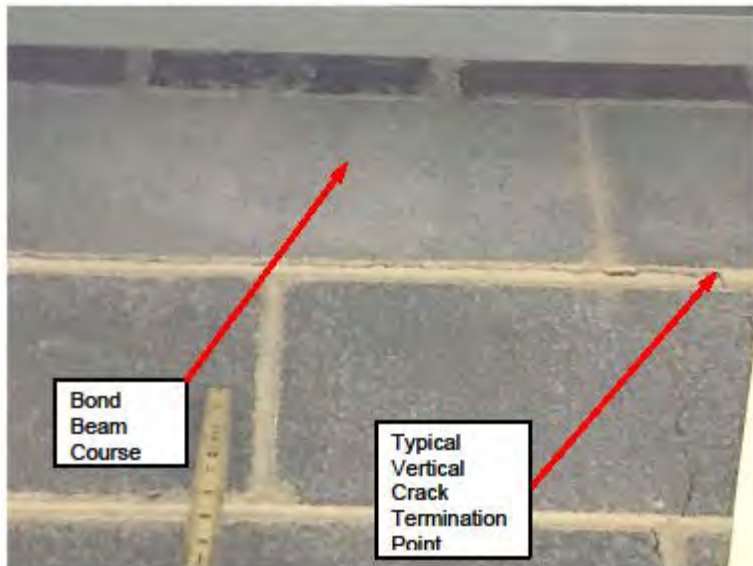
Cracks extend up to masonry block bond beam.

Photo 3 Town Hall – South Wall – Horizontal and Vertical Cracks

Photo 4 Town Hall – South Wall – Horizontal and Vertical Cracks

Horizontal cracks occur at bottom of masonry bond beams, separating bond beams from supporting walls.

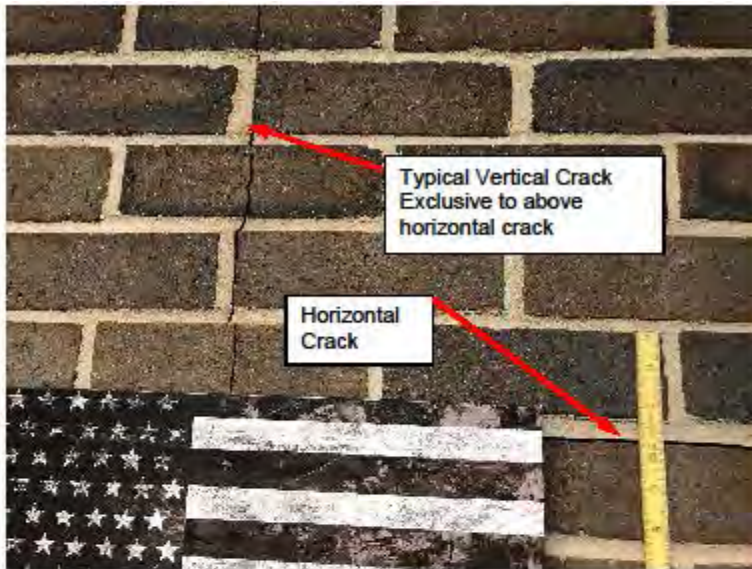
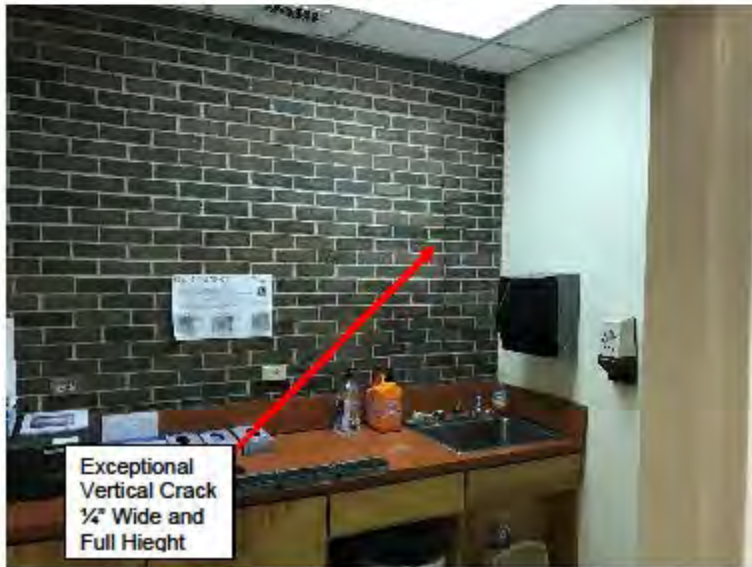
Vertical and horizontal cracks in load bearing double wythe brick wall.

Photo 9 Public Safety Building – West Wall – Horiz./ Vertical Cracks

Photo 10 Public Safety Building – East Wall – Vertical Crack

Some vertical cracks run full height of wall on interior of building.

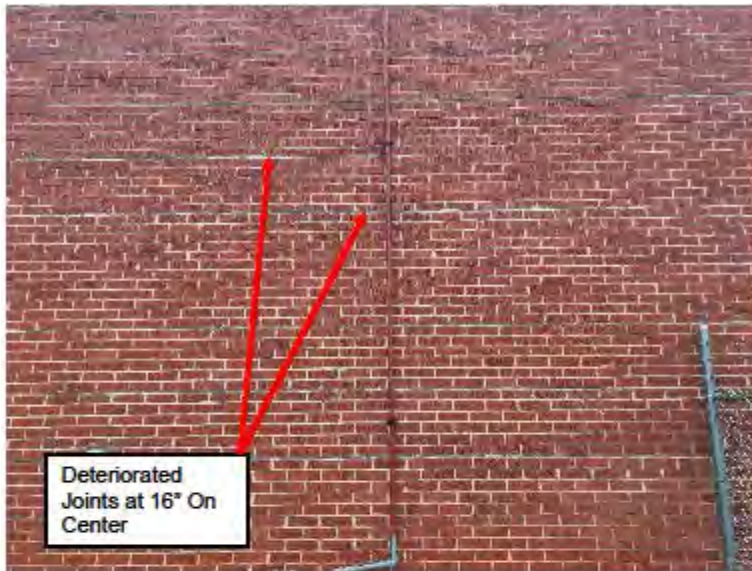
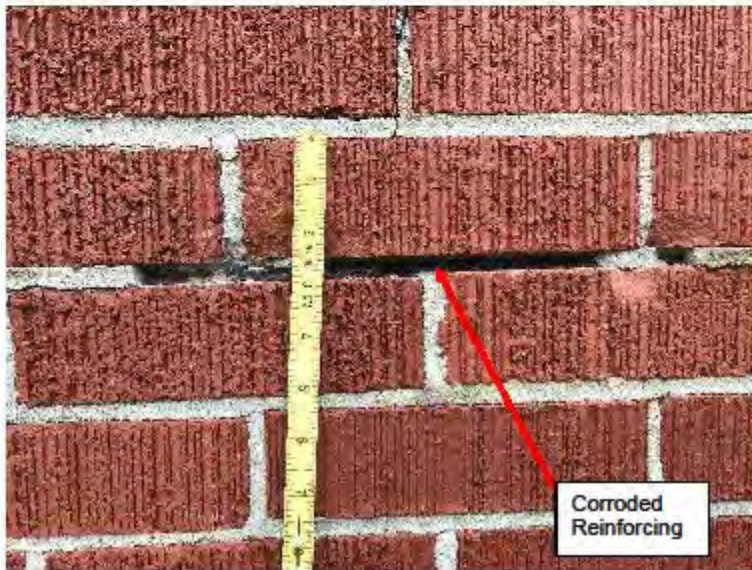
Exterior horizontal cracks at 16" on center at each band of steel ties.

Photo 15 Public Safety Building – South Wall – Deteriorated Joints

Photo 16 Public Safety Building – South Wall – Deteriorated Joints

Steel ties are rusting and pushing the mortar out. The deteriorated ties no longer hold the two wythes of brick together.
