Town of Valdese
Public Safety Building Report
2021

Re: Inspection of Cracks in Building for
Fire Department and Police Department

VALDESE FIRE DEPARTMENT
Public Safety Building Inspection

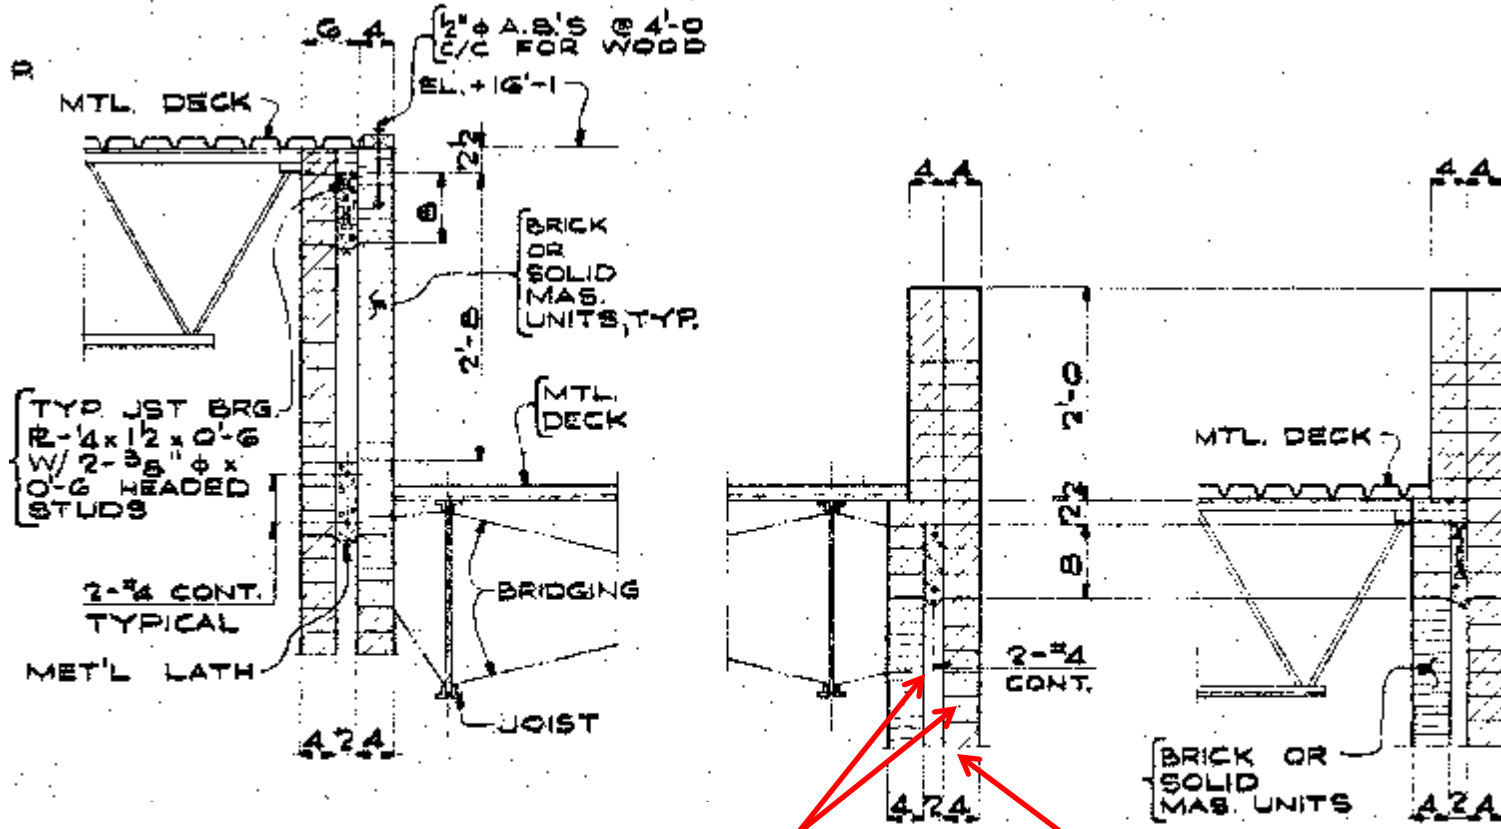
Public Safety Building Wall Section

The deteriorated steel ties no longer hold the two wythes of brick together.

Each wythe of wall is bowing out away from each other.
