Valdese Public Safety Building Evaluation

Outline

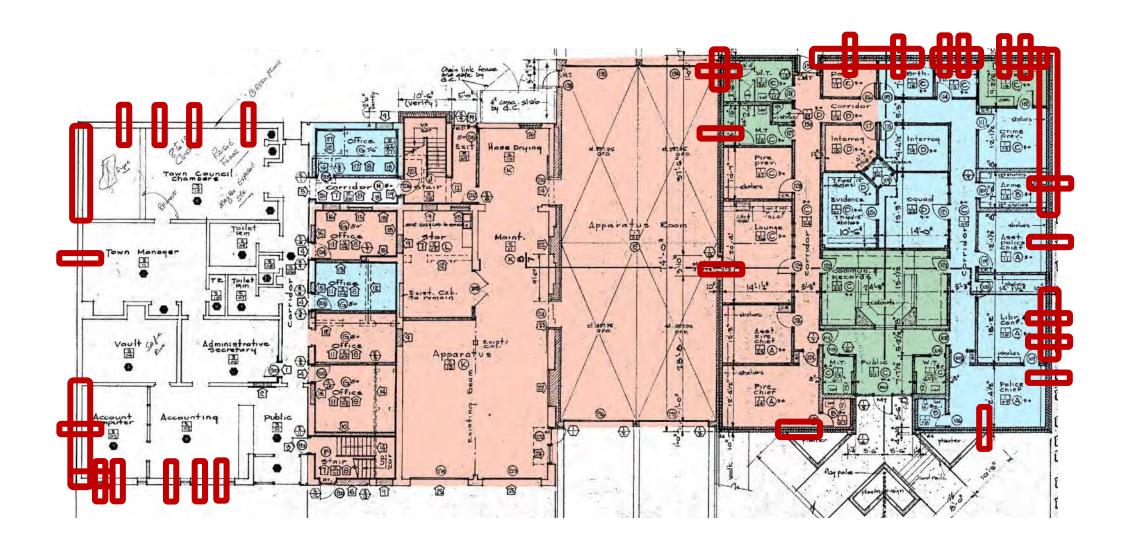
Interior Masonry Wall Cracks

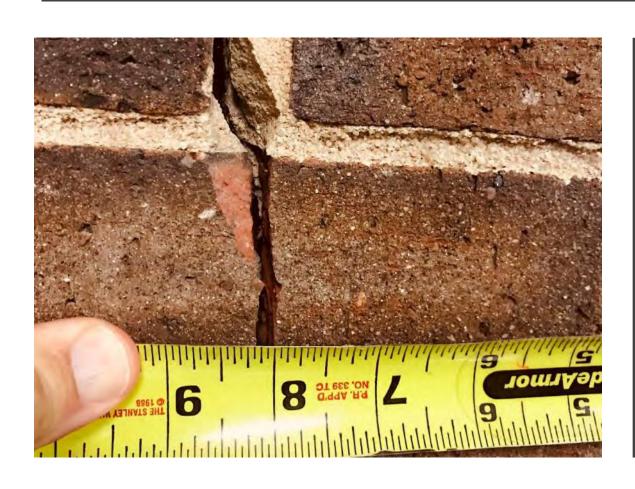
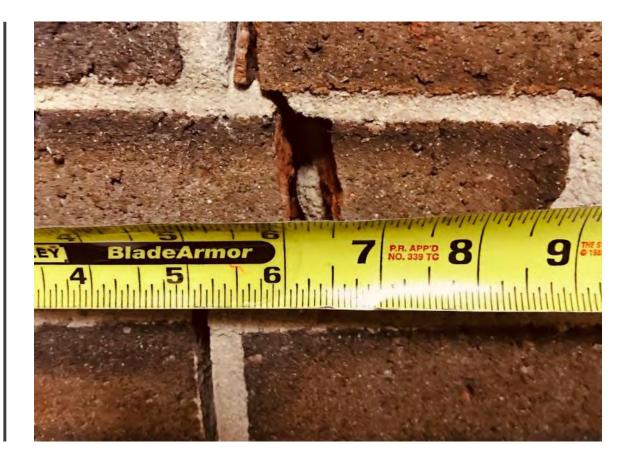
Interior Vertical Wall Cracks (Police)

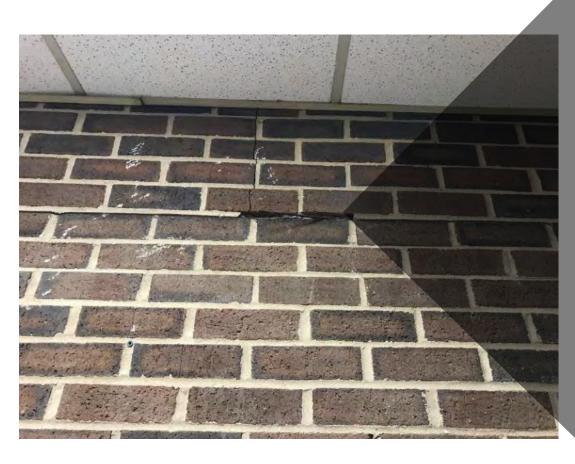
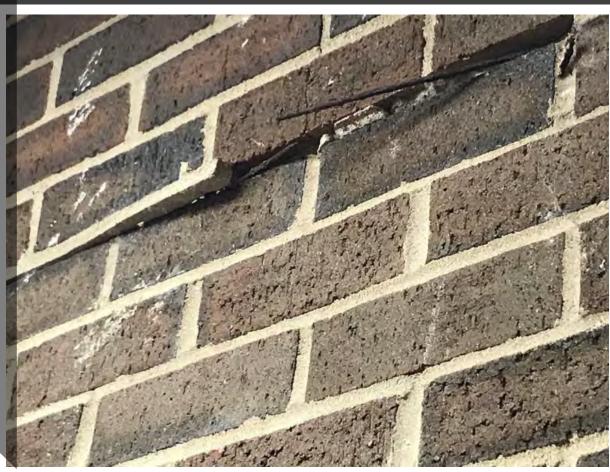
Interior Horizontal Wall Cracks (Police)

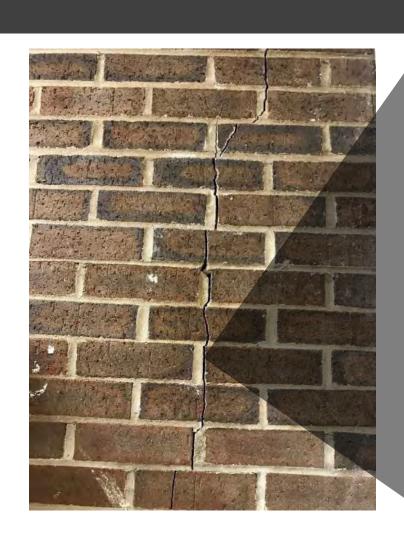
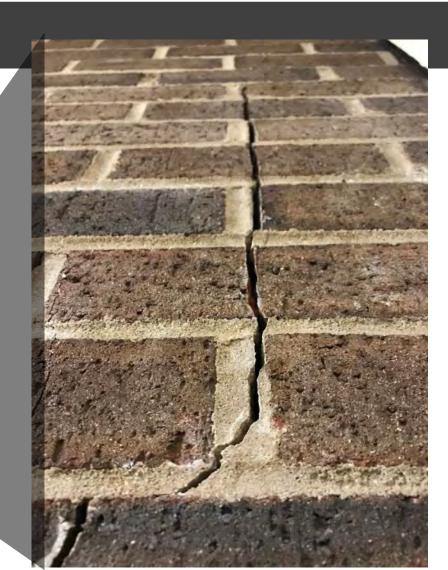
Interior Vertical Wall Cracks (Police)

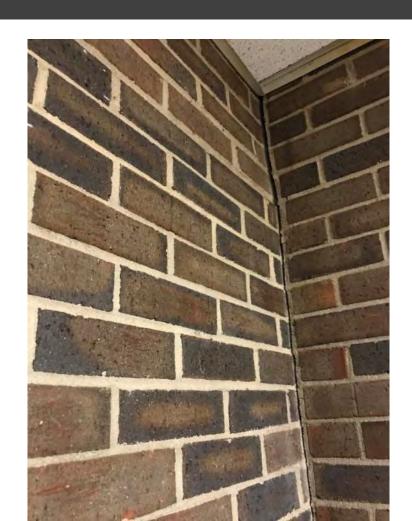
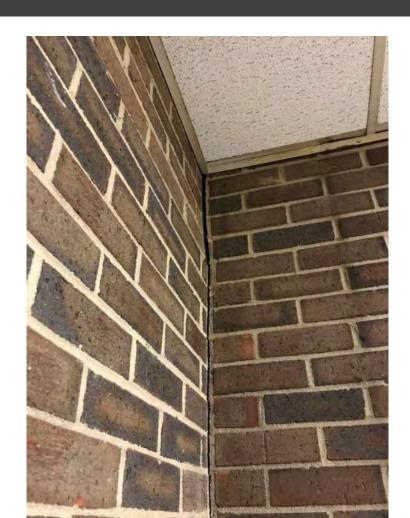
Interior Vertical Wall Cracks (Police)

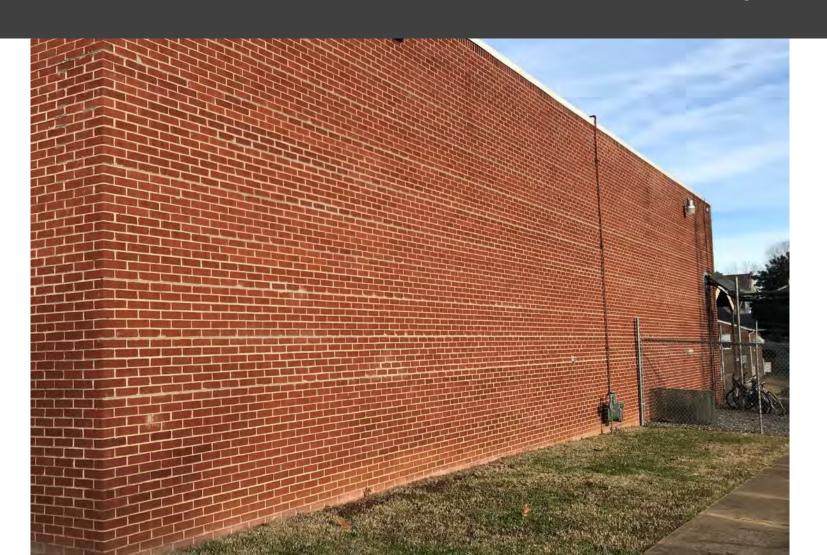
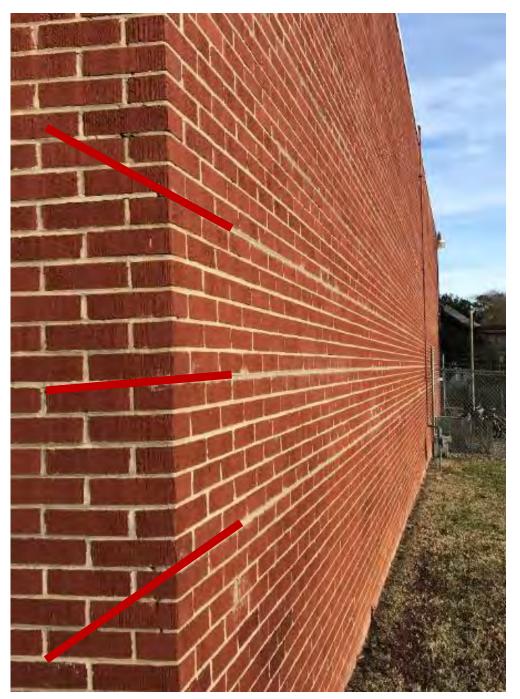
South Wall

Interior Wall Displacement (Police)

Previous Horizontal Wall Crack Repair

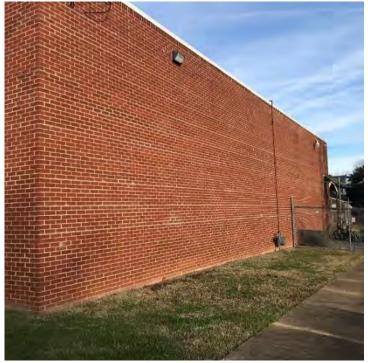
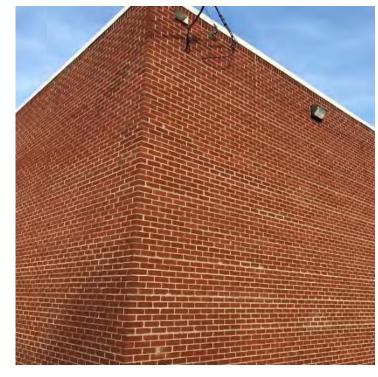
Exterior Horizontal Wall Crack Repair

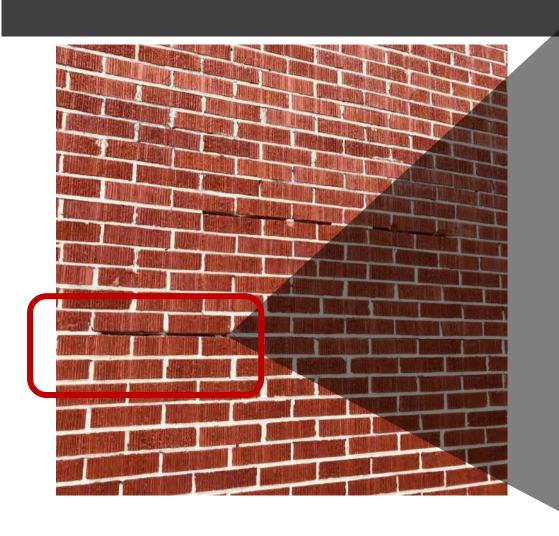
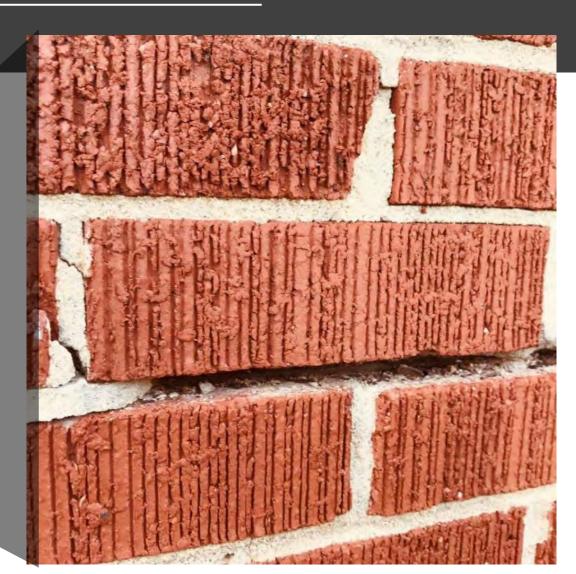
East Wall Cracks

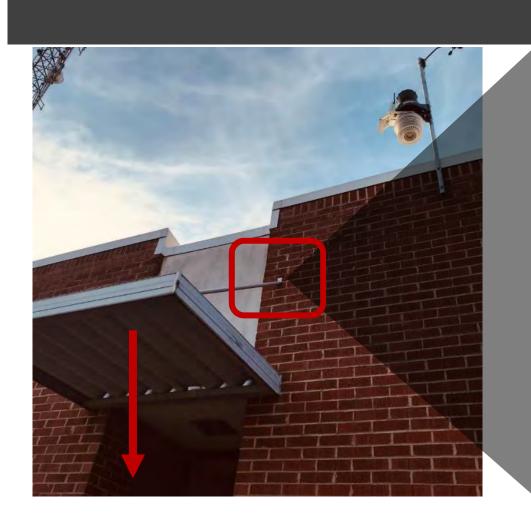
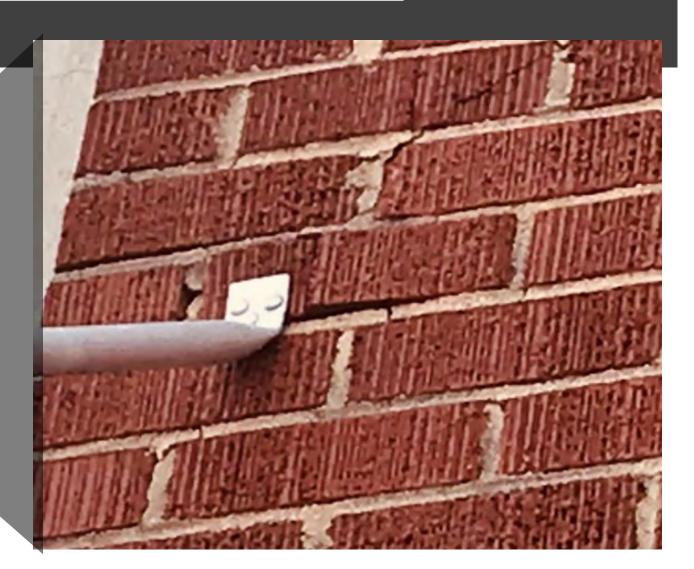
East Wall Canopy/Cracks

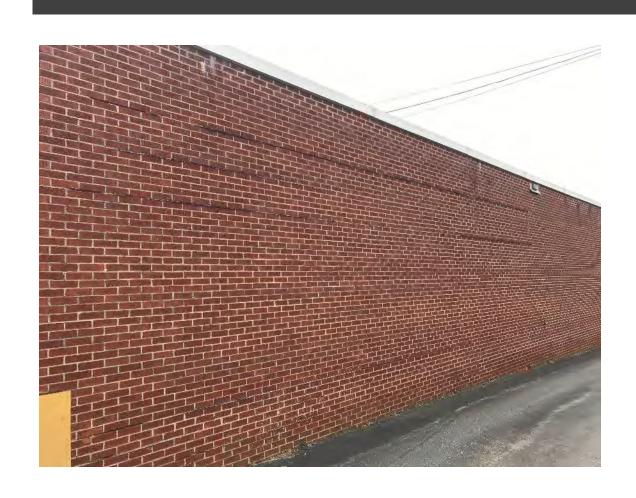
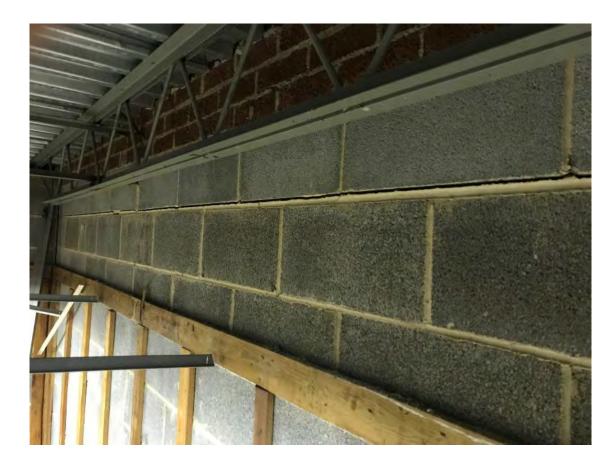
North Wall Cracks

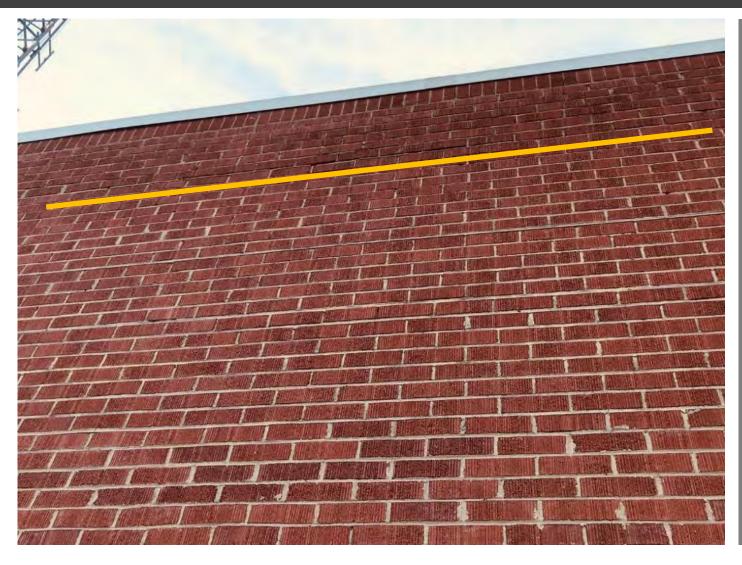
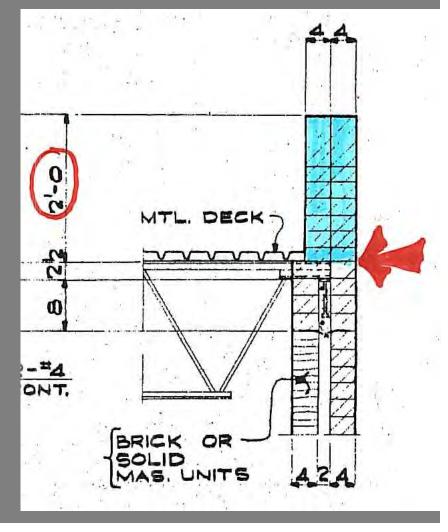
East Wall Parapet

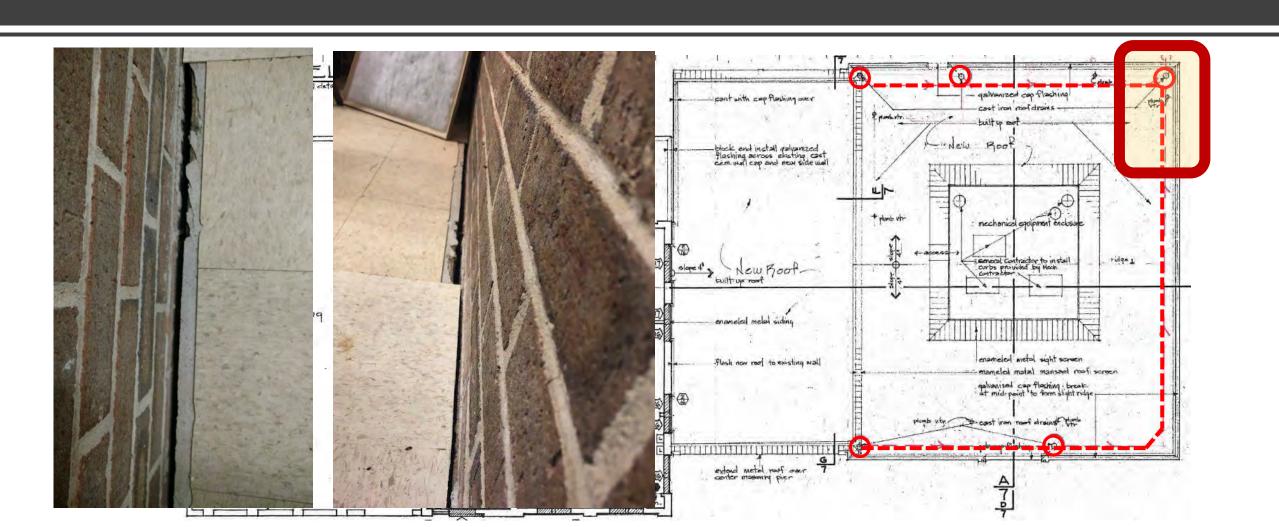
Water Leak

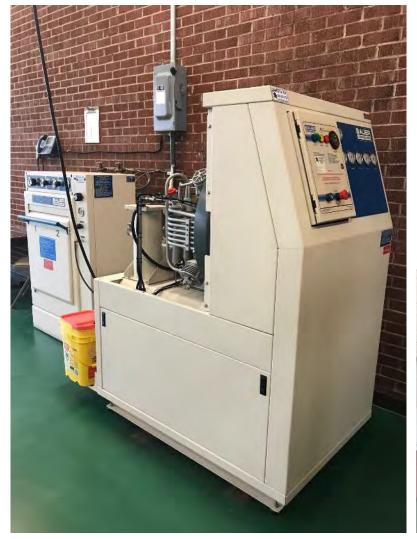
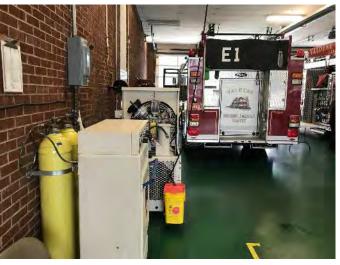
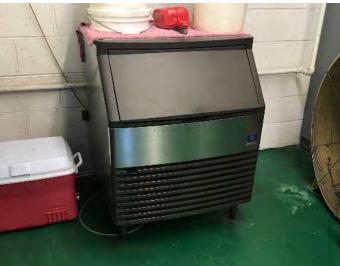
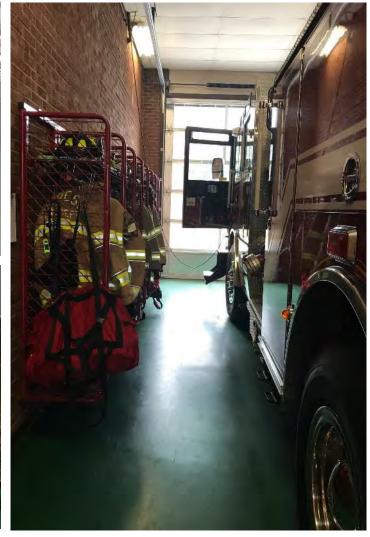
Existing Condition

Vehicle Exhaust Contamination

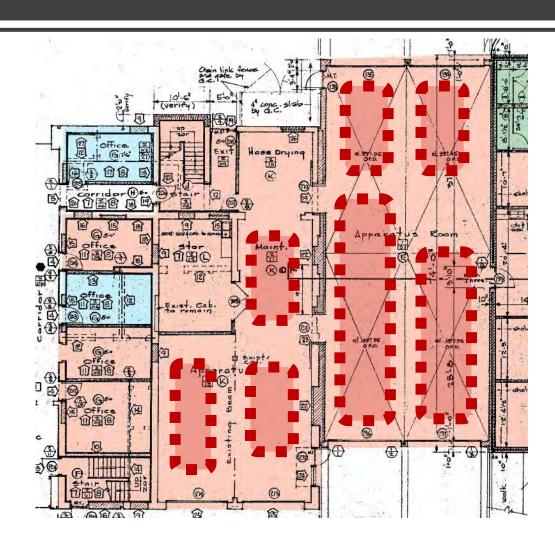
Existing Facility – Fire Truck Bays

- (2) drive thru bay (15'-0" x 70'-0")
- (2) back-in bays
- Store (7) vehicles
- Limited Flexibility (30'-0" x 70'-0")
- Retrofit Vehicle Exhaust & Ventilation
- Storage remote from Bay
