**Town of Valdese
Town Council Public Safety
Building Workshop
Old Rock School - Auditorium
400 Main St. W, Valdese
Tuesday, February 15, 2022
6:00 P.M.**

TOWN OF VALDESE PUBLIC SAFETY BUILDING EVALUATION

Version:	Final
Date of Issue:	February 10, 2022
Prepared By:	CBSA Architects
Prepared For:	Town of Valdese

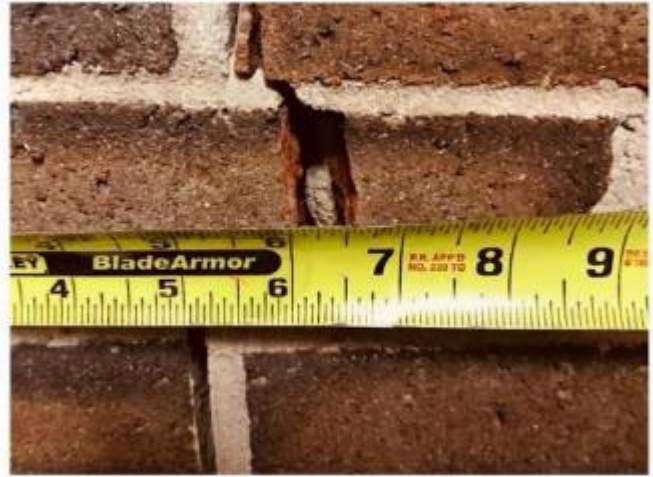
INTERIOR MASONRY WALL CRACKS

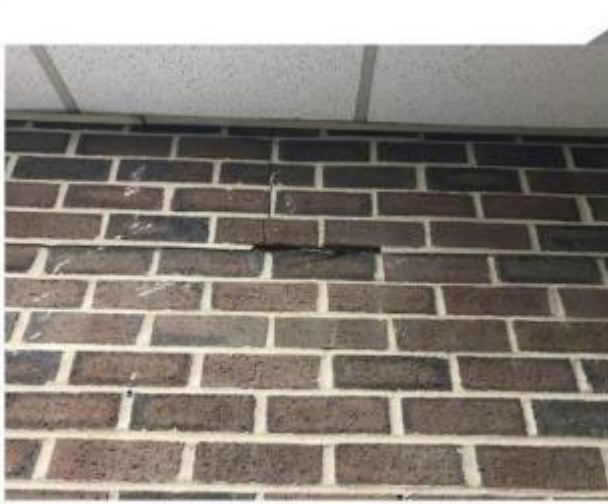
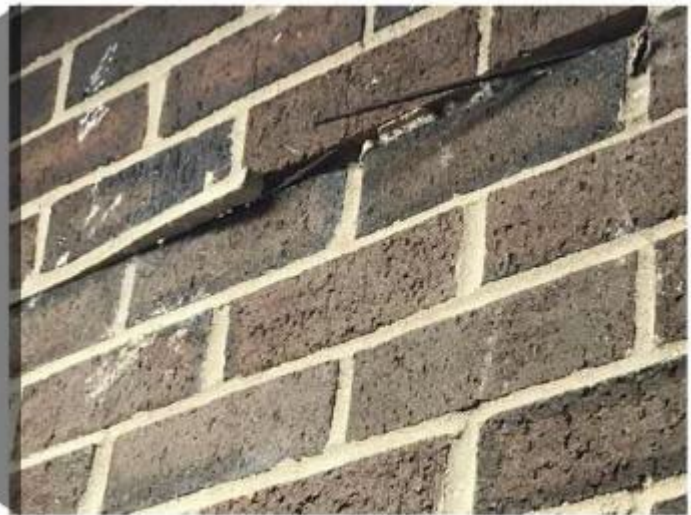
INTERIOR VERTICAL WALL CRACKS (POLICE)

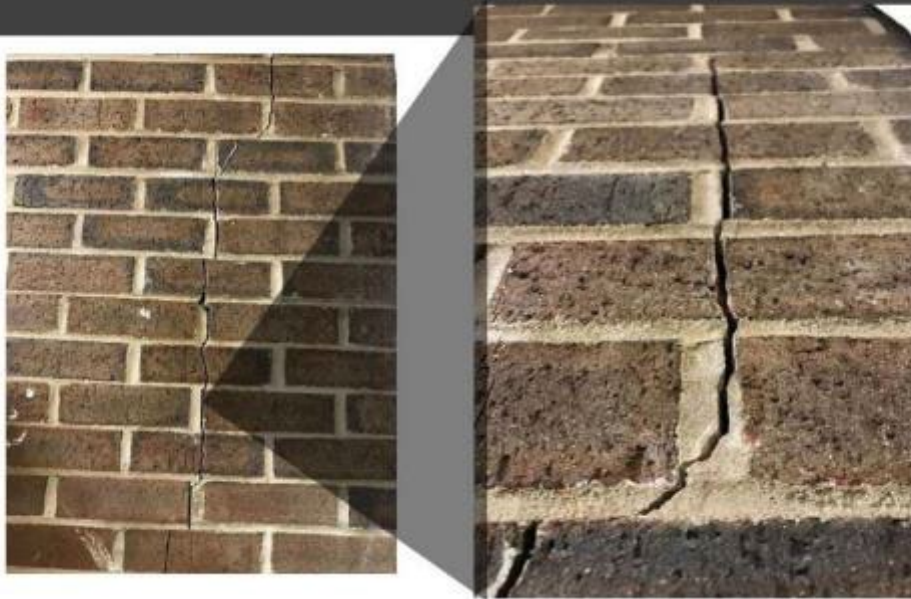
INTERIOR VERTICAL WALL CRACKS (POLICE)

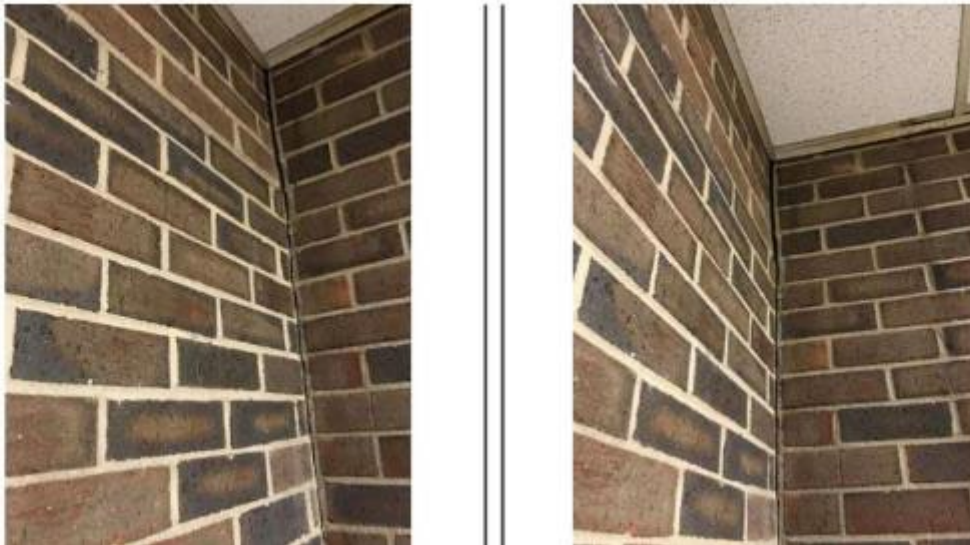
INTERIOR VERTICAL WALL CRACKS (POLICE)

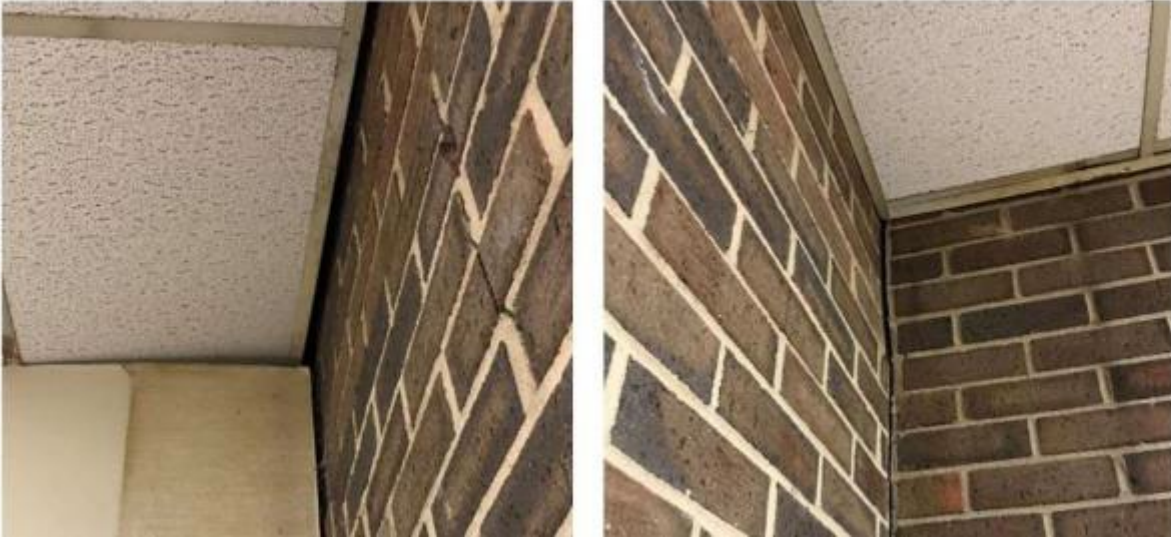
INTERIOR VERTICAL WALLS CRACKS (POLICE)

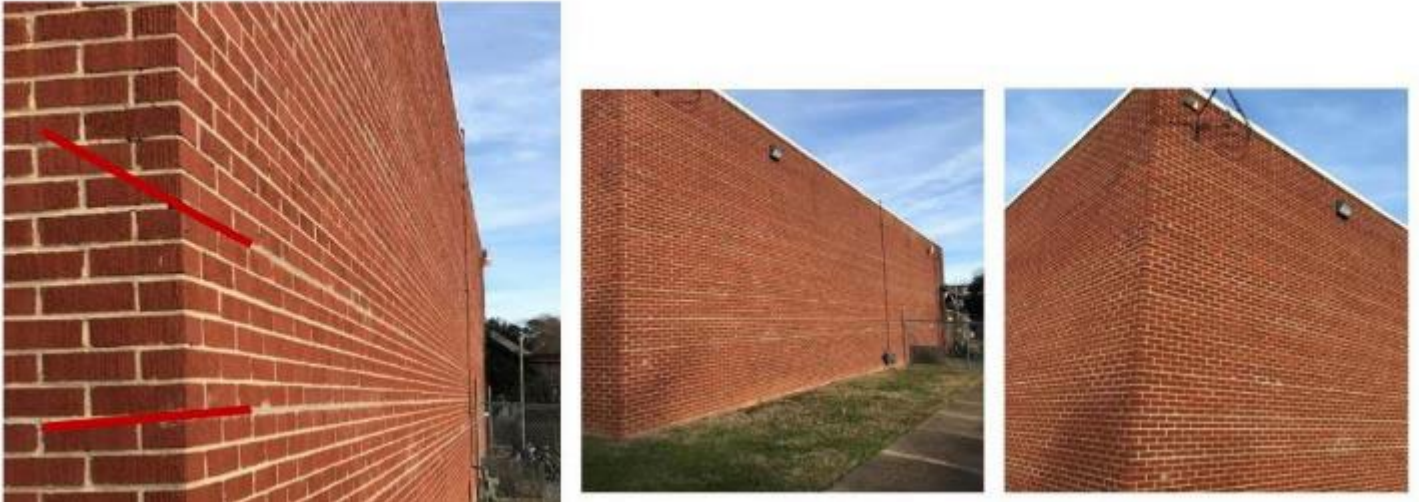
SOUTH WALL – PREVIOUS HORIZONTAL WALL CRACK REPAIR

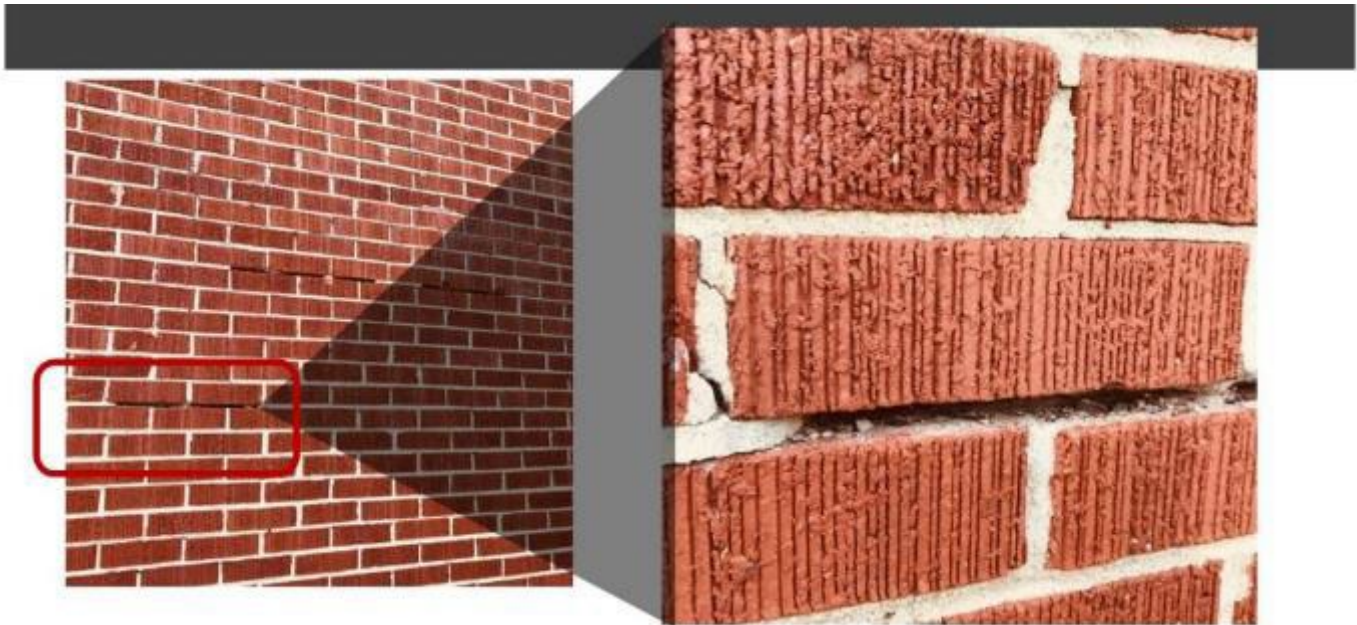
EXTERIOR HORIZONTAL WALL CRACK REPAIR

EAST WALL CRACKS

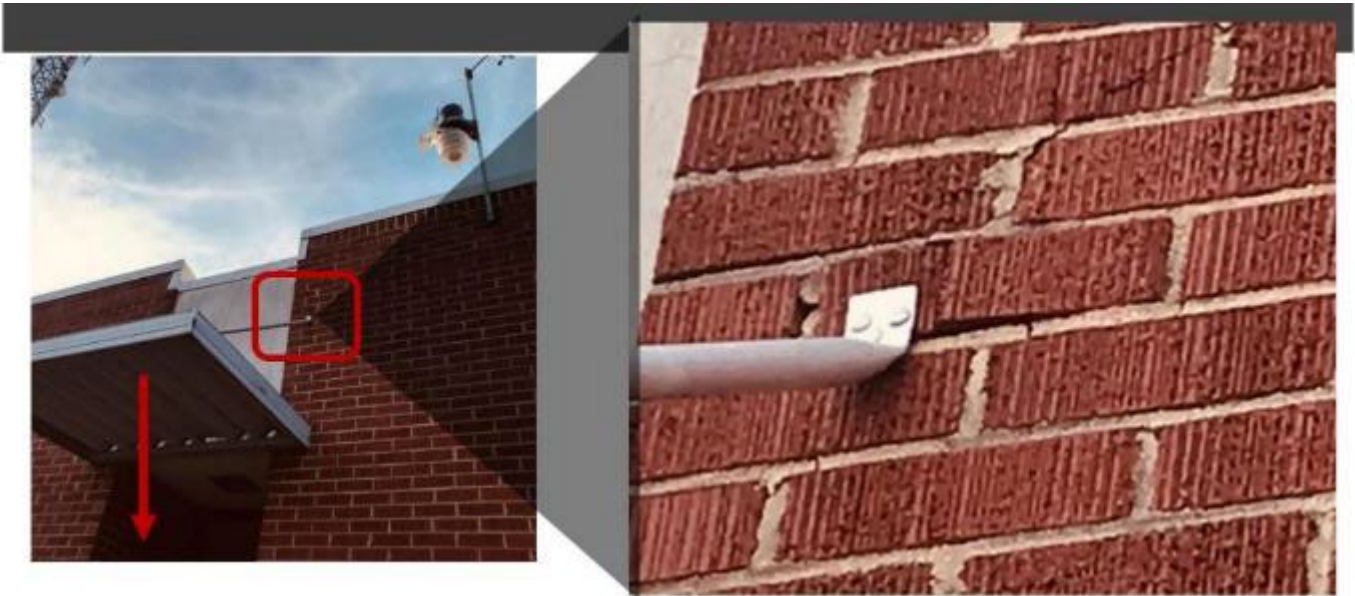
EAST WALL CANOPY / CRACKS

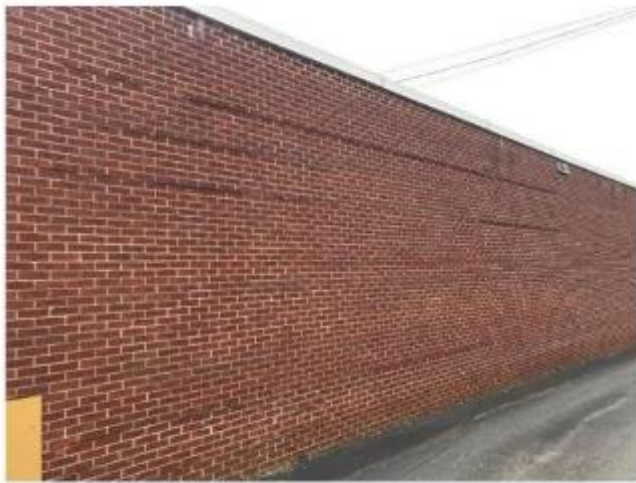
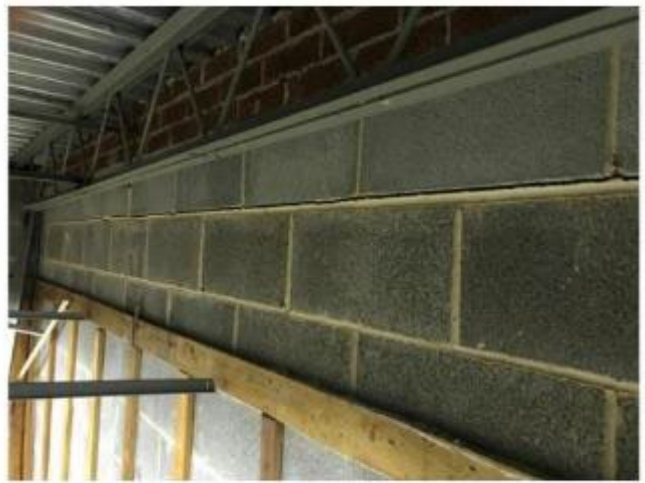
NORTH WALL CRACKS

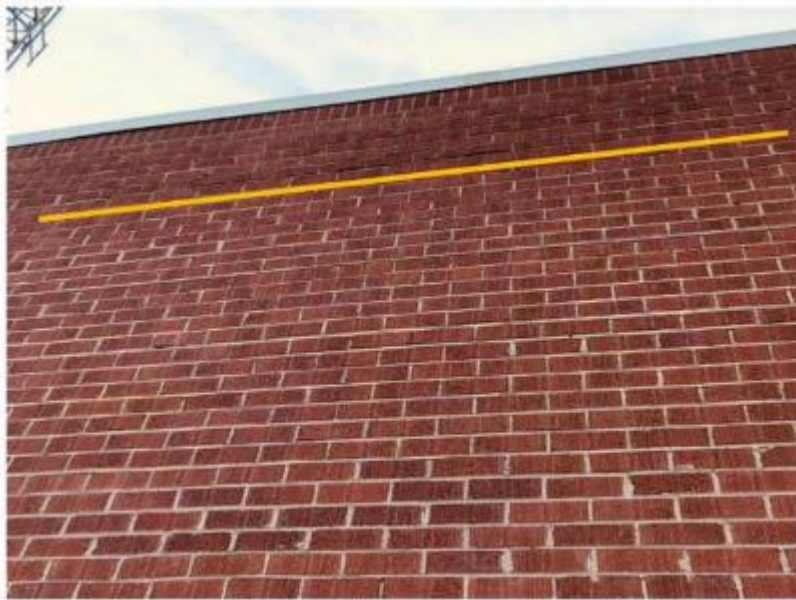
Along the east façade of South Building the horizontal mortar joint has deteriorated along the roof bearing elevation of the masonry wall. The parapet wall is broken at the bearing elevation and extends 2’-0” beyond. There is concern that the parapet wall is at risk since the wall has no positive anchorage to the building structure and the top of wall is not supported to resist lateral movement. We recommend that the parapet wall be removed and reinstalled so that it can be anchored to the building structure. This will be necessary along the full east elevation of South Building and extend approximately 10’-0” westward along the south elevation. The roof will need to be modified and patched to allow parapet wall replacement.

EAST WALL PARAPET

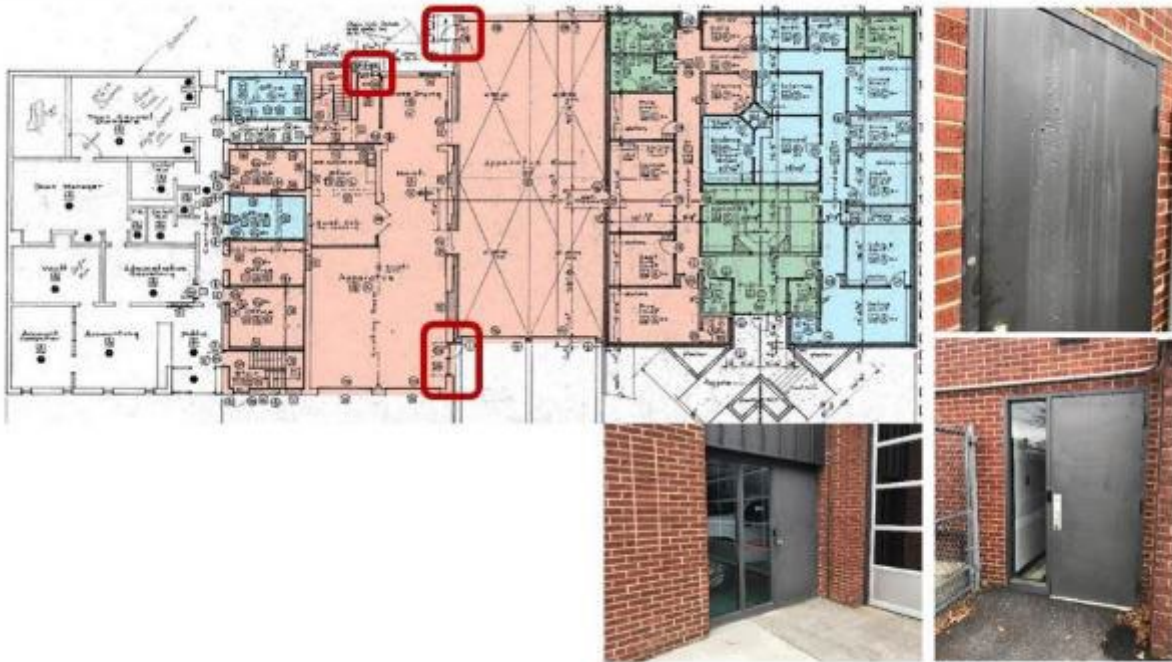
Three hollow metal door and frame assemblies appear to be corroding and need to be replaced. At one of the assembly locations the anchor straps which are laid into the masonry wall to anchor the frame in place appears to have rusted and broken. The door frame assembly can move within the wall and is not anchored secure.

REPLACE EXTERIOR STEEL DOORS & FRAMES

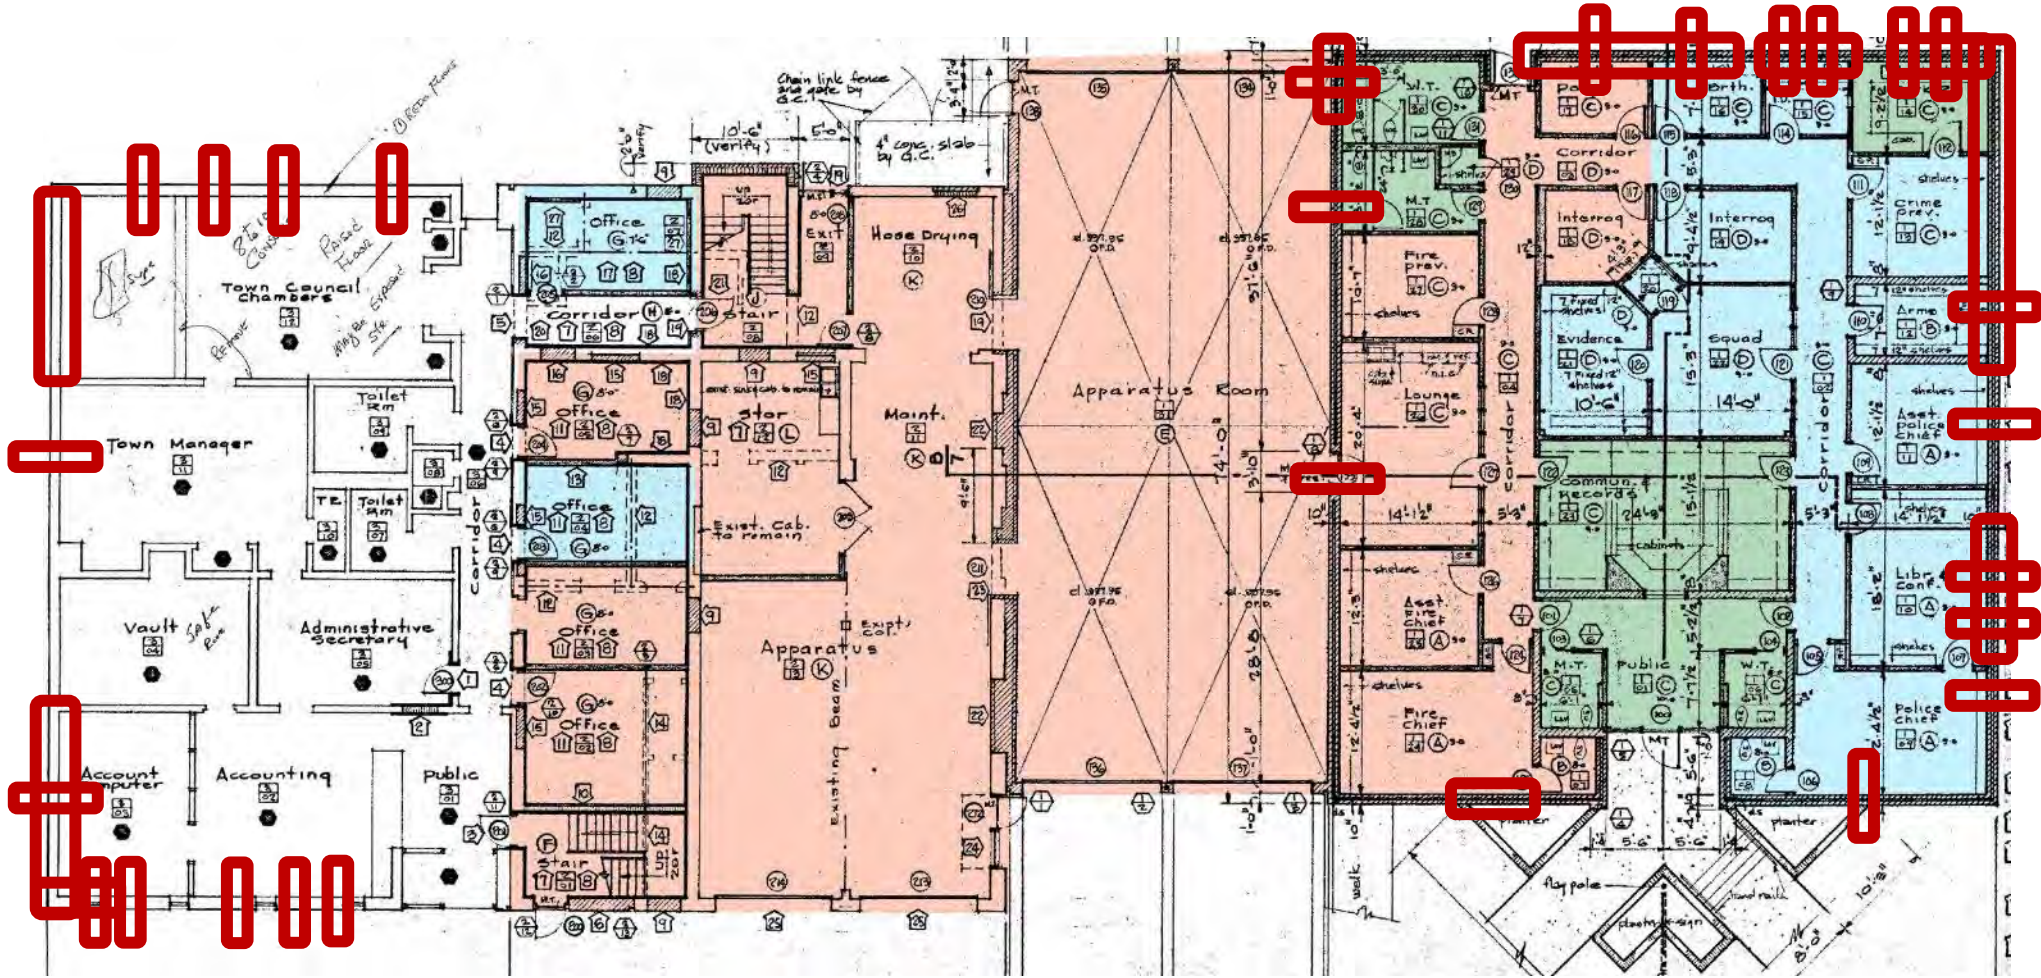
Interior Vertical Wall Cracks (Police)

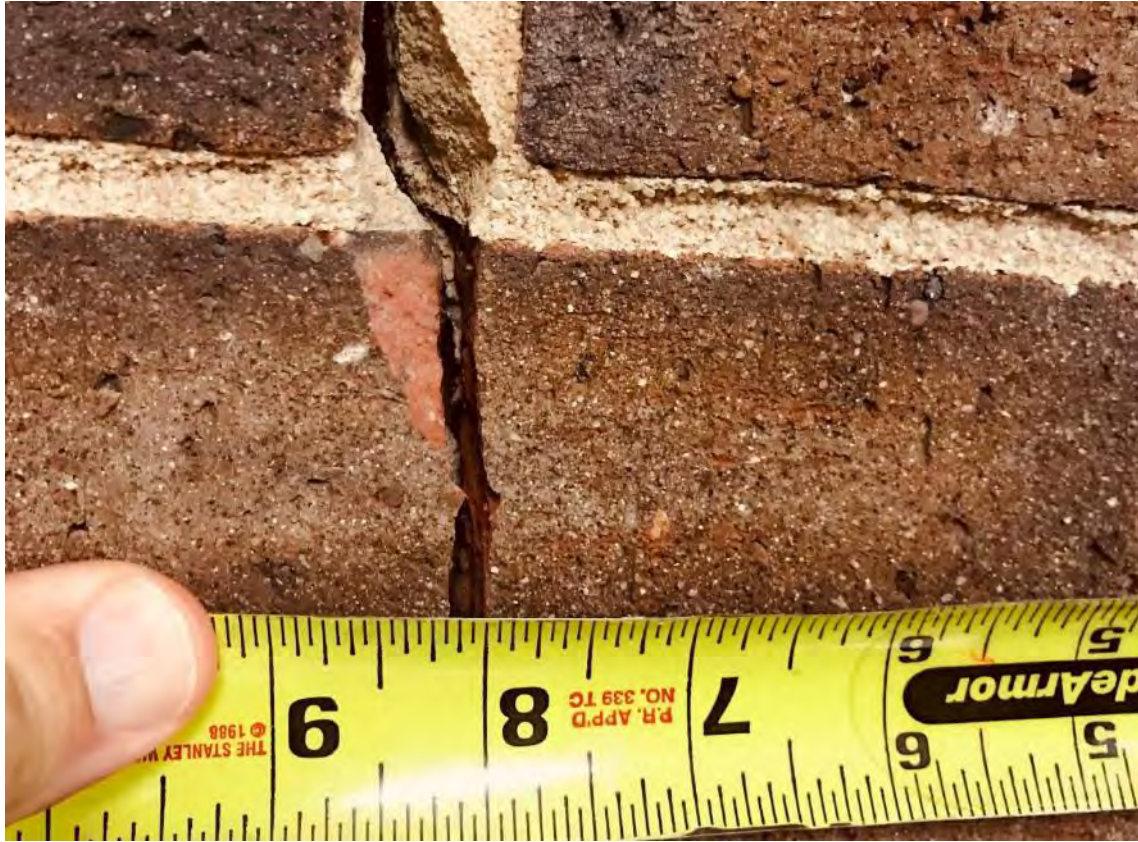
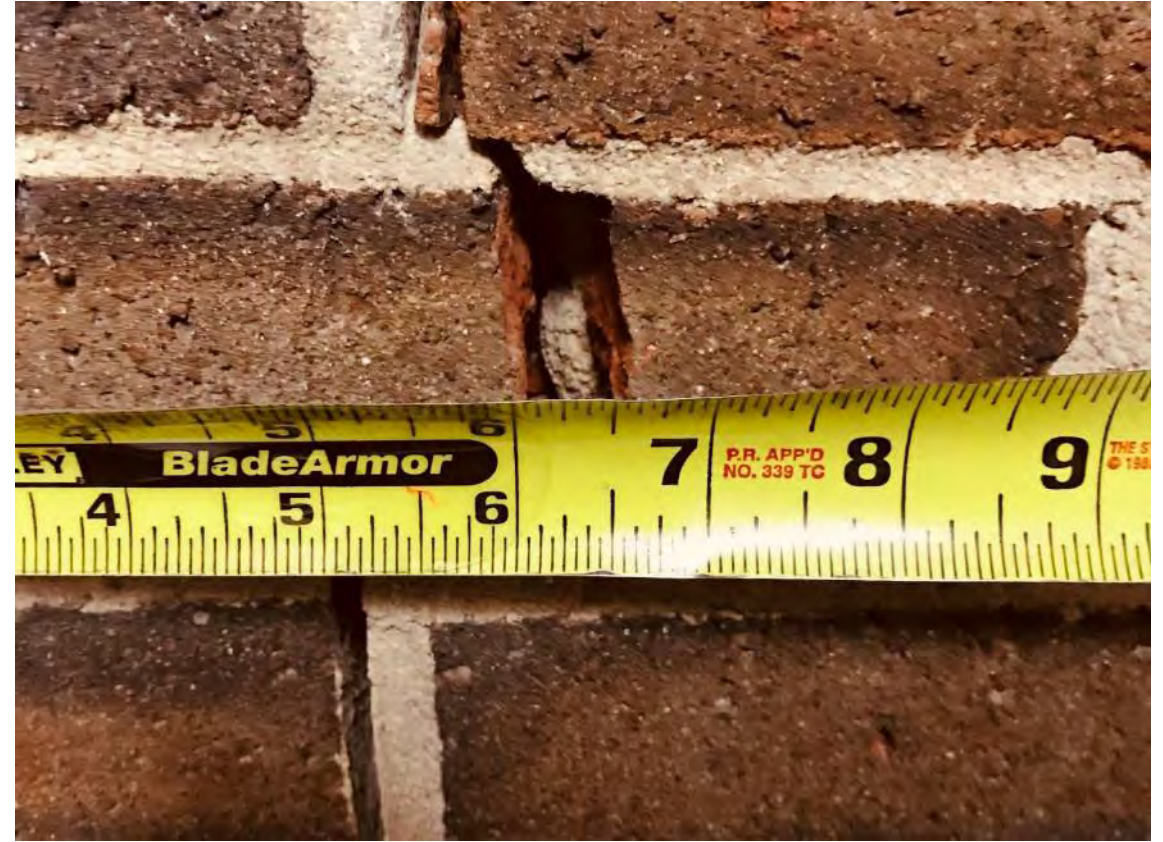
Interior Horizontal Wall Cracks (Police)

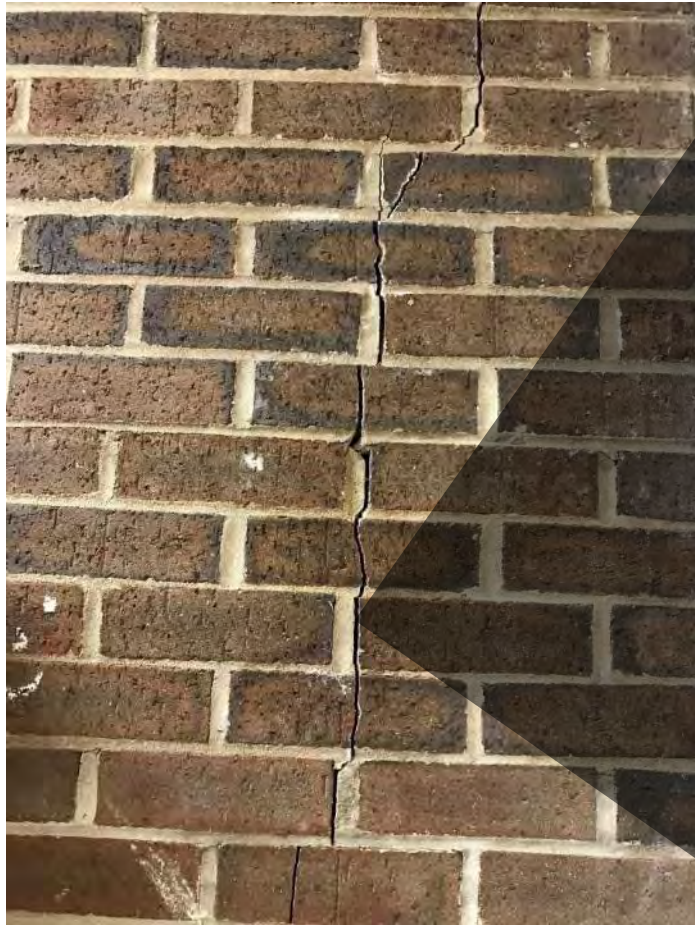
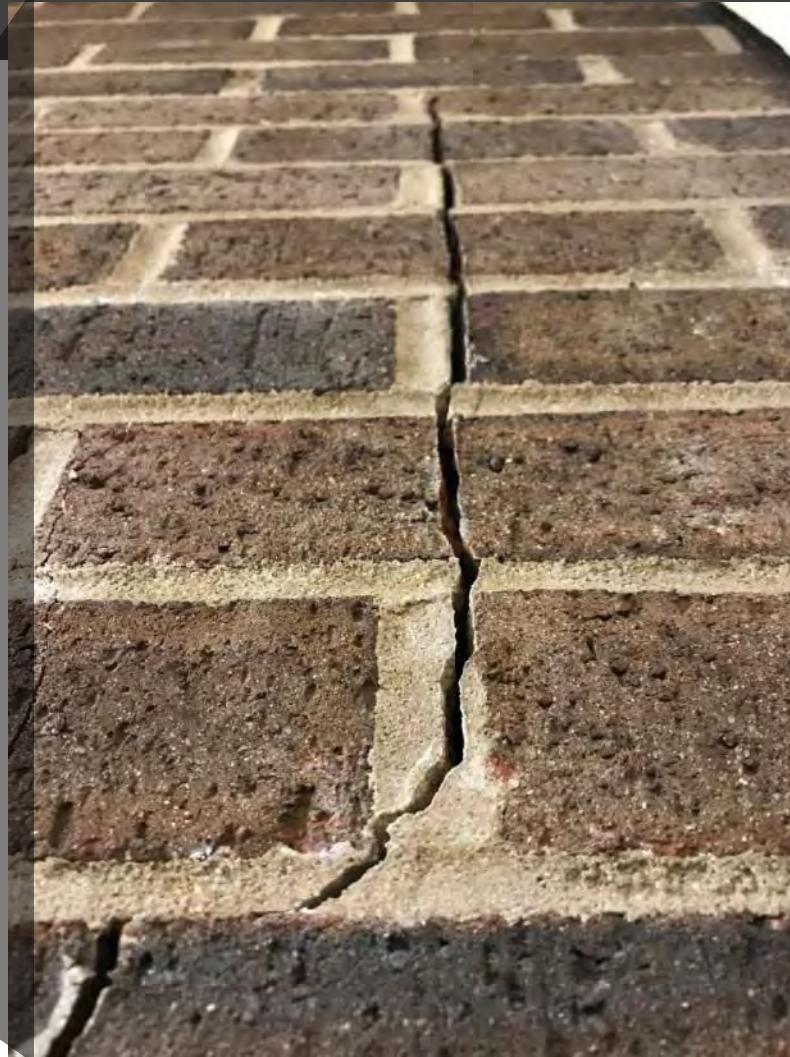
Interior Vertical Wall Cracks (Police)

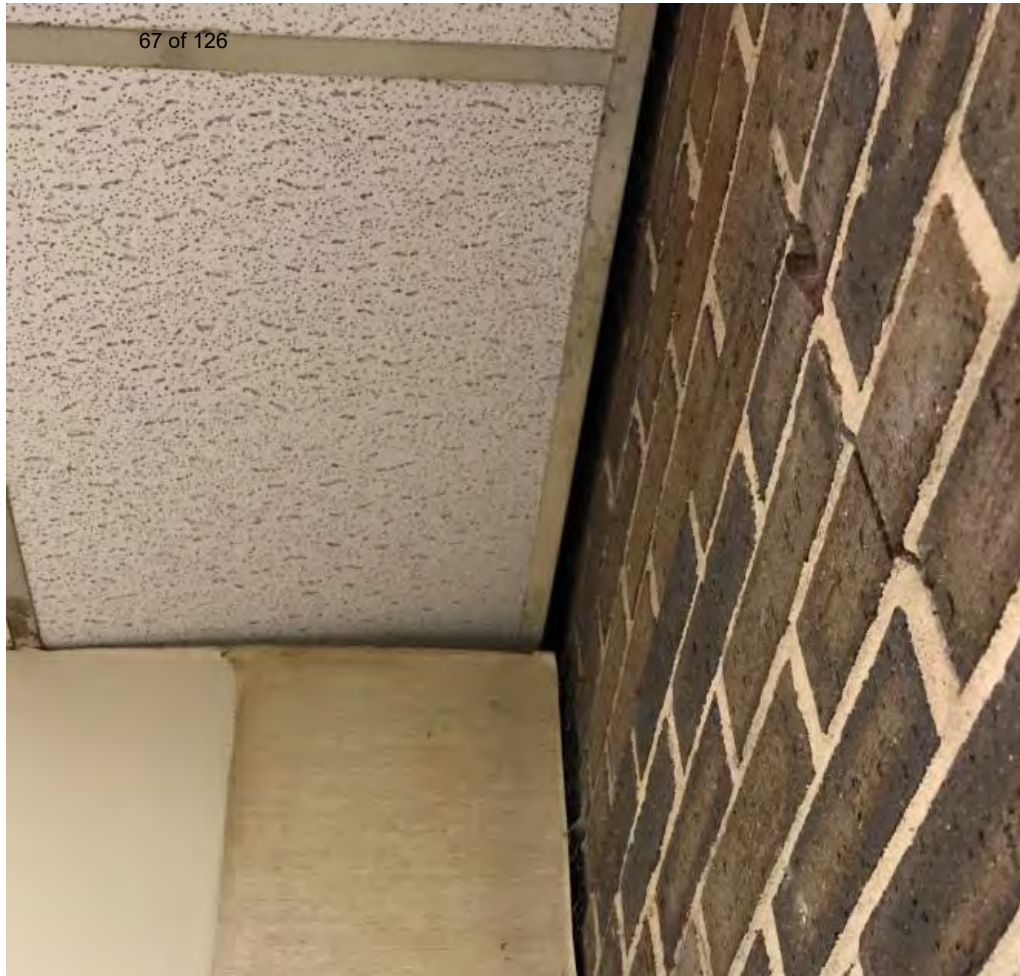
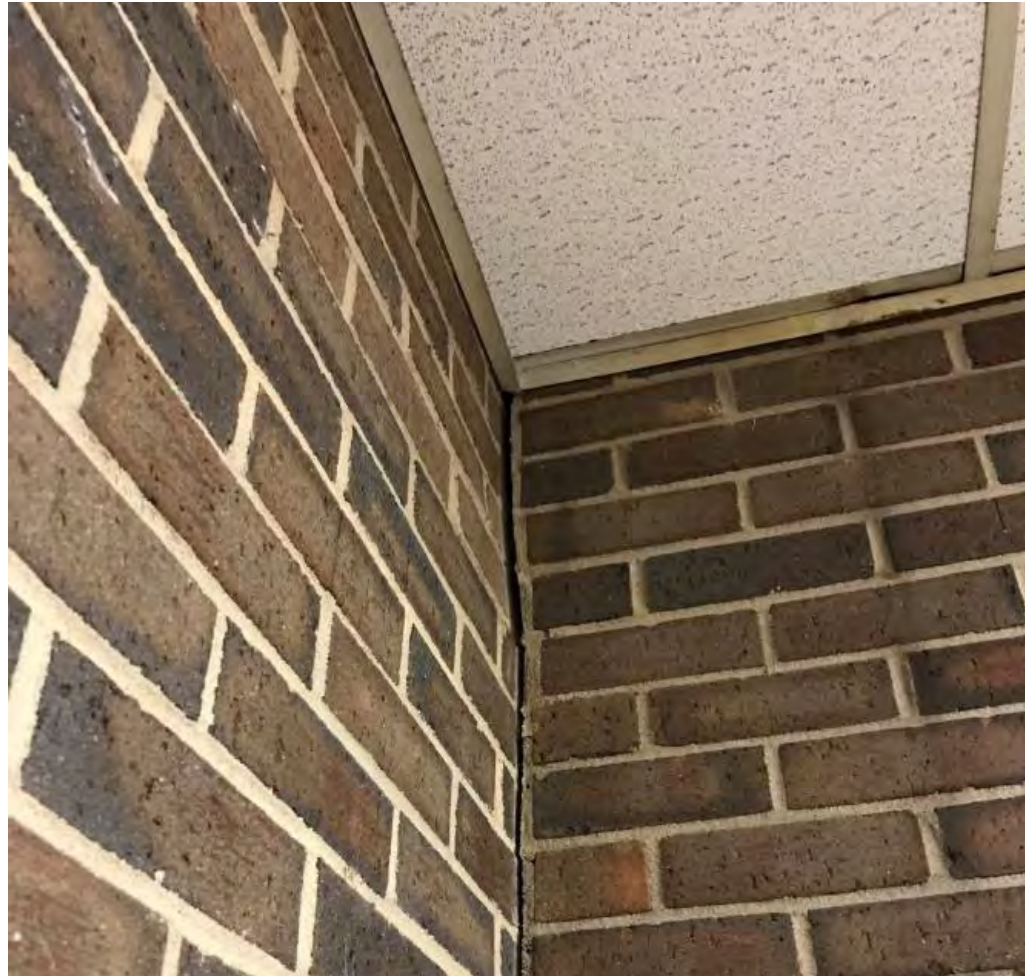
Interior Wall Displacement (Police)

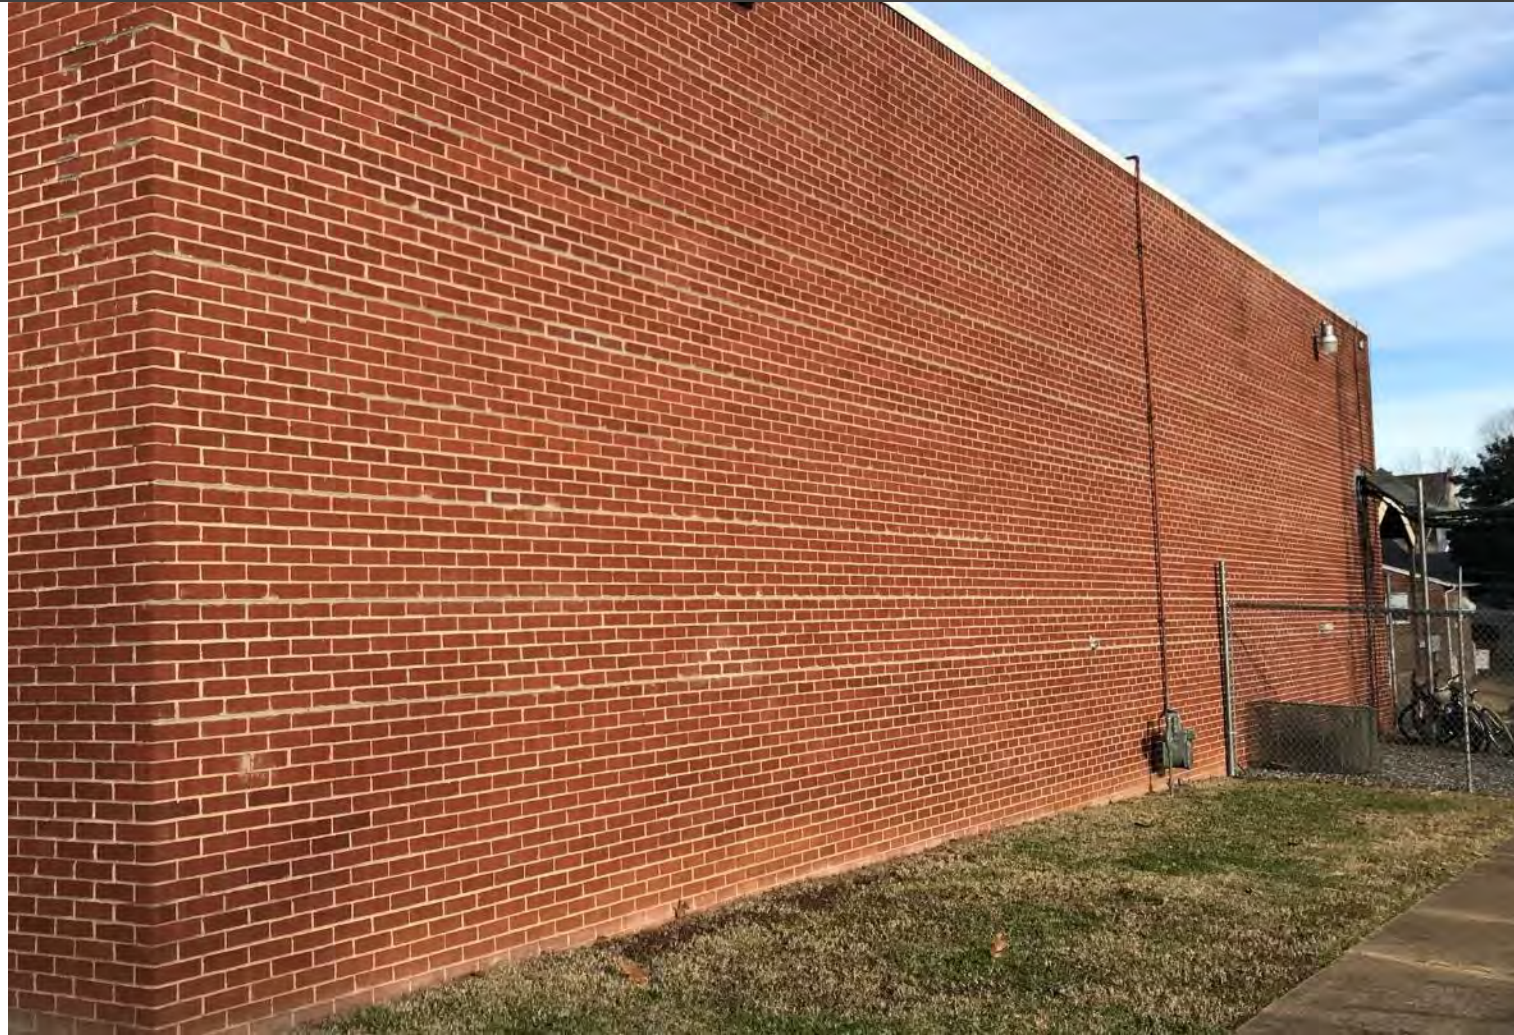
South Wall

Previous Horizontal Wall Crack Repair

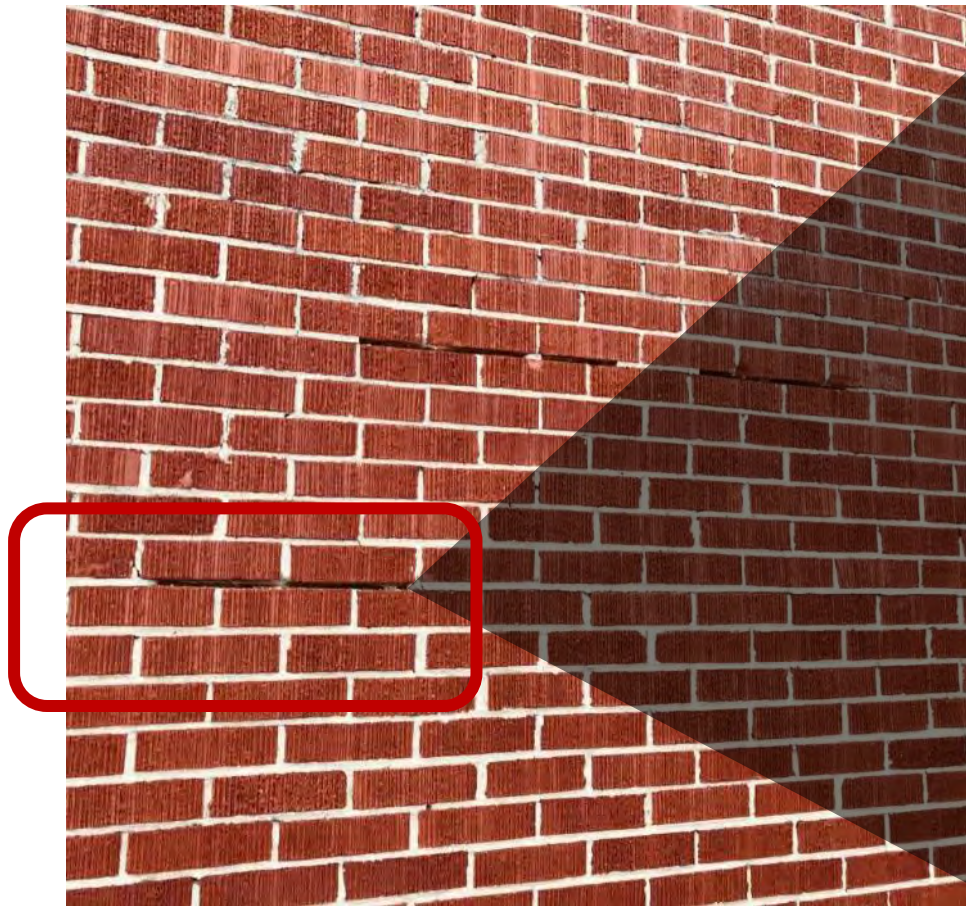
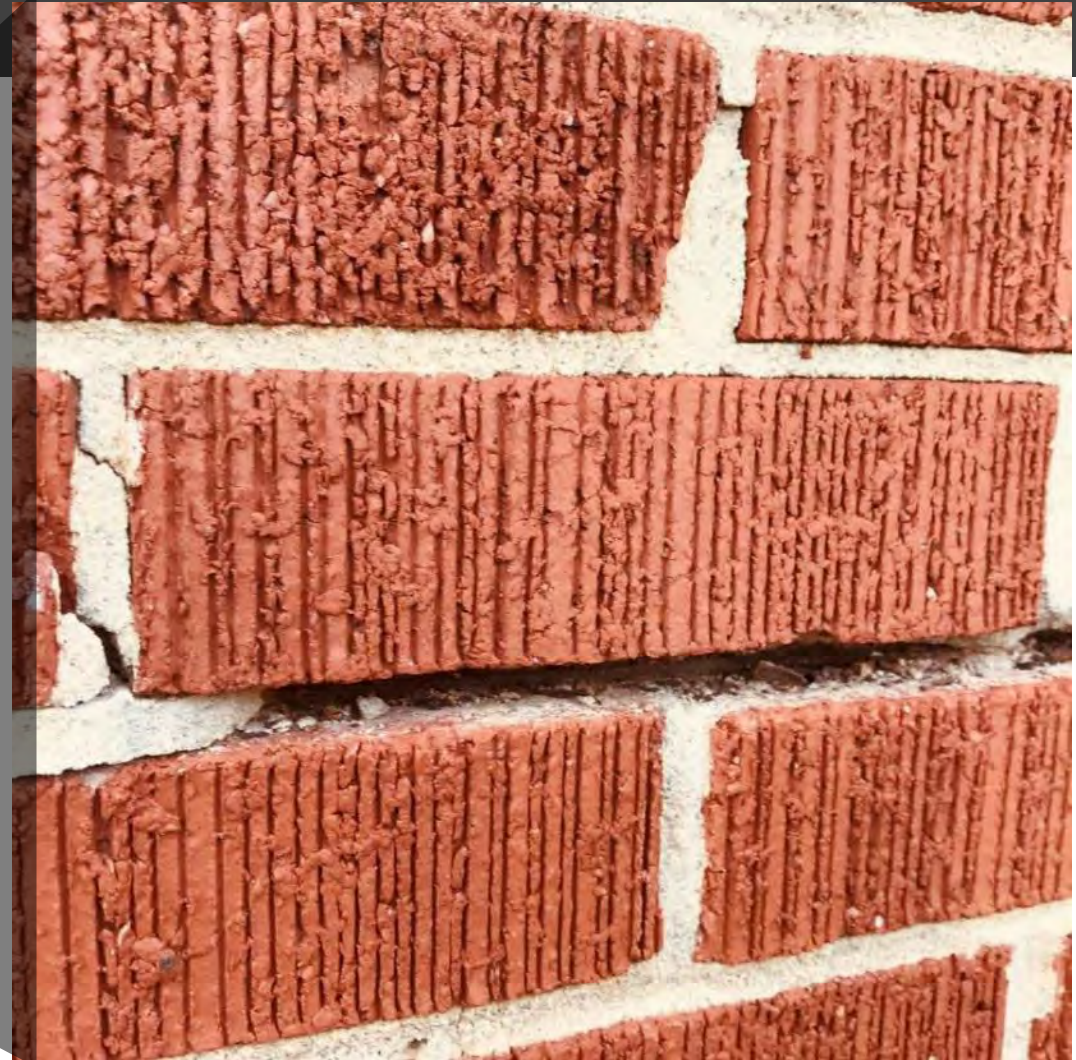
East Wall Canopy/Cracks

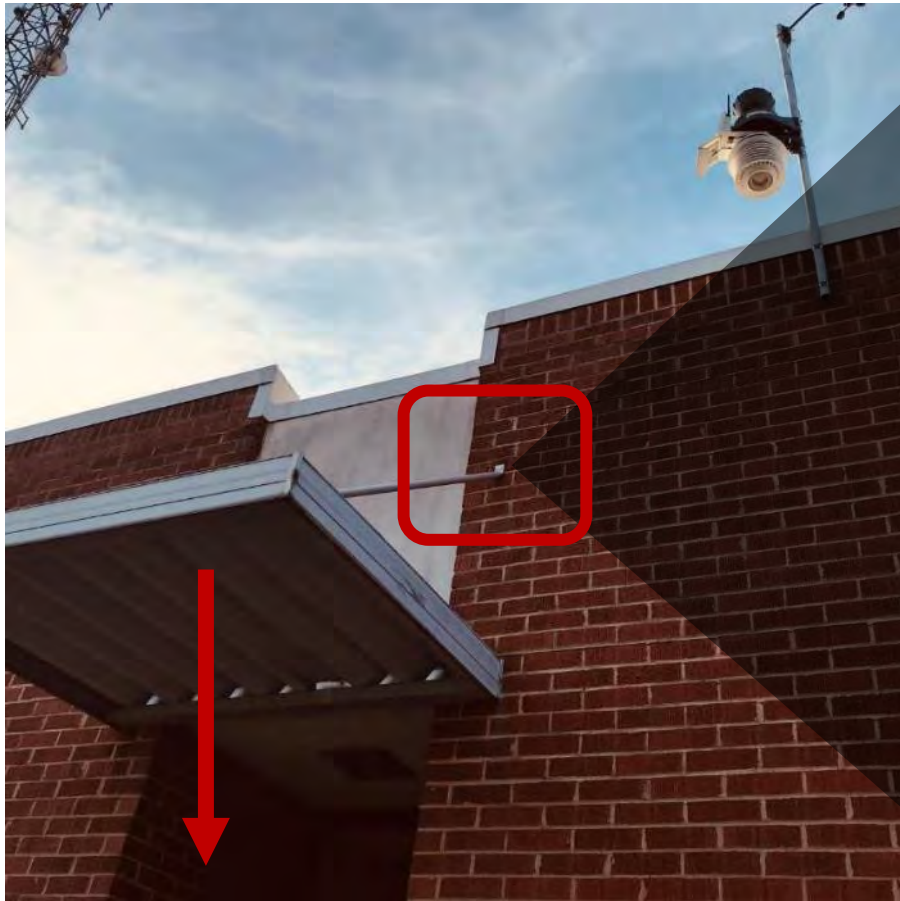
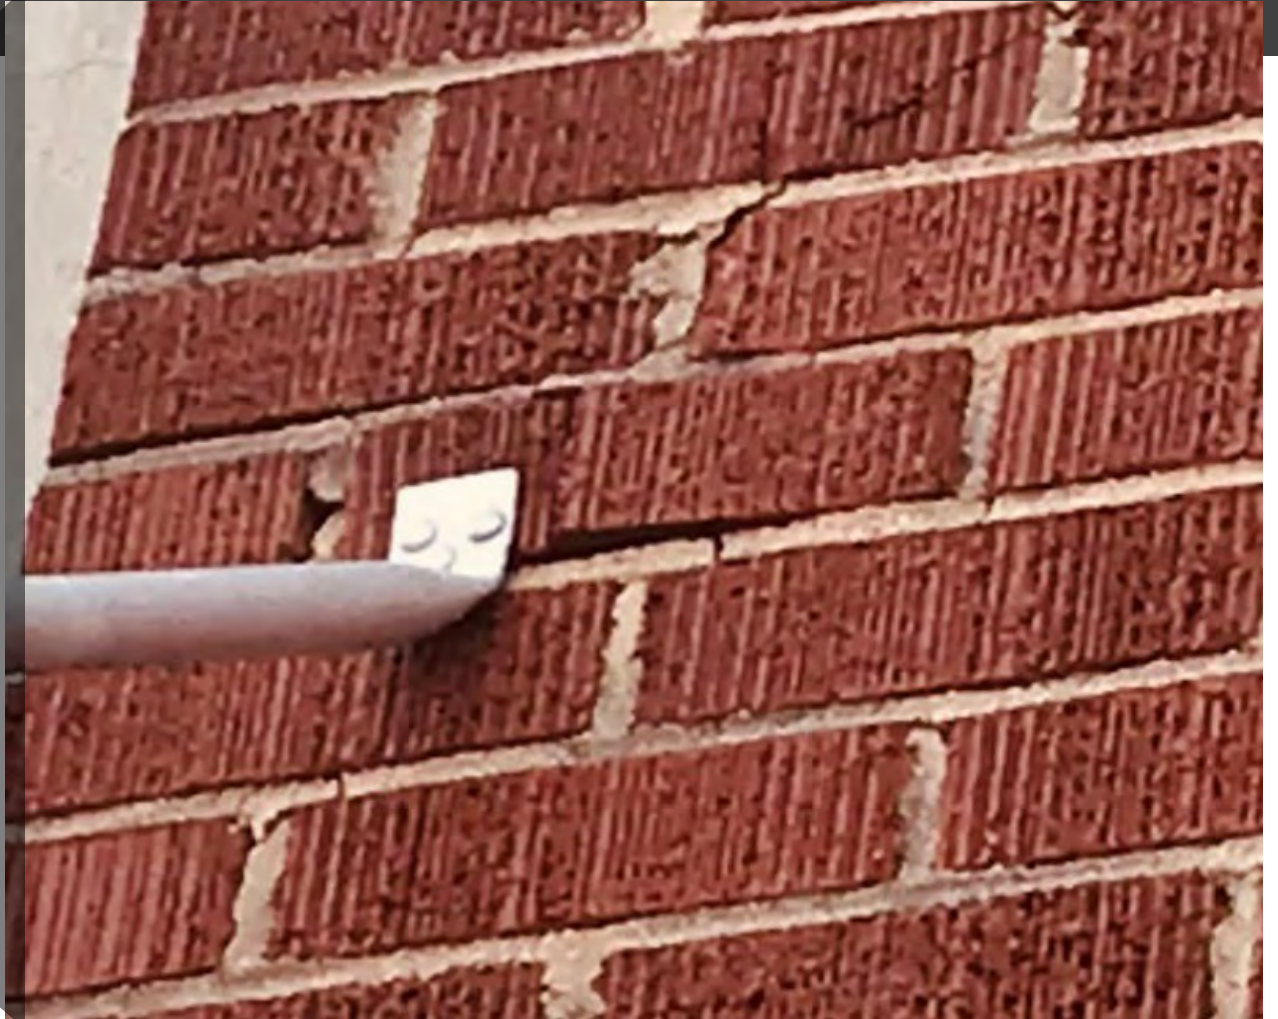
North Wall Cracks

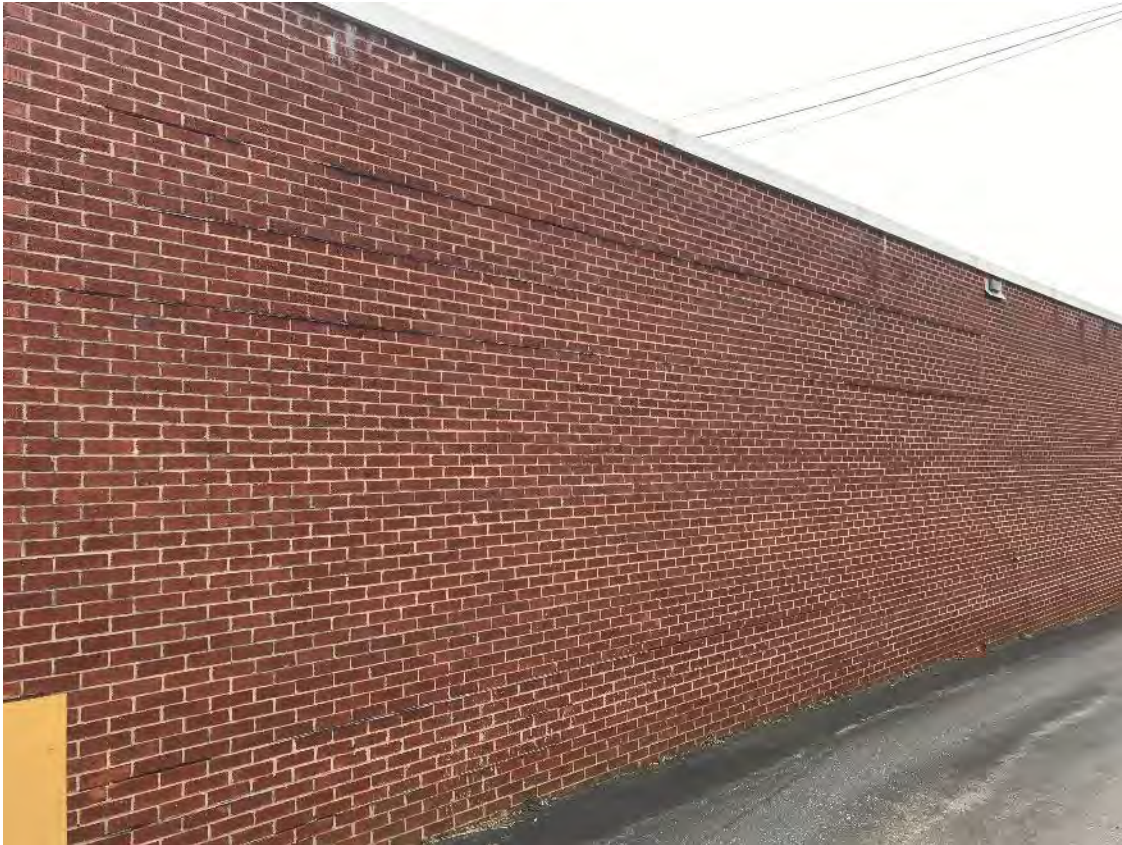
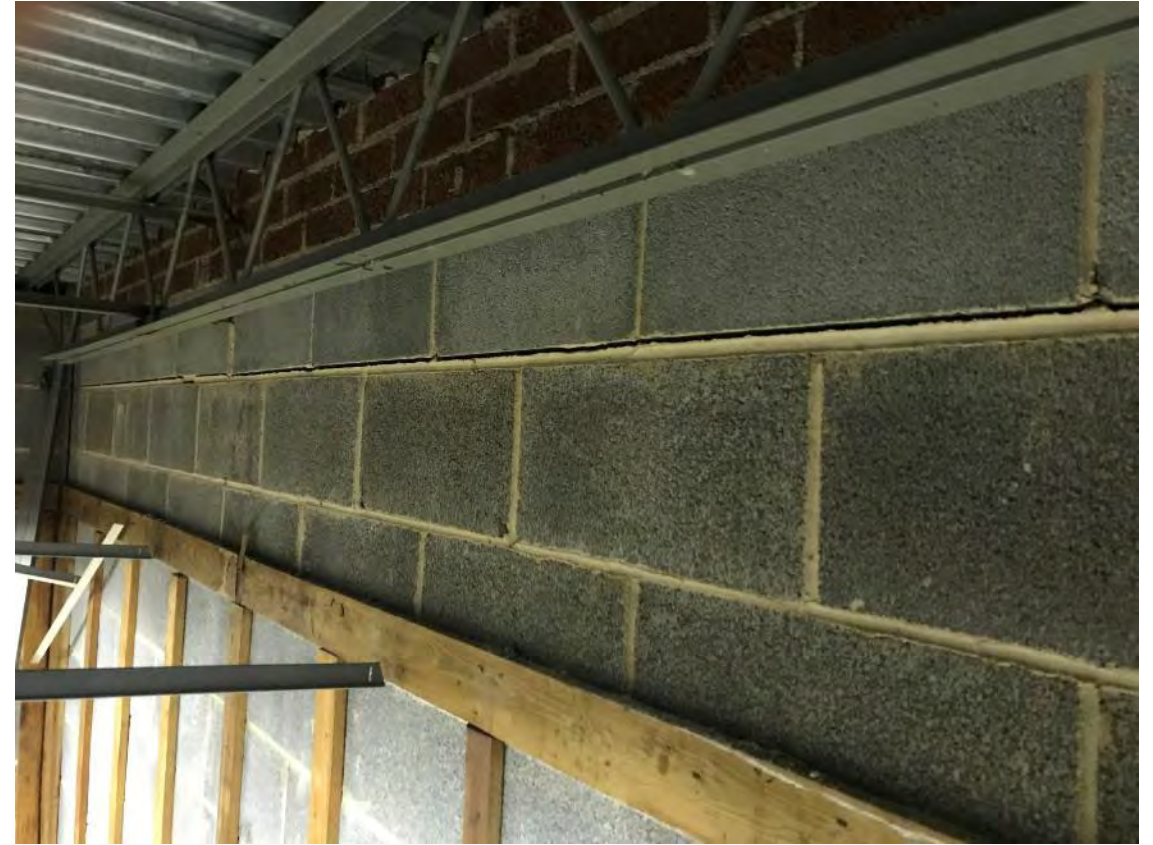
East Wall Parapet
