March 2018

VALDESE PUBLIC SAFETY BUILDING **INSPECTION**

Revision 1 - FINAL CHARLES MICHAEL ALBERTO, PE PREPARED FOR Chief Watts, Valdese Fire Department

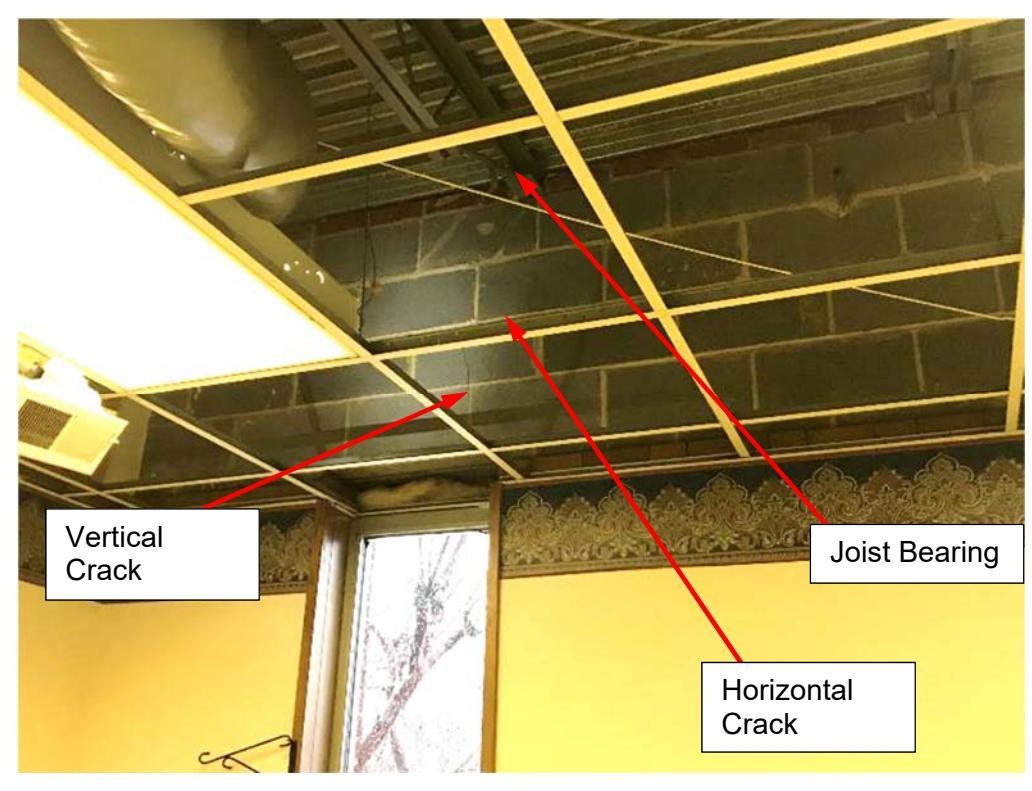
Photo 1 Town Hall – West Wall – Horizontal and Vertical Cracks

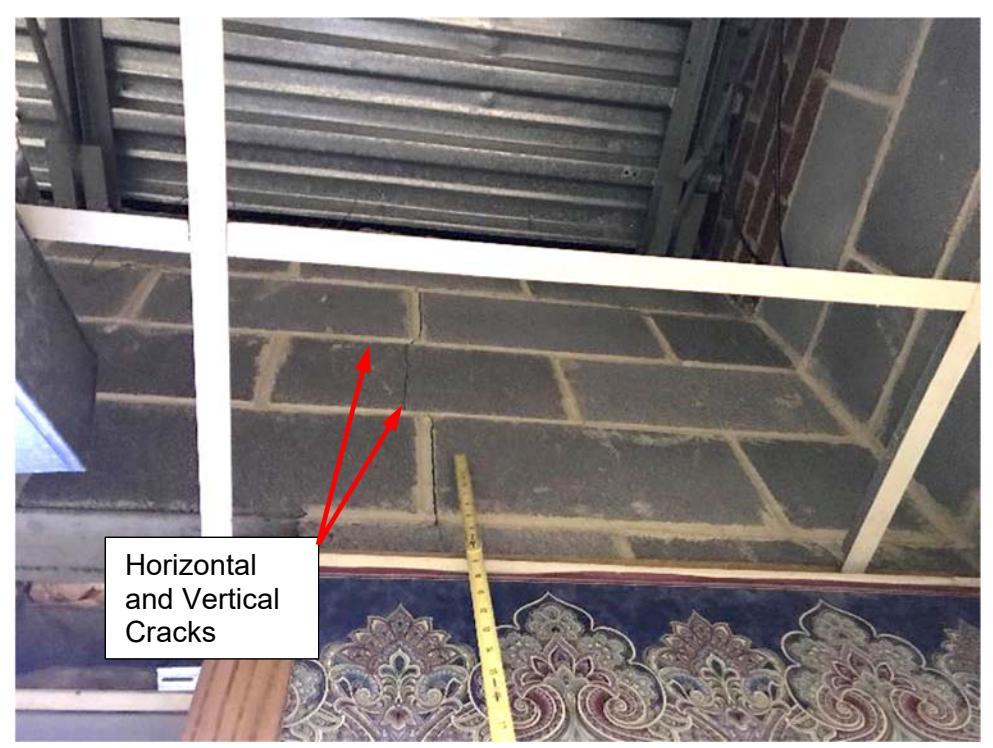
Vertical cracks are located at approximately 10 feet on center in the rear room of the building along the east exterior wall and part of the north wall. The cracks generally extend from floor to near the ceiling, but do not appear to extend above the reinforced bond beam at the top of the cmu interior wythe. It is reasonably obvious that the reason this is so is because the grouted and reinforced bond beam is restrained against cracking relative to the hollow unreinforced interior cmu wythe immediately below. Typical vertical cracks are depicted in Photos 2, 3, 4, and 5.

Photo 2 Town Hall – West Wall – Horizontal and Vertical Cracks

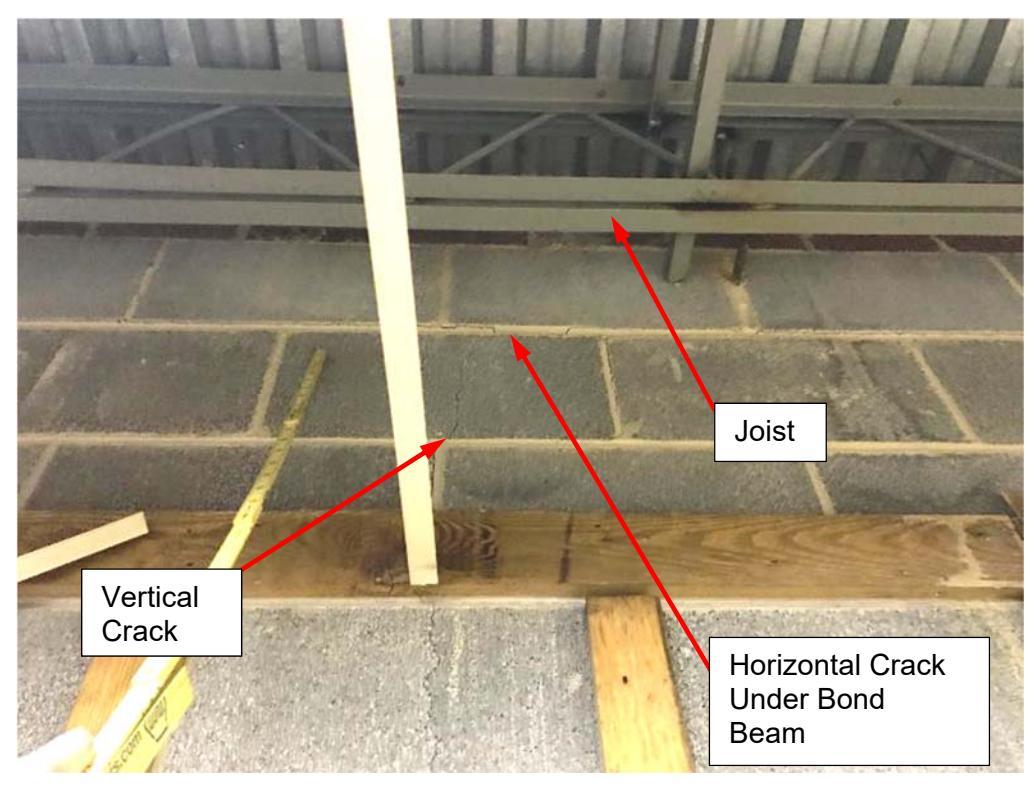
The horizontal cracks are typically located at the approximate elevation of the bottom of the steel reinforced Bond Beam, see Photo 3 and 4 and Figure 7. This condition persists along the north exterior wall and east exterior wall. Per Figure 7 from the Town Hall record drawings, the joint at the bottom of the bond beam is located at the crack elevation. In addition, the presumed horizontal joint reinforcing elevation is at the joint at the bottom of the bond beam. Horizontal joint reinforcing and the infilled bond beam appear to create a stress concentration at that elevation with respect out of plane loading.

Photo 3 Town Hall – South Wall – Horizontal and Vertical Cracks

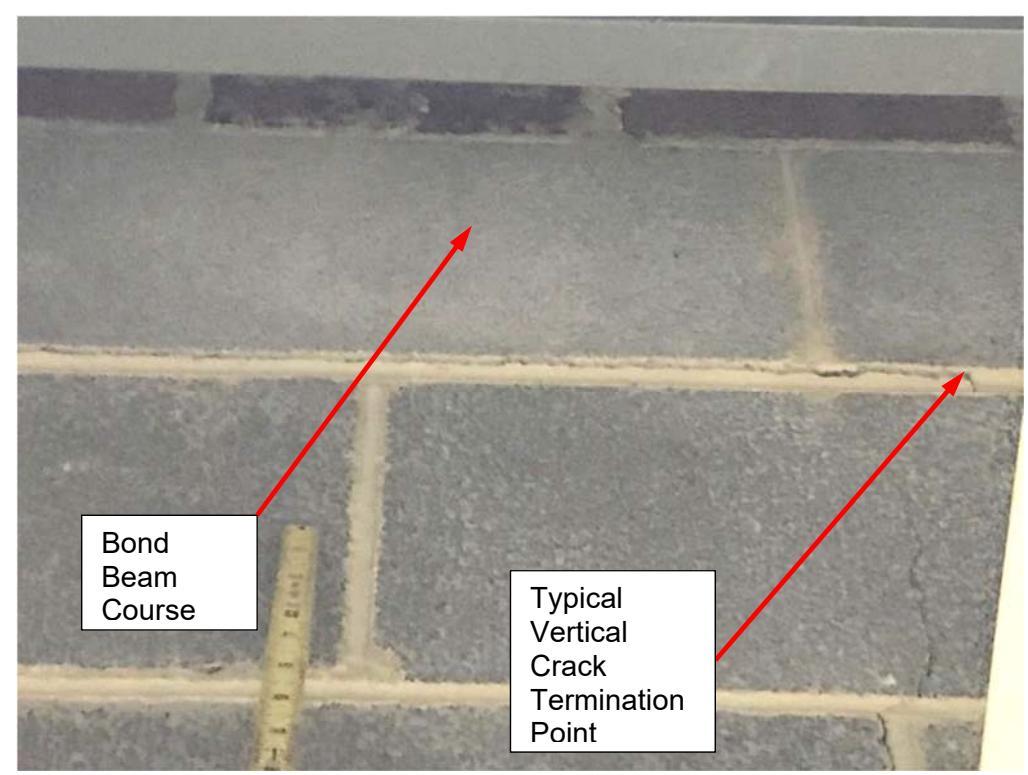
Photo 4 Town Hall – South Wall – Horizontal and Vertical Cracks

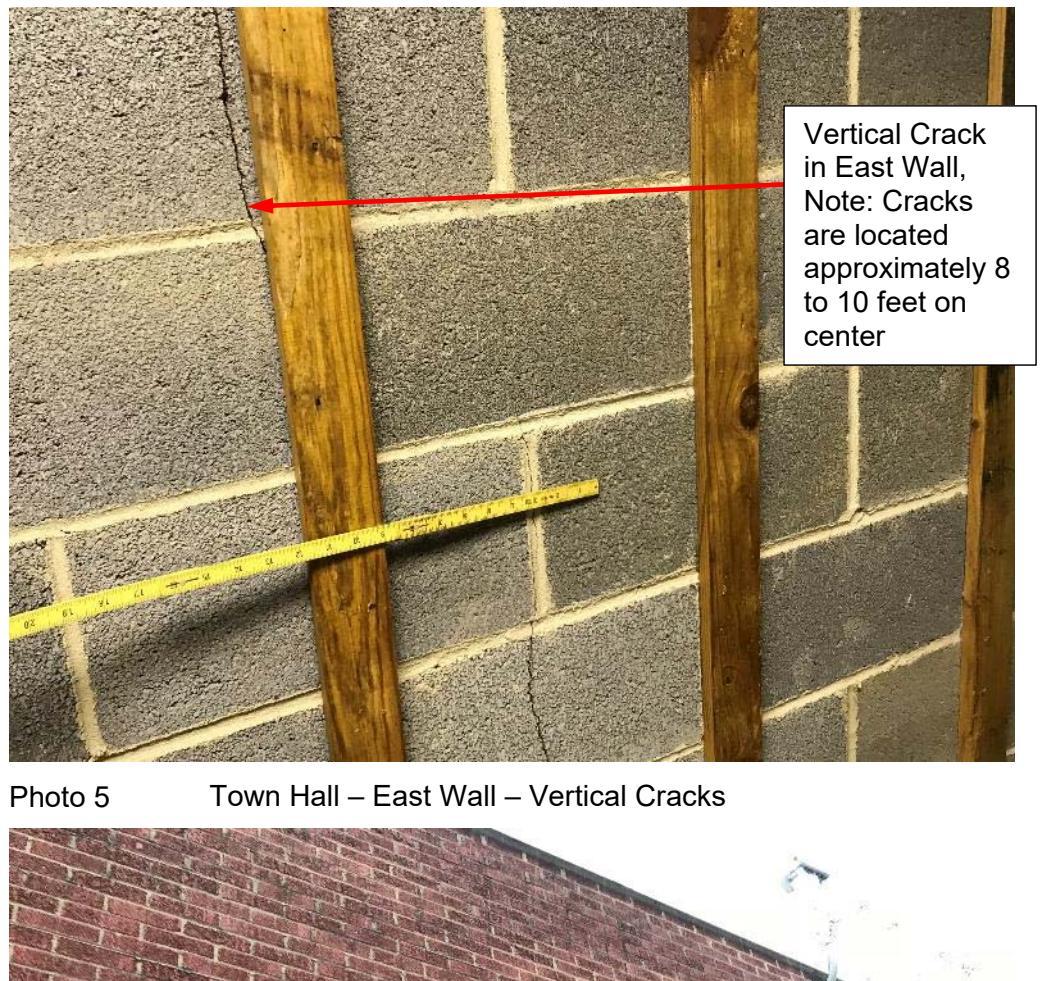
Photo 5 Town Hall – East Wall – Vertical Cracks

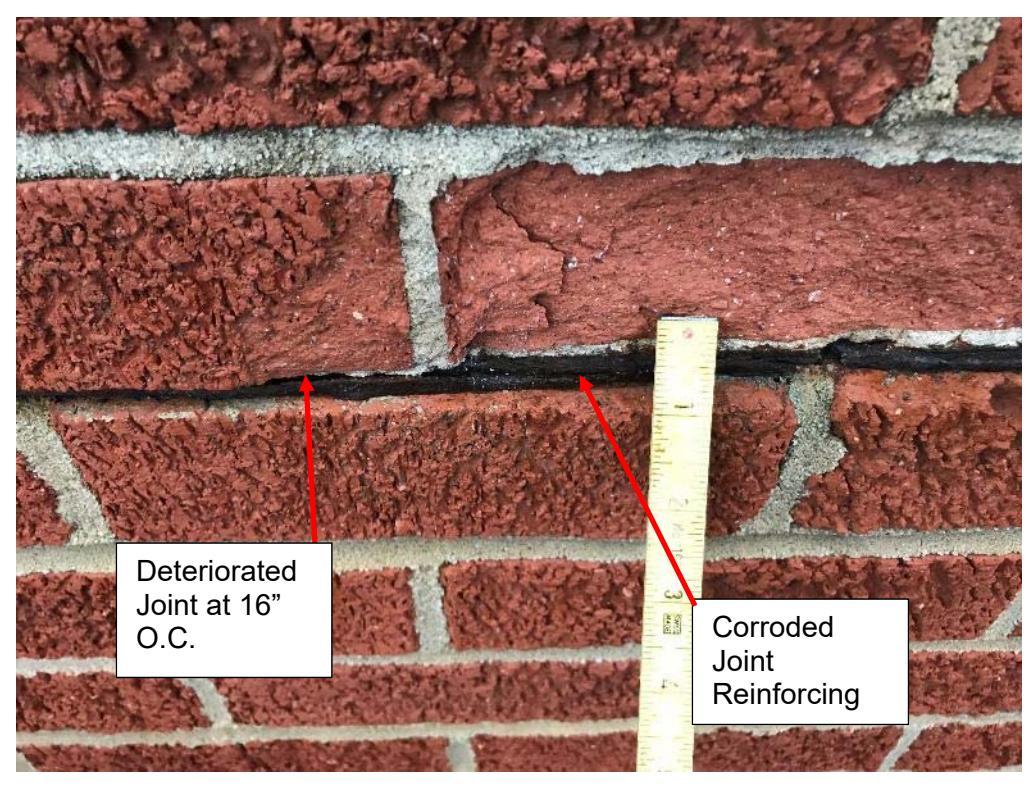
Photo 7 Town Hall – South Wall – Deteriorated Joints

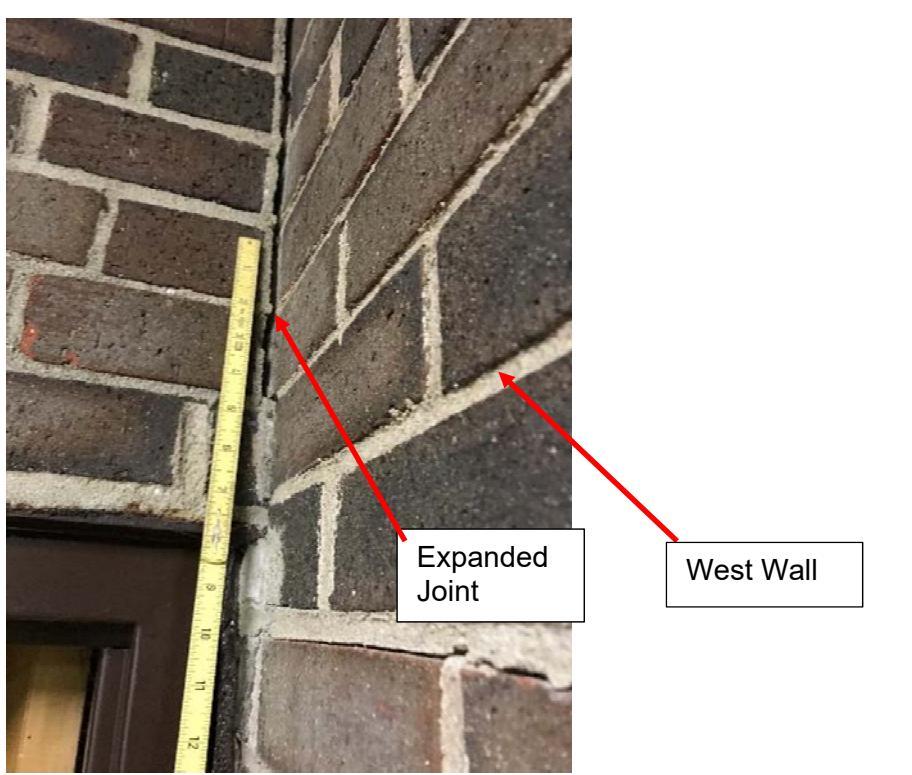
Photo 8 Public Safety Building – West Wall – Expanded Joint/Crack

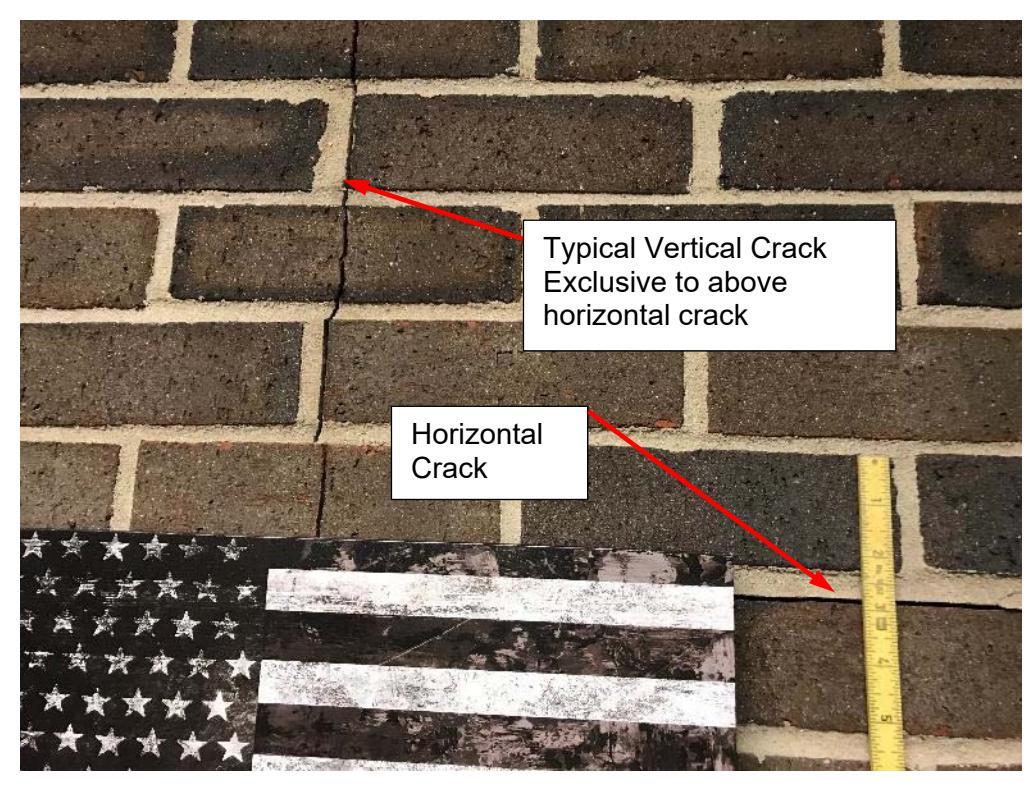
Photo 9 Public Safety Building – West Wall – Horiz./ Vertical Cracks

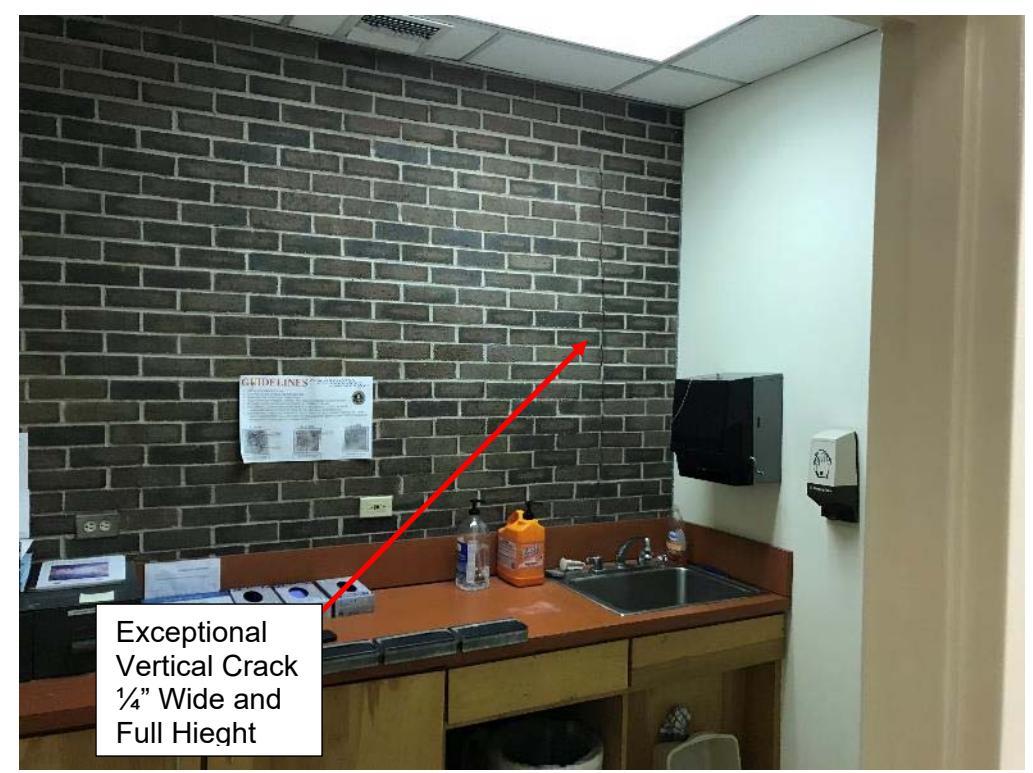
horizontal joint reinforcing may have accentuated crack development. For instance, the large crack in Photo 10 may have developed at an interruption in horizontal joint reinforcing. The crack is approximately 3/8" wide.

Photo 10 Public Safety Building – East Wall –Vertical Crack

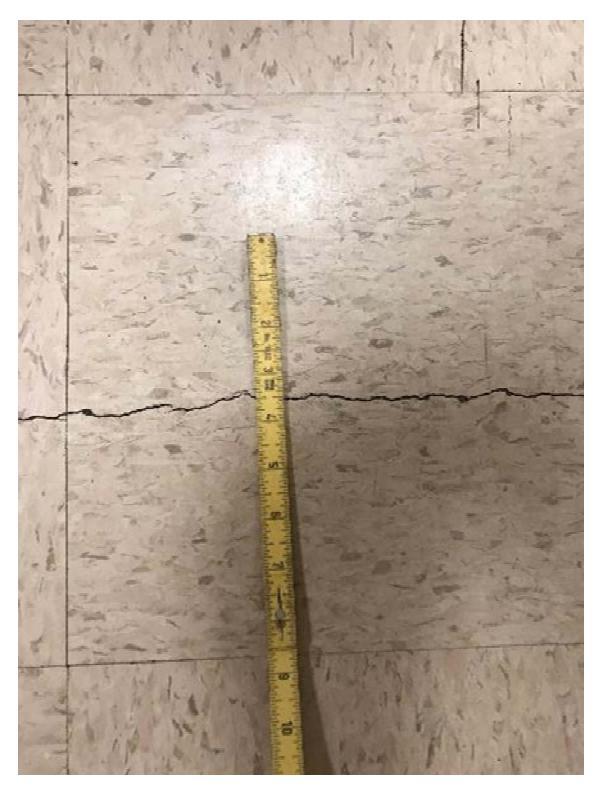
Some slab cracking is evident through the linoleum tile in interrogation, Photo 11. The cracks appear isolated. Separation is evident between the slab and the wall along the east wall as shown in Photo 27. The separation may be attributable to the same forces acting out of plane on the walls to create the horizontal crack.

Photo 11 Public Safety Building – Interior Slab – Crack

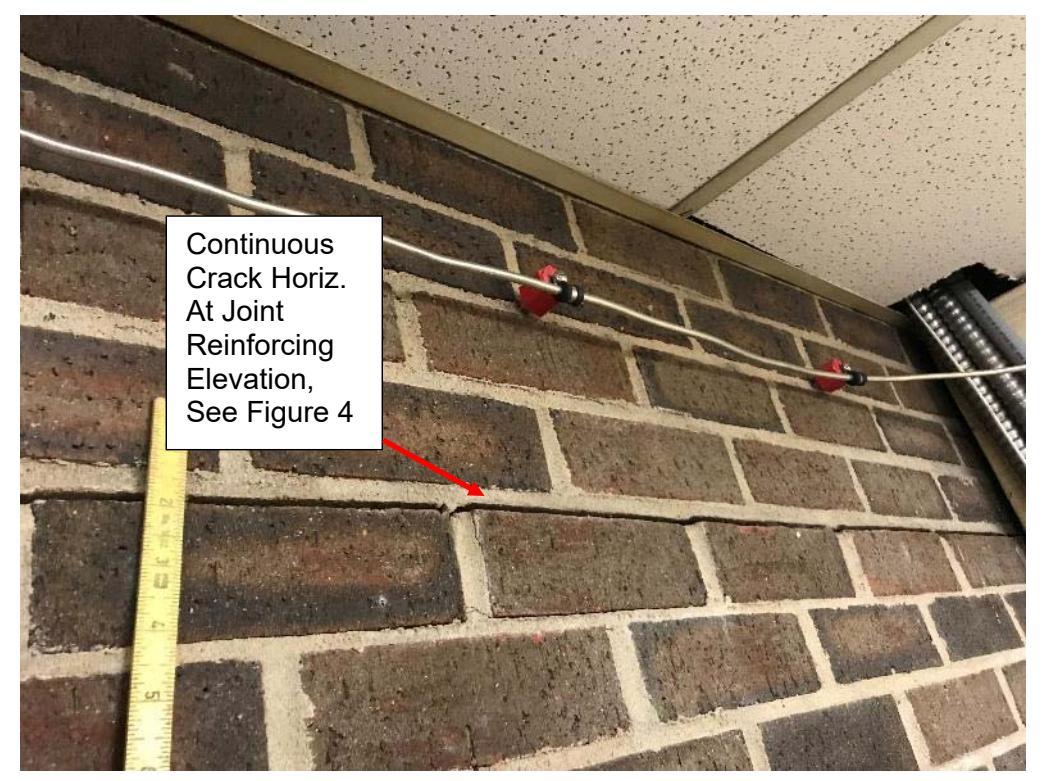
A horizontal crack runs virtually the entire perimeter of the building and is located approximately 4 $\frac{1}{2}$ bricks below the drop ceiling on the east wall the south wall and part of the north wall per Photos 12 and 13. The west wall horizontal crack elevation varies to approximately 10 $\frac{1}{2}$ bricks below the drop ceiling which is consistent with a horizontal joint reinforcing spacing of 16". Similarly, 4 $\frac{1}{2}$ bricks below the drop ceiling is consistent with joint reinforcing detailed in Figure 4 per Record Drawings.

Photo 12 Public Safety Building – South Wall – Horizontal Crack

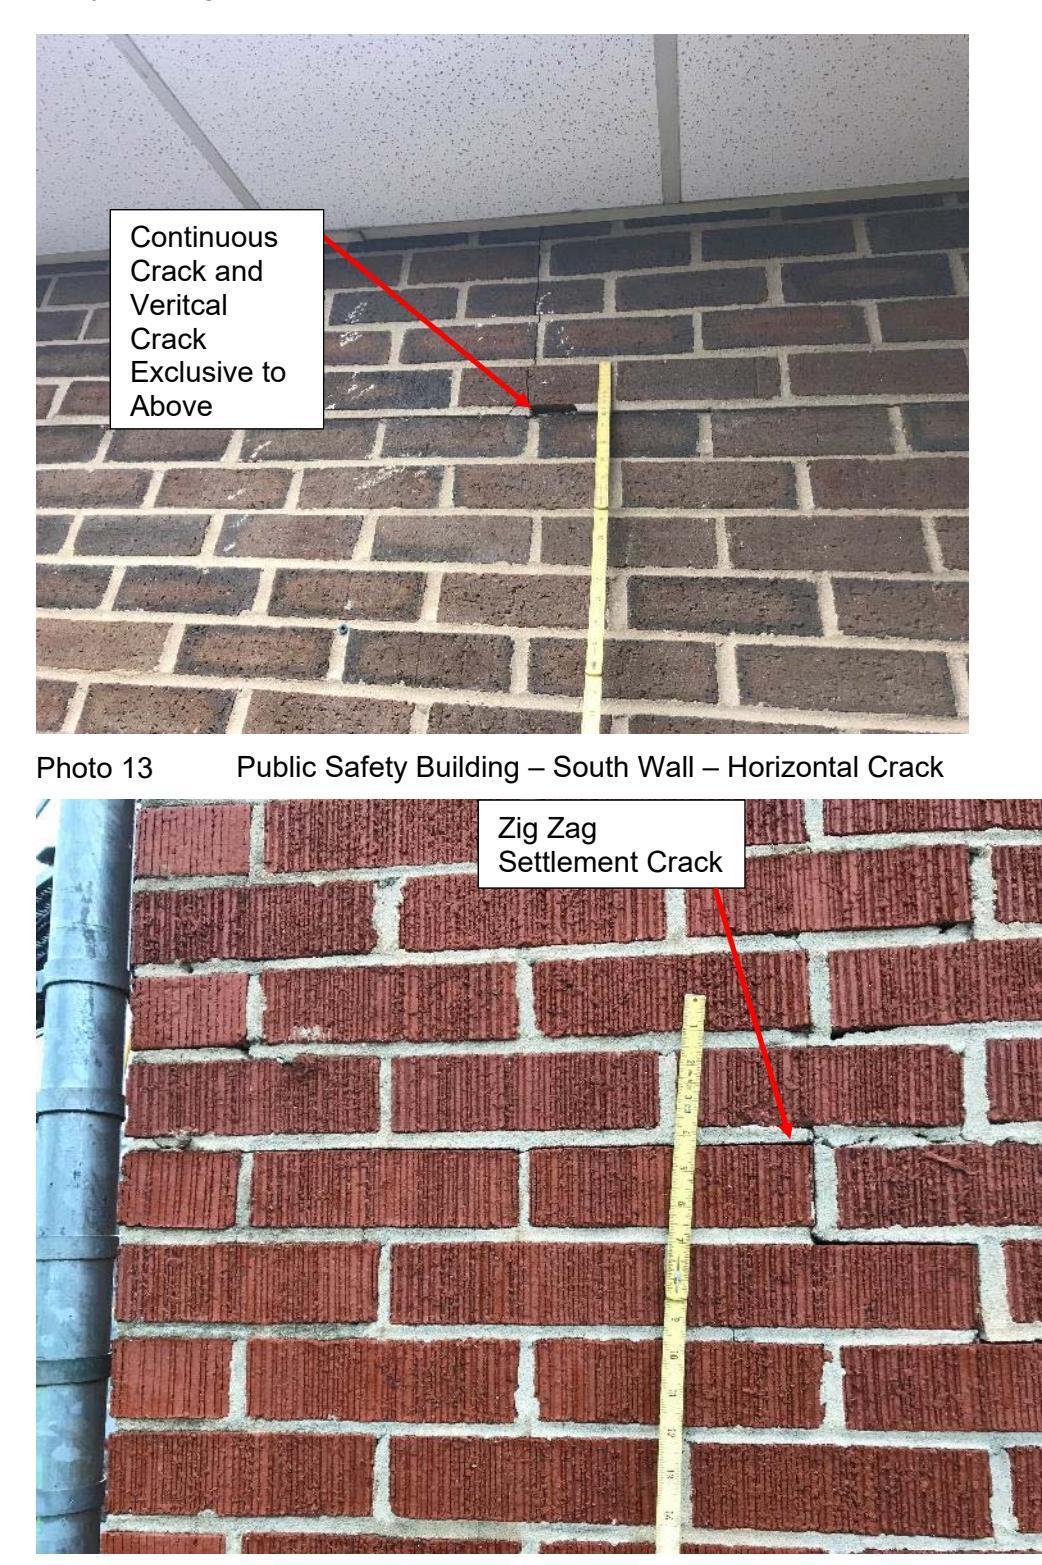
Exterior wall defects are similar to the Town Hall and generally appear attributable to corrosion of horizontal joint reinforcing. Some previous repairs are evident on the south wall. Another difference is an isolated differential settlement crack located at the southeast corner as shown in Photo 14. The crack is somewhat mirrored internally inside the IT room.

The only obvious settlement cracks are located on the southeast corner of the Public Safety Building. The cracks should be gauged and monitored.

Photo 14 Public Safety Building – Southeast Corner – Zig Zag Crack

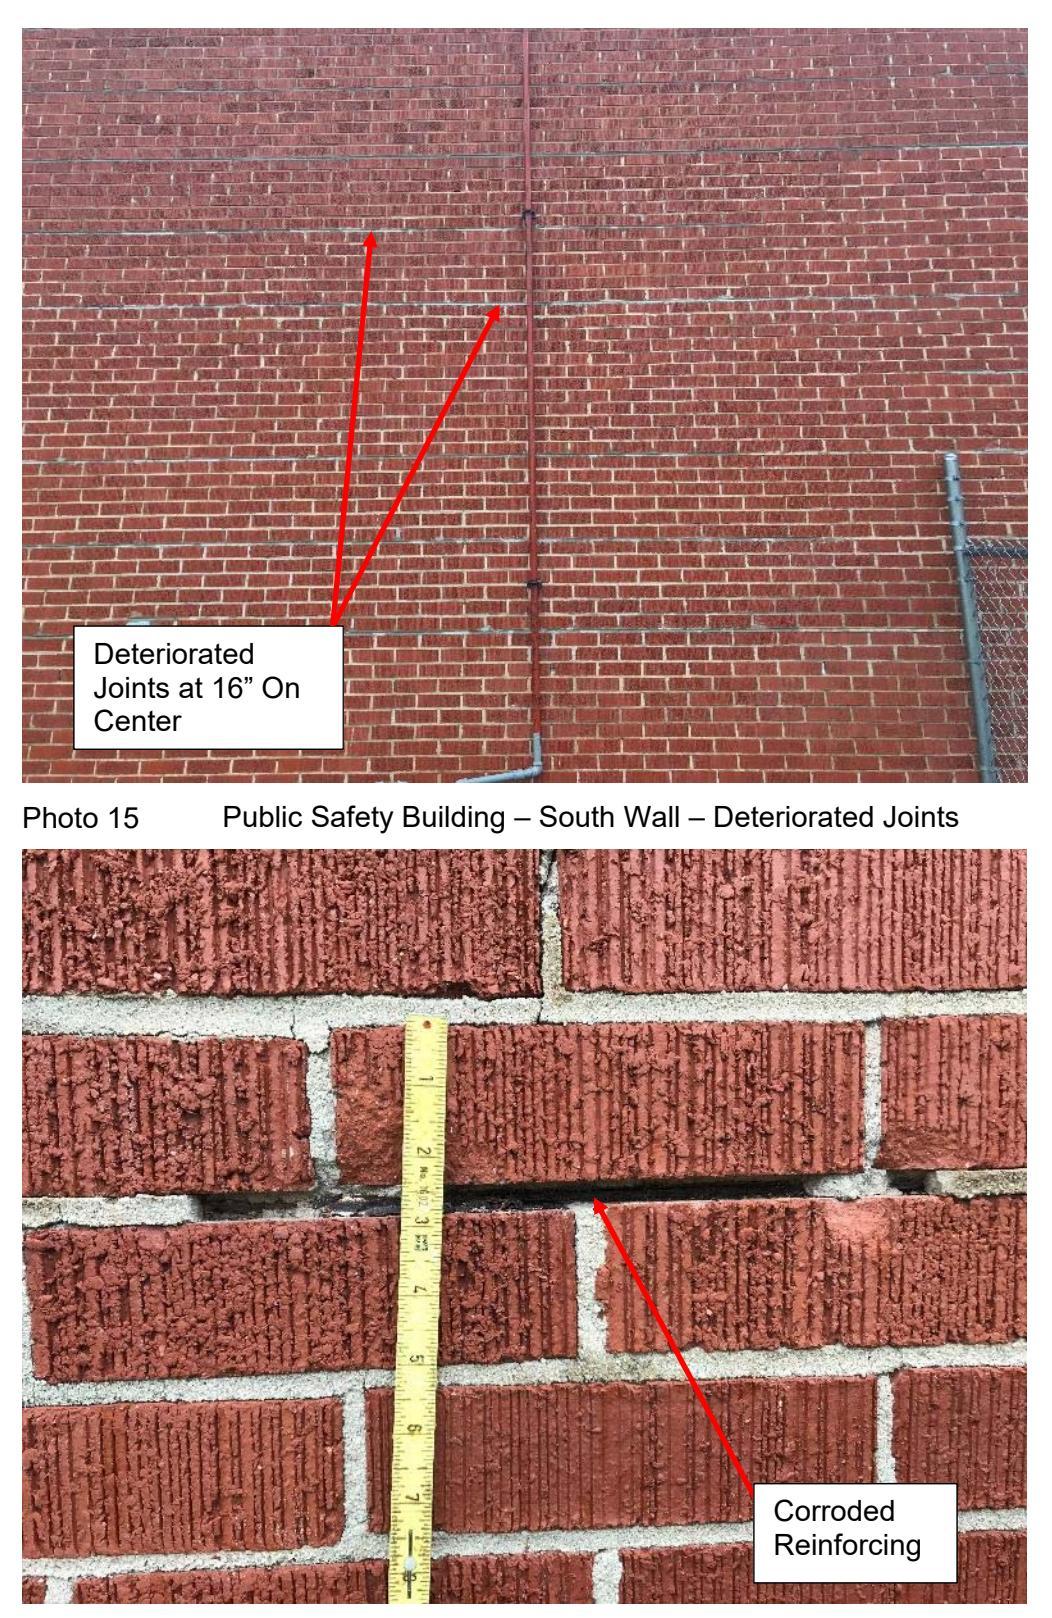
Photo 16 Public Safety Building – South Wall – Deteriorated Joints

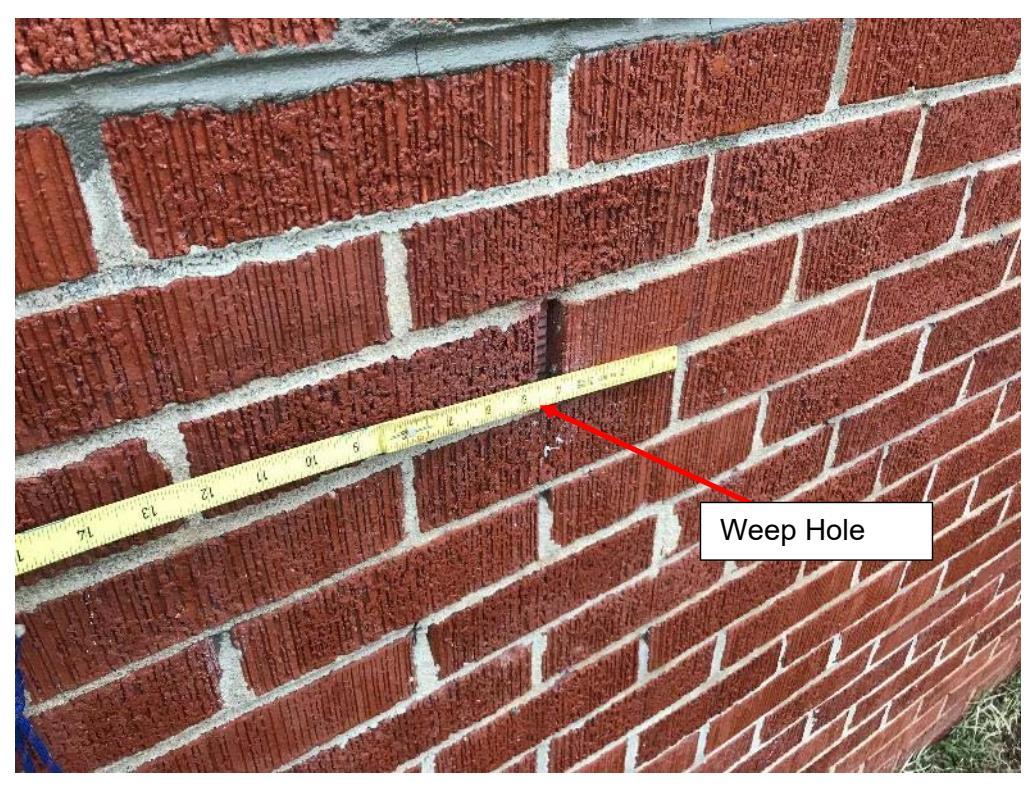
Photo 17 Public Safety Building – South Wall – Repaired Joint and Weep

As for the joint repairs existing, they are appropriate, but should not be considered long lasting. Also, without replacement of severely compromised corroded reinforcing, the fix is largely cosmetic. Future joint repairs of this kind should be thoroughly applied. That is, the reinforcing needs to be evaluated as part of the joint repair procedure. Where reinforcing is significantly degraded, it should be replaced with new hot dip galvanized reinforcing.

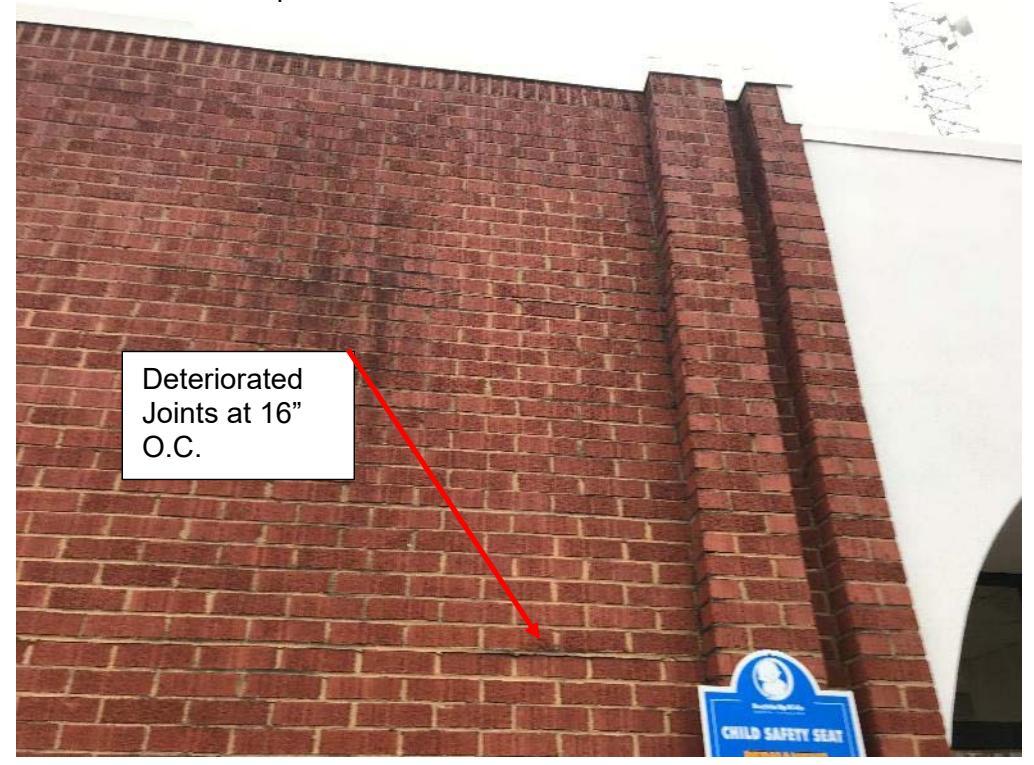
Photo 18 Public Safety Building – West Wall – Deteriorated Joints

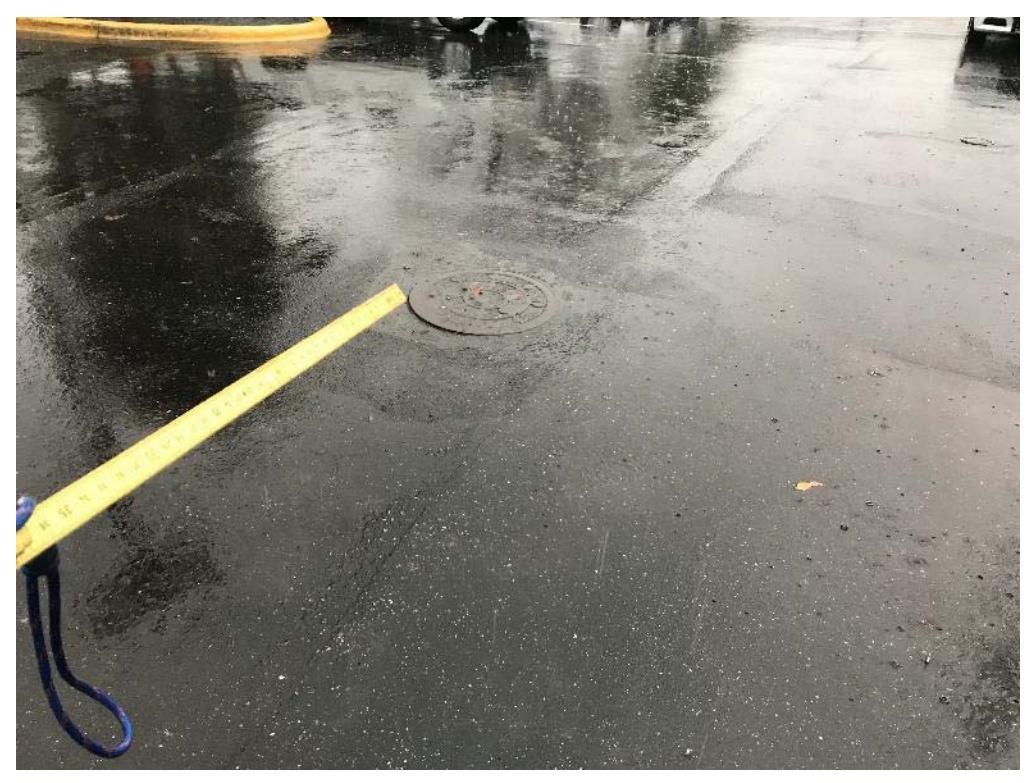
It is difficult to say why exactly the column has cracked. The proximity of the engine bay door connections may be a potential cause, but it is important to note the historical problematic nature of this location. Per testimony from Chief Watts at the time of inspection, there is a history of sink hole development at a manhole junction box location approximately 20 feet from the engine bay doors to the east, Photo 19 and 20.

Photo 19 Public Safety Building – East Side – Manhole

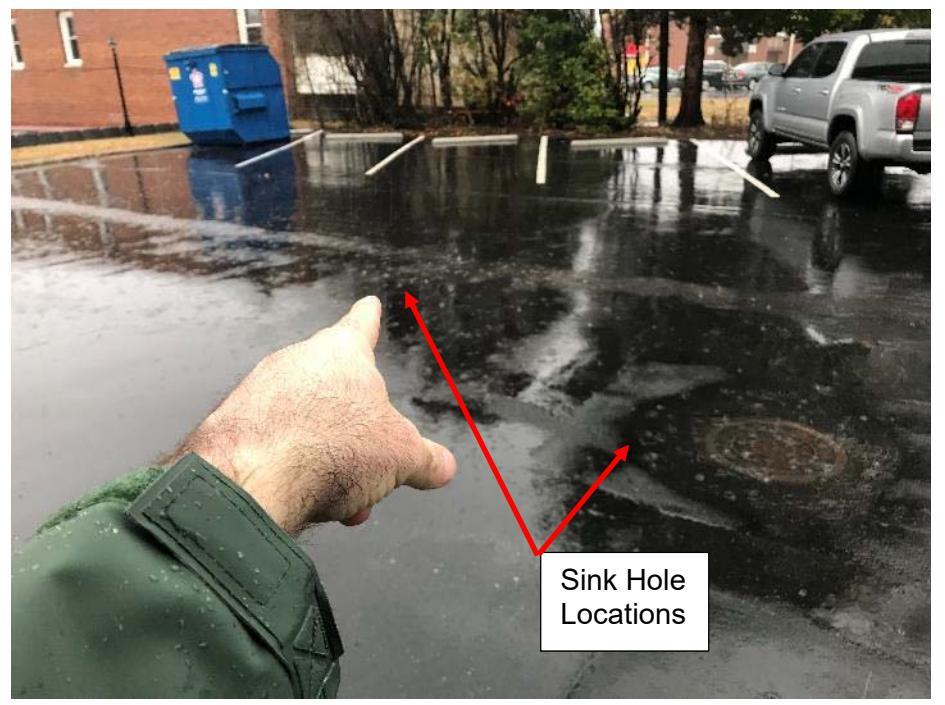
The historical sinkhole requires additional evaluation. Placement of critical infrastructure over underground drain pipes is not good practice. The question is generally not if their will ever be a problem, but rather a question of when. All material degrades over time. In the case of storm pipes, corrosion, abrasion, and chloride ion penetration will ultimately lead to failure of the pipe. Corrosion and abrasion affect both steel and concrete pipes. Chloride ion penetration only affects concrete pipes and manhole boxes, but ultimately leads to internal steel reinforcing corrosion and concrete spalling.

Photo 20 Public Safety Building – East Side – Historical Sink Hole

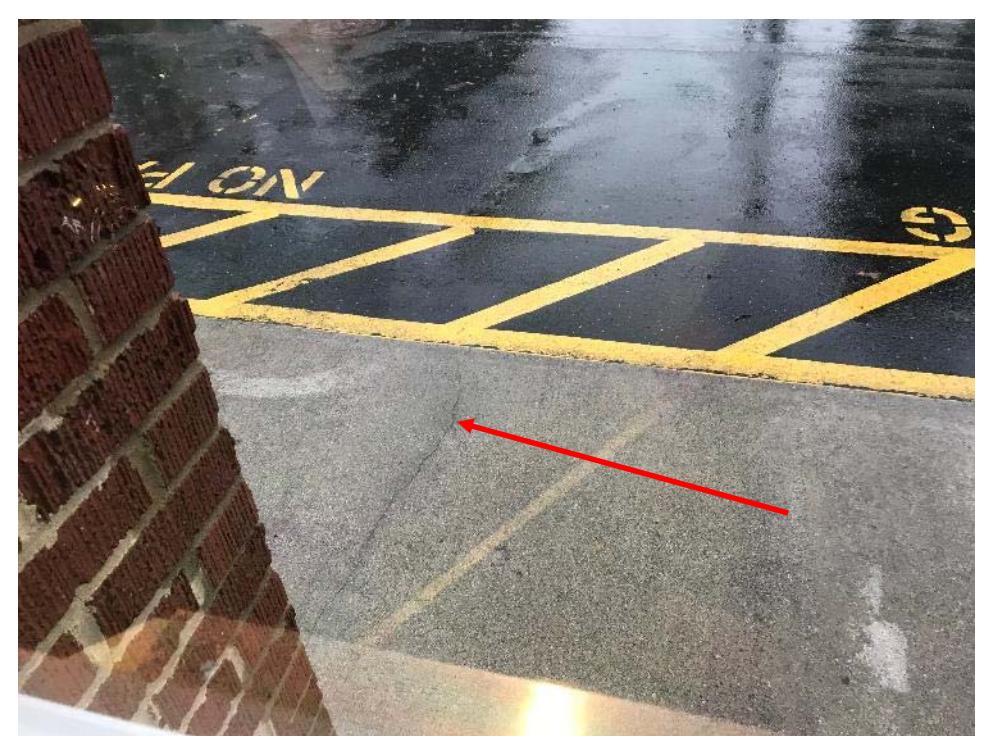
Photo 21 Public Safety Building – East Side – Cracked Slab

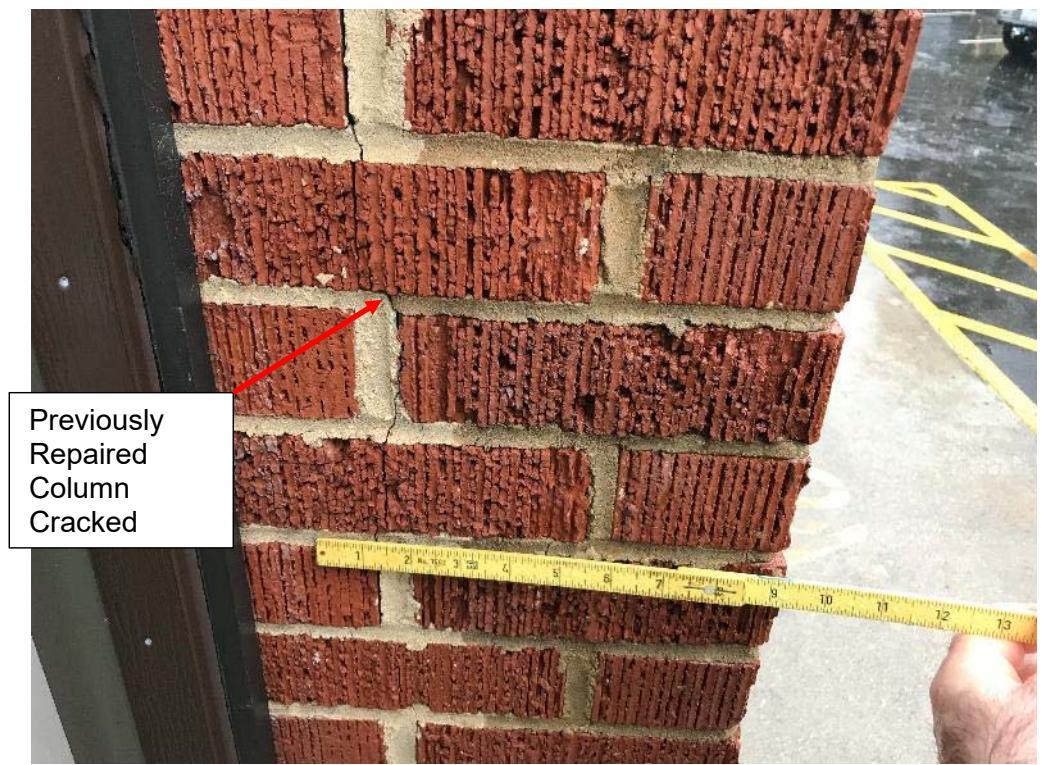
According to testimony at the time of the inspection, the east bay door column was once repaired previously. The repaired column has since cracked as shown in Photo 22. The concrete slab at the east bay doors has also cracked, and it appears attributable to typical slab cracking phenomenon.

The cracked column between bay doors on the east side appears to be a minor condition. However, it is coincidental that the column exhibits cracking and is also in close proximity to the known historical sink hole location. It is possible that the crack is on account of minor original construction or repair construction defect. However, it is also within the realm of possibility it is associated with some other larger instability. The crack should be monitored with crack gauges and reevaluated if it worsens.

Photo 22 Public Safety Building – East Side – Cracked Column

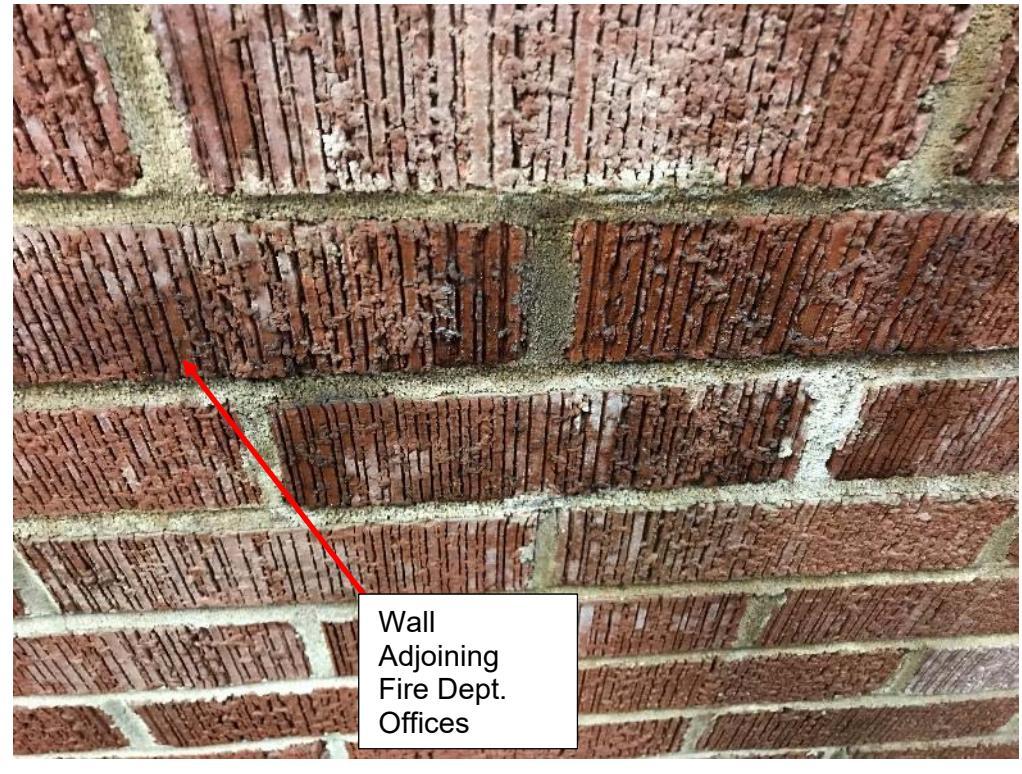
The efflorescence in the engine bay is minimal and likely is residual early bloom or minor ambient moisture in the cavity escaping. It is possible a roof leak has contributed, but implications appear minor at this time. The condition should be monitored and reevaluated if it worsens.

Photo 23 Public Safety Building – Engine Bay – Efflorescence

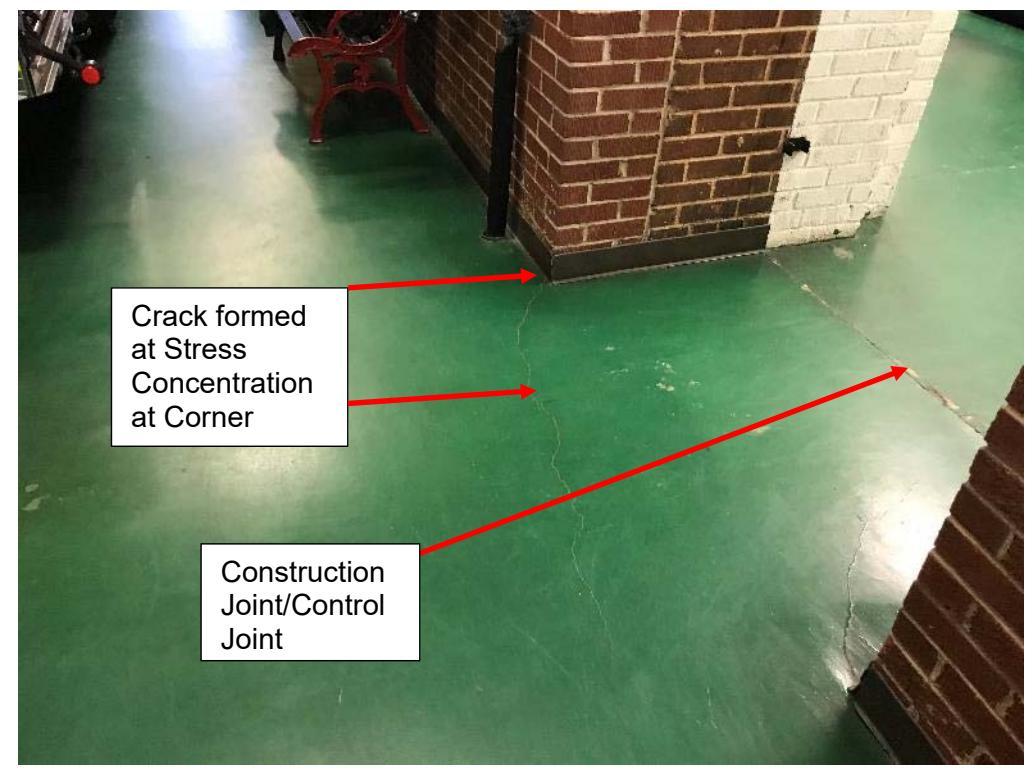
The slab inside the engine bay exhibits cracking at locations of stress concentration like corners and slab pipe penetrations as shown in Photos 24 and 25. Especially since no control joints are evident, the cracks appear attributable to typical shrinkage and/or temperature cracking in slabs on grade.

The cracks in the engine bay slab appear attributable to shrinkage on account of absent control joints and locations consistent with stress concentrations. The condition should be monitored and reevaluated if it worsens. The same conclusion is appropriate for the external concrete slab on the east side outside the bay doors.

Photo 24 Public Safety Building – Engine Bay – Cracked Slab

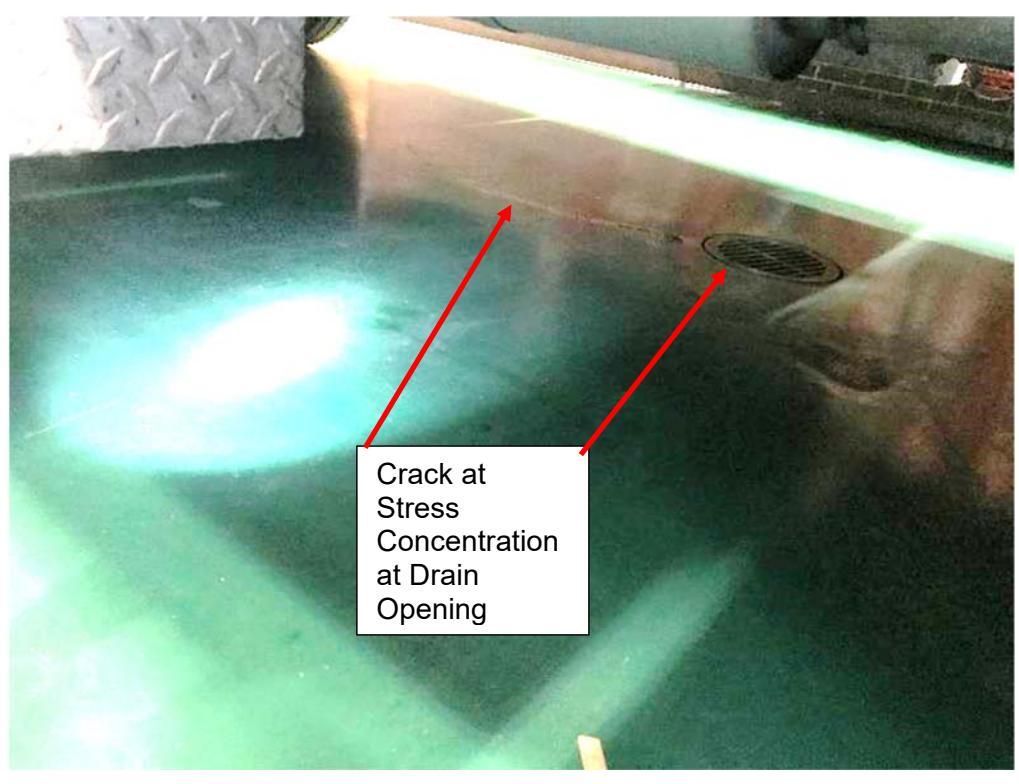
Photo 25 Public Safety Building – Engine Bay – Cracked Slab

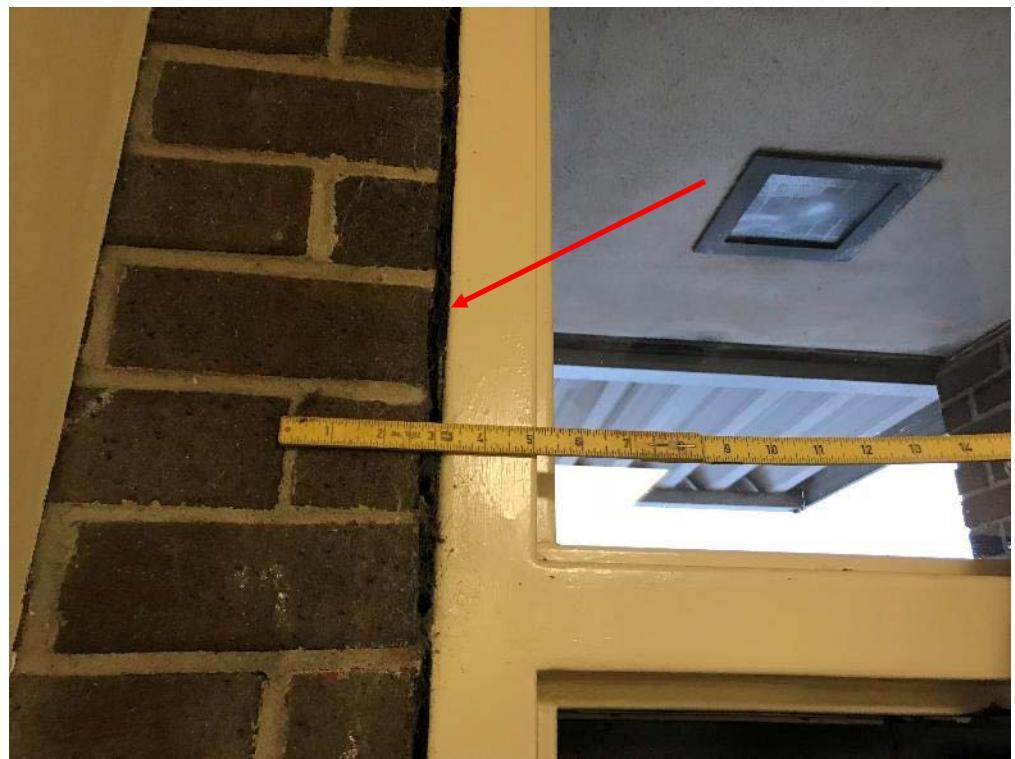
Photo 26 Public Safety Building – East Wall – Separation at Door Frame

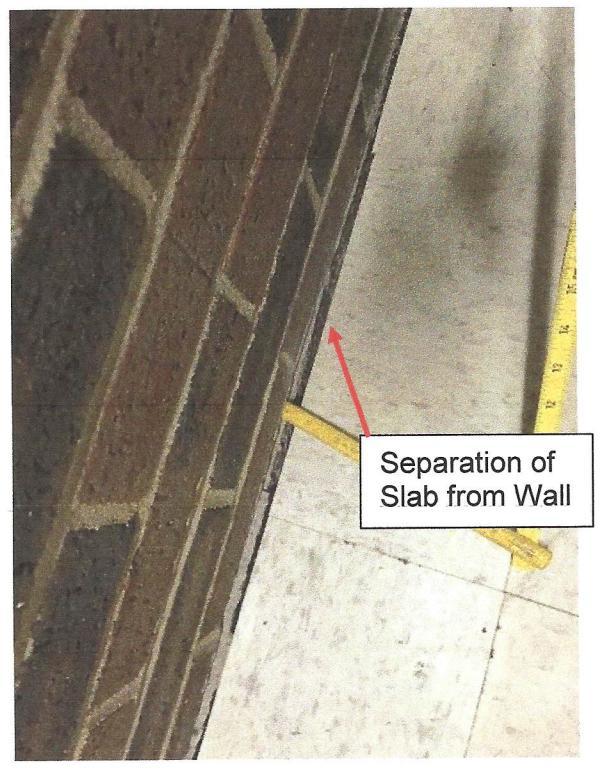
Photo 27 Public Safety Building – East Wall IT Room – Wall Separation
