Town of Valdese
Public Safety Building Report
2021

Re: Inspection of Cracks in Building for
Fire Department and Police Department

VALDESE FIRE DEPARTMENT
Public Safety Buidling Inspection

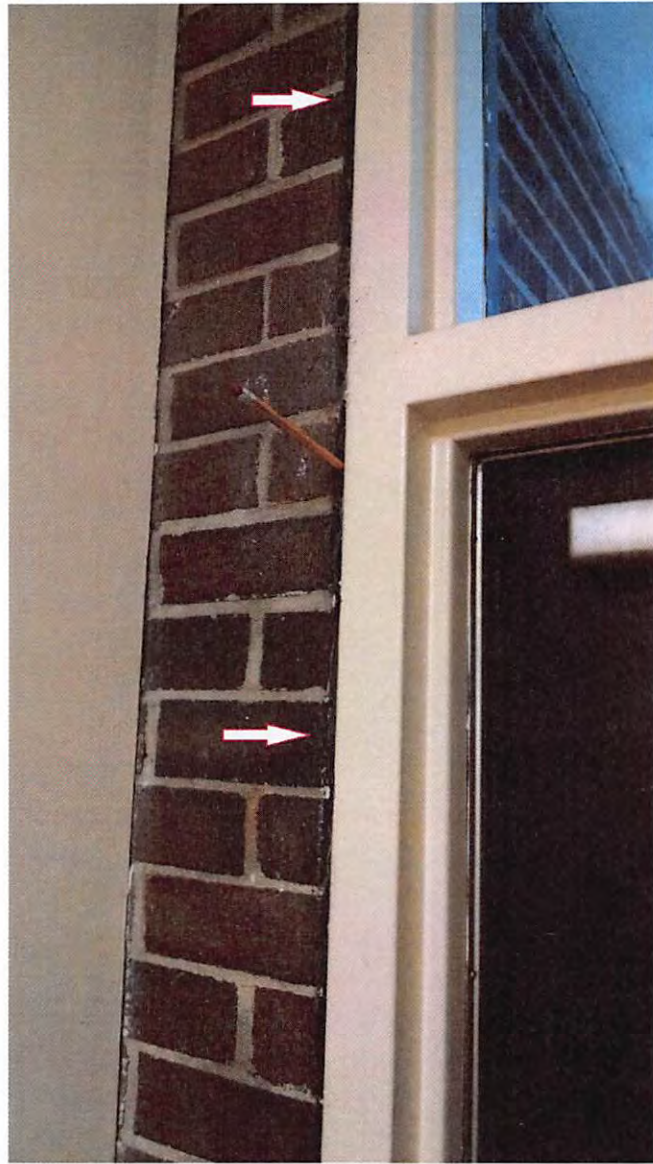
ANOTHER VIEW OF WALL SEPARATING FROM DOOR FRAME ON EXTERIOR DOOR
ON EAST SIDE OF BUILDING.

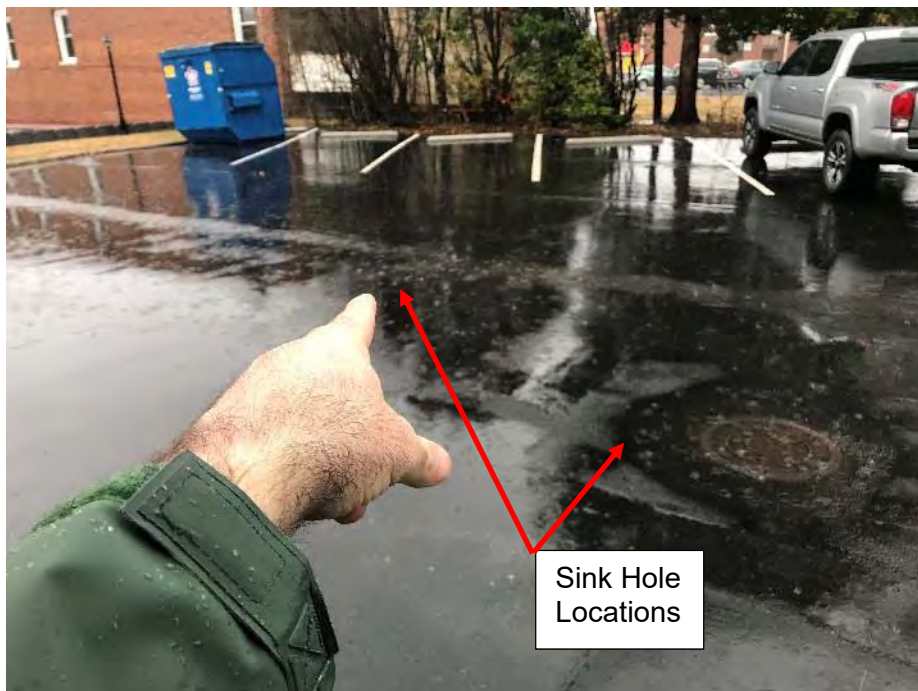
Photo 20 Public Safety Building – East Side – Historical Sink Hole

It is difficult to say why exactly the column has cracked. The proximity of the engine bay door connections may be a potential cause, but it is important to note the historical problematic nature of this location. Per testimony from Chief Watts at the time of inspection, there is a history of sink hole development at a manhole junction box location approximately 20 feet from the engine bay doors to the east, Photo 19 and 20.

Apparently, a city storm sewer pipe is not only located near the engine bay, but runs underneath as depicted in Figures 2 and 3. Building above storm drainage pipes is not considered good practice contemporarily unless no other options are available. According to Chief Watts it is not clear if any special repair measures were undertaken at the time of sinkhole repair. Therefore, it is unclear if the cause of the sinkhole was adequately addressed at the time of previous repair or if partial pipe leakage can be expected to persist or not. Until such time confirmation is made, it is prudent to assume the issue is unresolved.

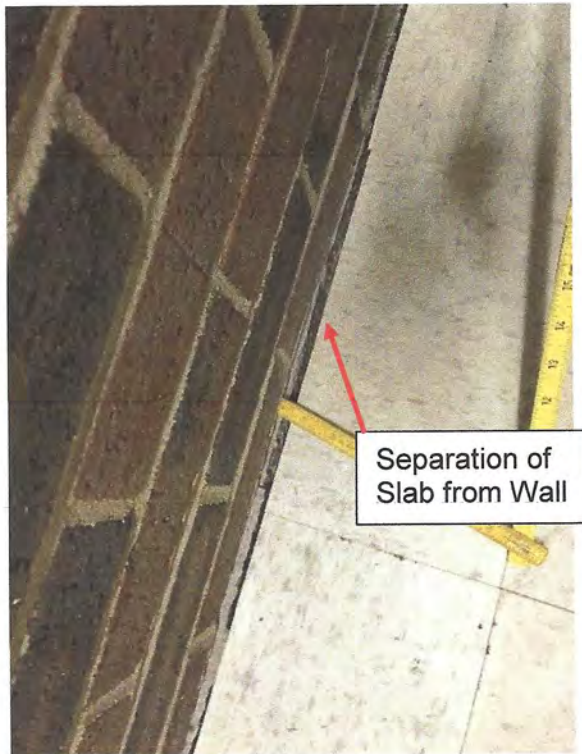
Some slab cracking is evident through the linoleum tile in interrogation, Photo 11. The cracks appear isolated. Separation is evident between the slab and the wall along the east wall as shown in Photo 27. The separation may be attributable to the same forces acting out of plane on the walls to create the horizontal crack.

Photo 27 Public Safety Building – East Wall IT Room – Wall Separation

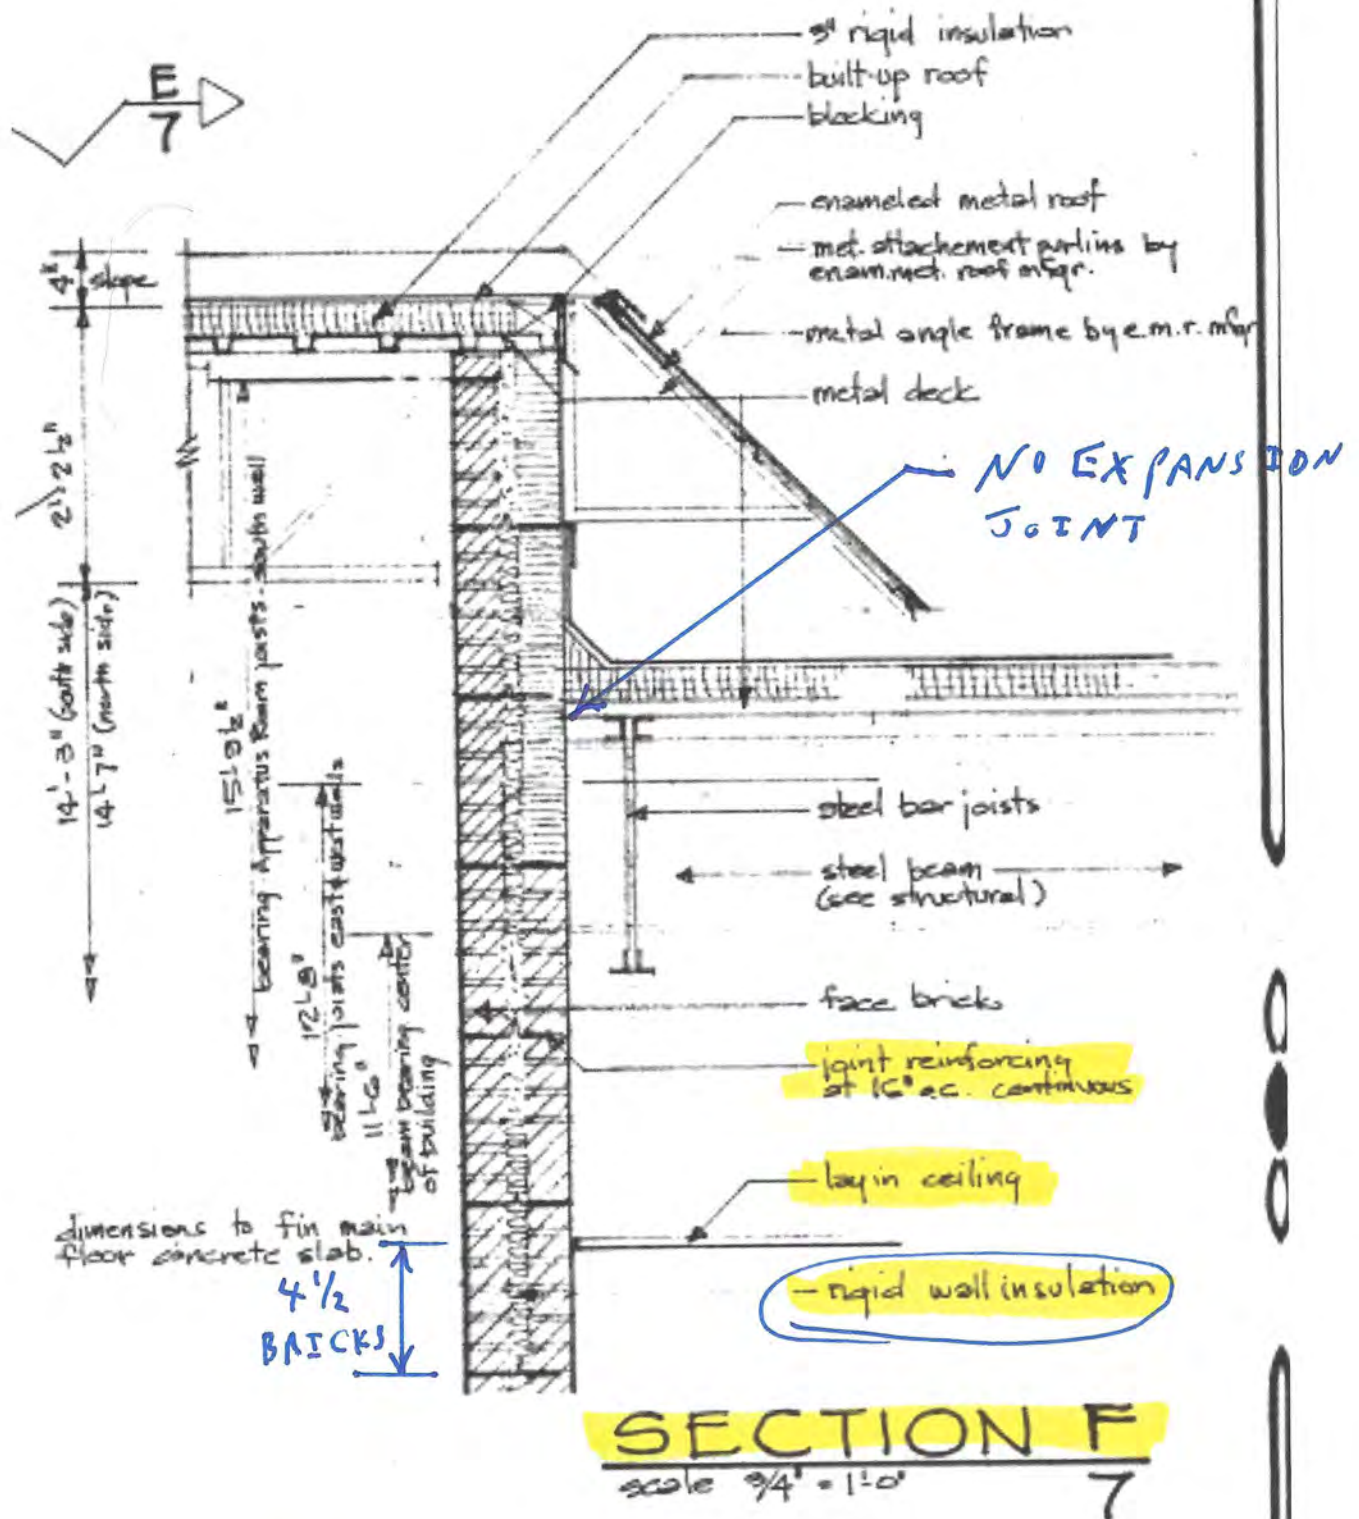
FIGURE 4
SECTION F

A horizontal crack runs virtually the entire perimeter of the building and is located approximately 4 ½ bricks below the drop ceiling on the east wall the south wall and part of the north wall per Photos 12 and 13. The west wall horizontal crack elevation varies to approximately 10 ½ bricks below the drop ceiling which is consistent with a horizontal joint reinforcing spacing of 16". Similarly, 4 ½ bricks below the drop ceiling is consistent with joint reinforcing detailed in Figure 4 per Record Drawings.

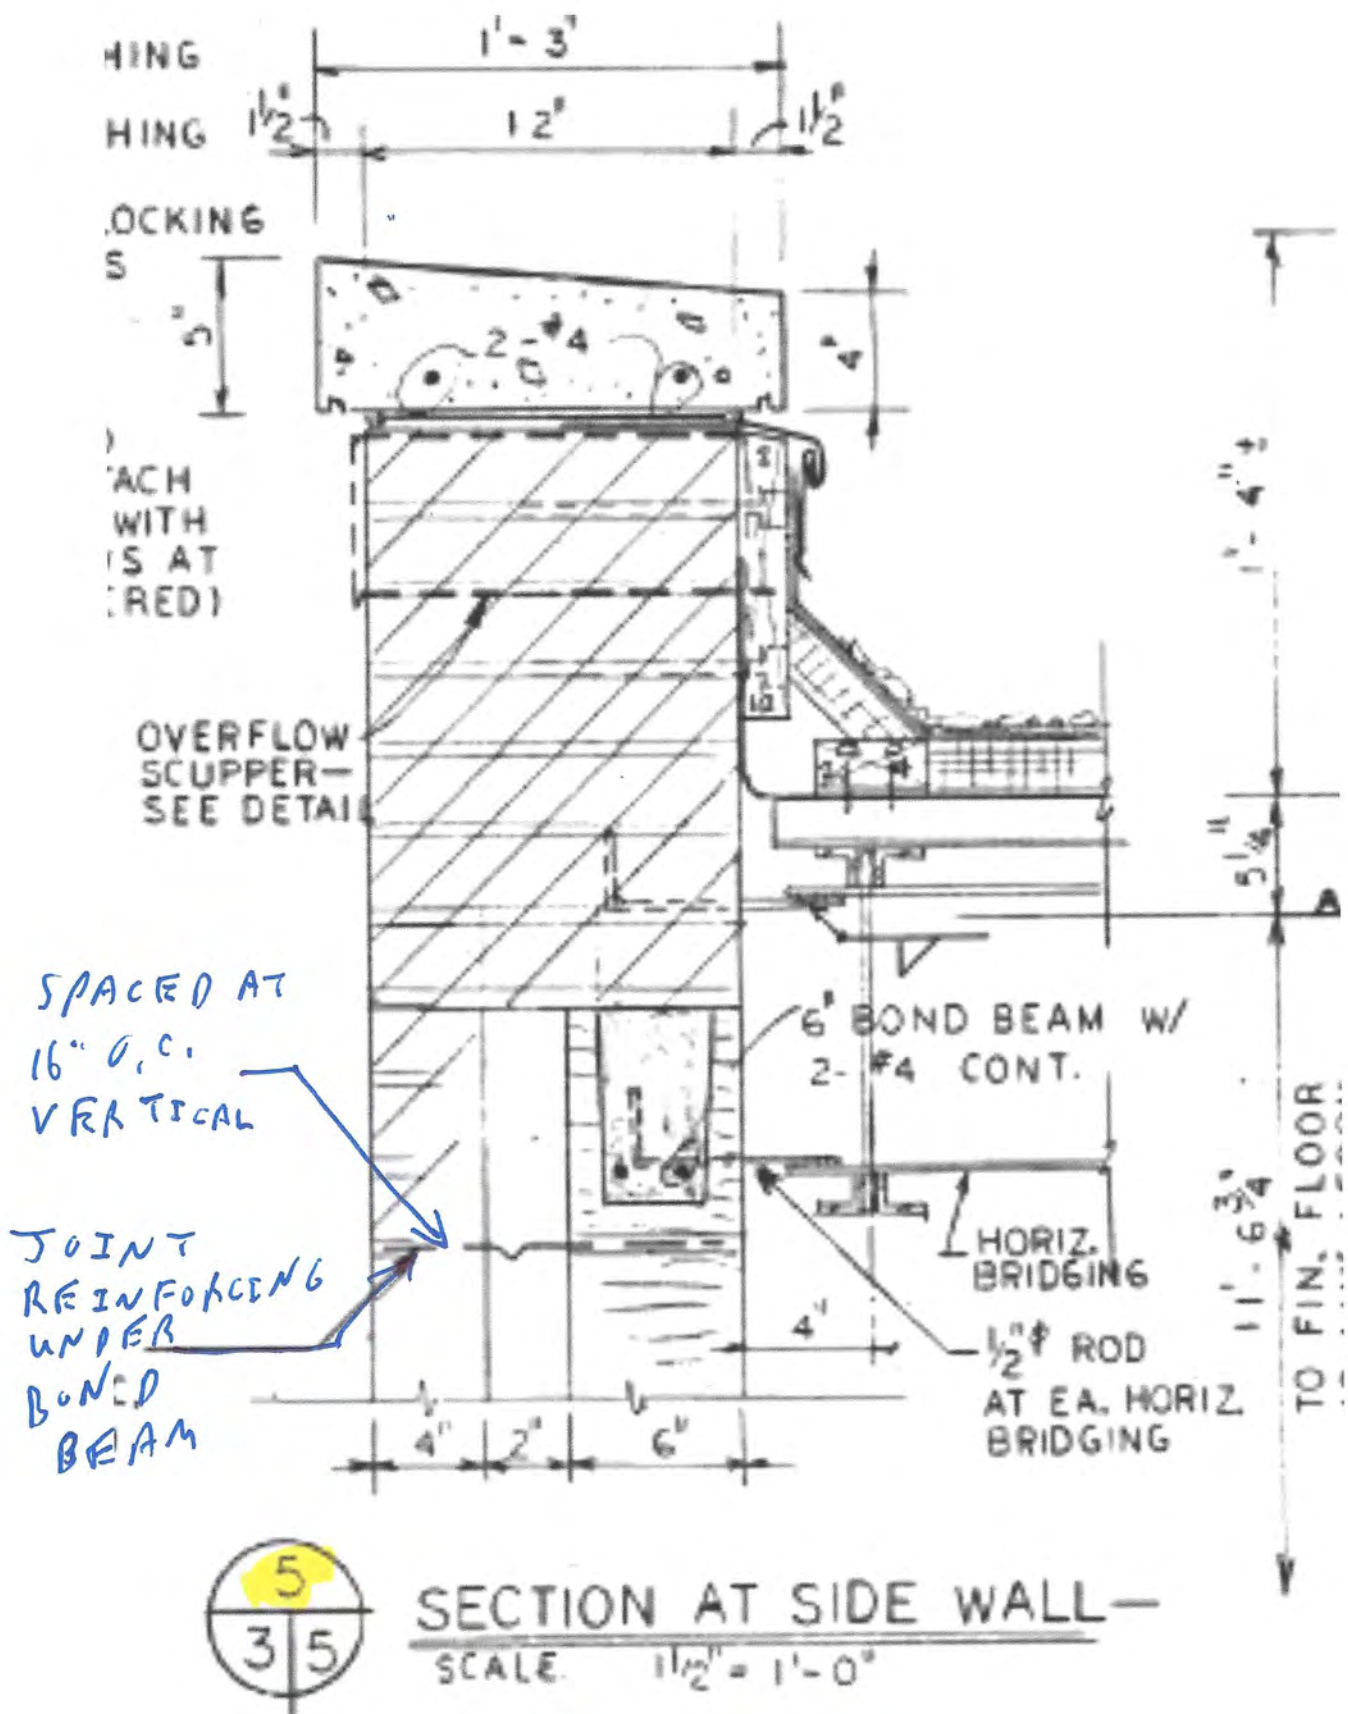
FIGURE 7
SECTION 5

The horizontal cracks are typically located at the approximate elevation of the bottom of the steel reinforced Bond Beam, see Photo 3 and 4 and Figure 7. This condition persists along the north exterior wall and east exterior wall. Per Figure 7 from the Town Hall record drawings, the joint at the bottom of the bond beam is located at the crack elevation. In addition, the presumed horizontal joint reinforcing elevation is at the joint at the bottom of the bond beam. Horizontal joint reinforcing and the infilled bond beam appear to create a stress concentration at that elevation with respect out of plane loading.

Outside, cracking is generally not apparent, but spalling is pervasive along the north exterior wall. The spalling is generally isolated to the masonry joints and is spaced at approximately 16" on center vertically. The spacing matches the joint reinforcing spacing detailed in Figure 7. It appears the steel joint reinforcing has corroded and spalled the joints (popped the mortar) due to expansive corrosion induced forces. Brick has also spalled in a few locations as shown in Photo 7. Buildings built circa the 1970's utilized joint reinforcing and walls ties that were not coated or galvanized. A short time later, galvanizing was introduced but was of a lesser quality when compared to modern hot dip galvanizing. It is reasonable to assume that this building built in 1973 utilized uncoated joint reinforcing and the apparent susceptibility to corrosion is the result. The joint reinforcing may have also been placed too close to the exterior mortar joint surface allowing for water to more quickly reach the susceptible steel.

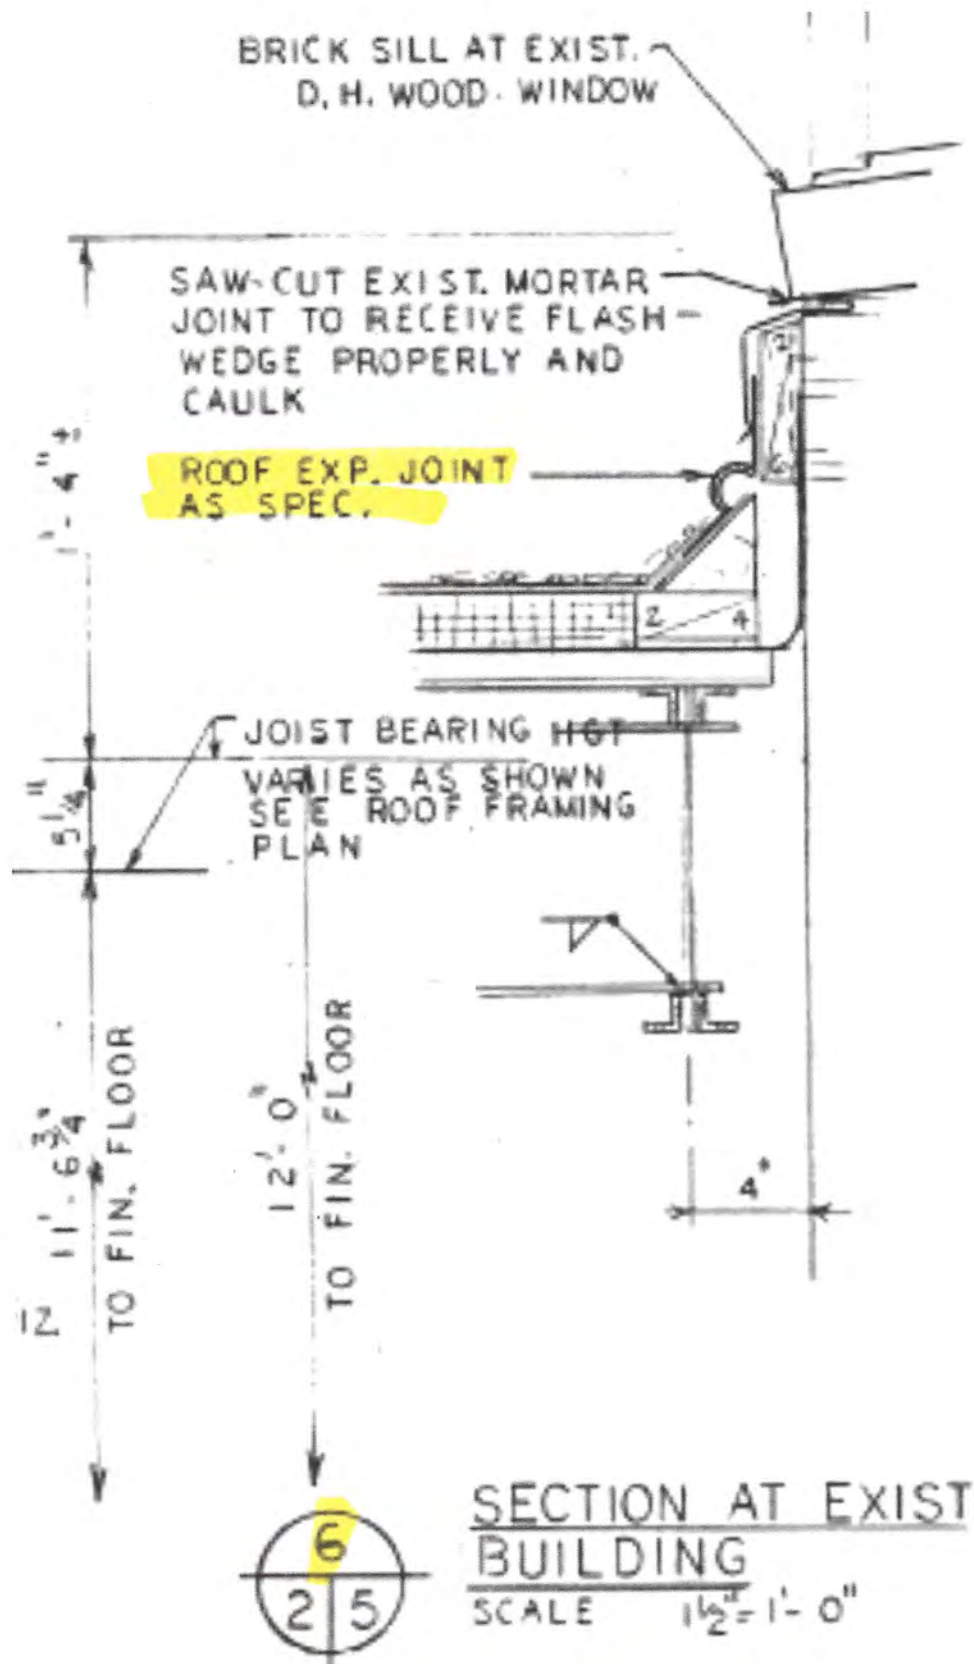
FIGURE 8

The roof was equipped with one expansion joint per record drawings and shown in attached Figure 8. The expansion joint is located along the south wall which is shared by the old previously existing Firehouse building. No expansion joints were provided, per record drawings, at either the east or west walls. It is clear that expansive forces should be expected in the east to west direction. It is less clear why expansive forces effected the horizontal crack in the north wall since expansion forces should have been partially alleviated by the joint at the south wall. It is possible the joint was either installed incorrectly or was less effective than the designer's intent.
