Town of Valdese
Public Safety Building Report
2021

Re: Inspection of Cracks in Building for
Fire Department and Police Department

VALDESE FIRE DEPARTMENT
Public Safety Building Inspection

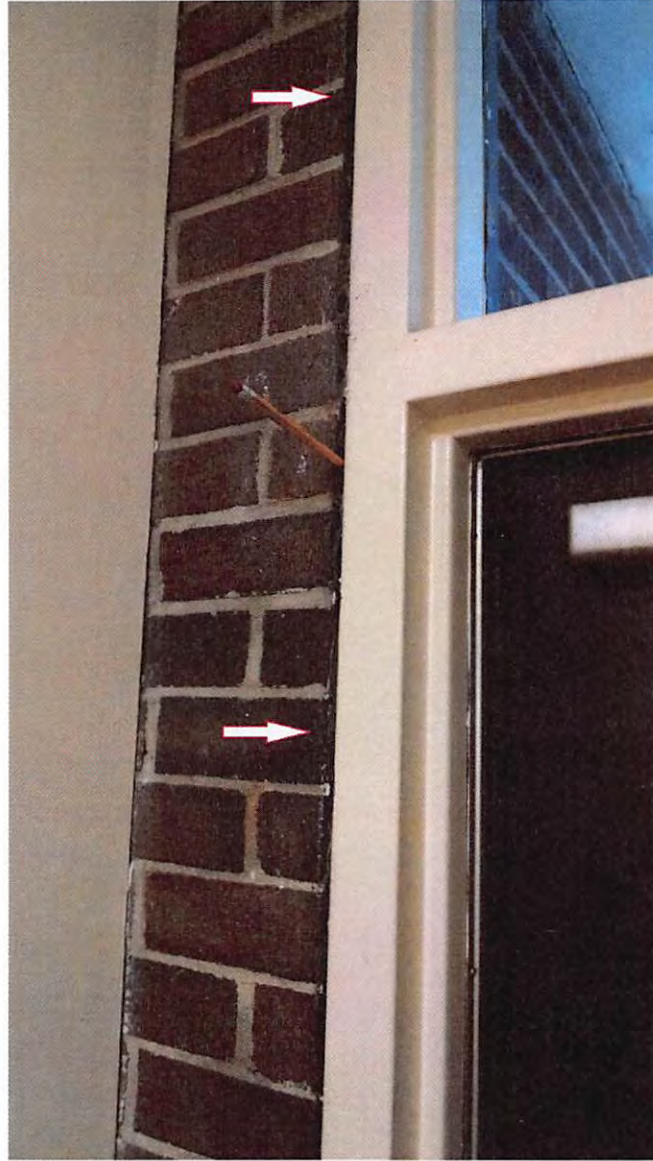
ANOTHER VIEW OF WALL SEPARATING FROM DOOR FRAME ON EXTERIOR DOOR ON EAST SIDE OF BUILDING.

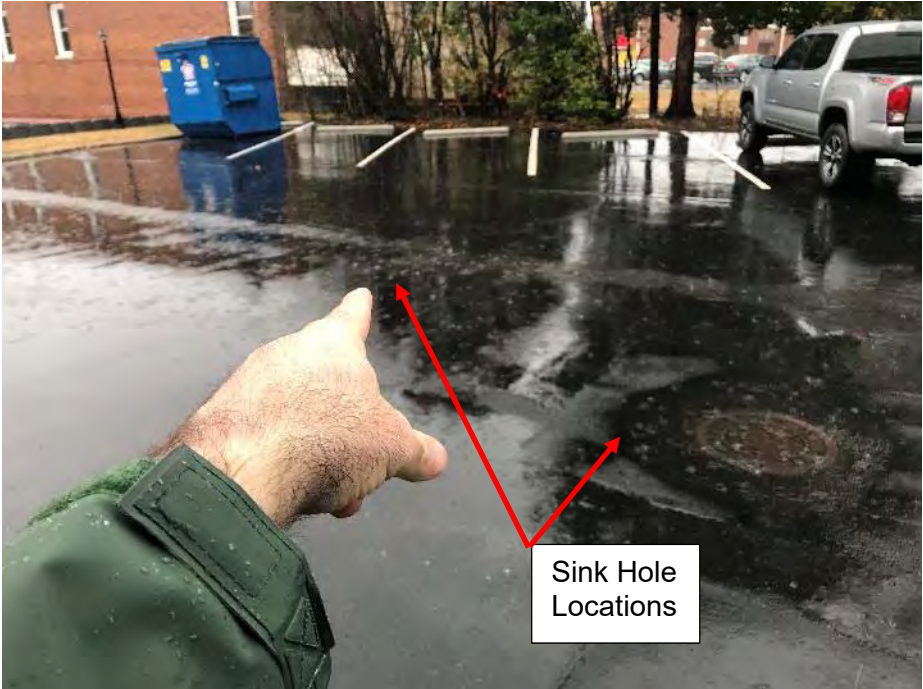
Photo 20 Public Safety Building – East Side – Historical Sink Hole

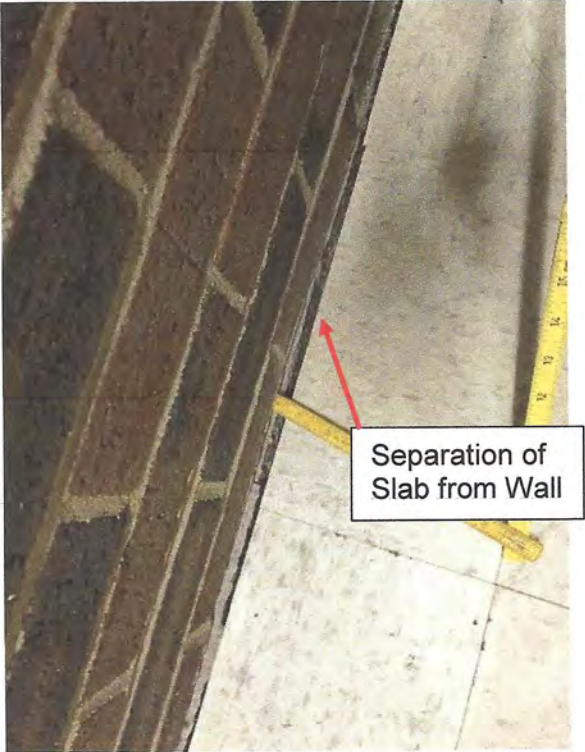
Photo 27 Public Safety Building – East Wall IT Room – Wall Separation

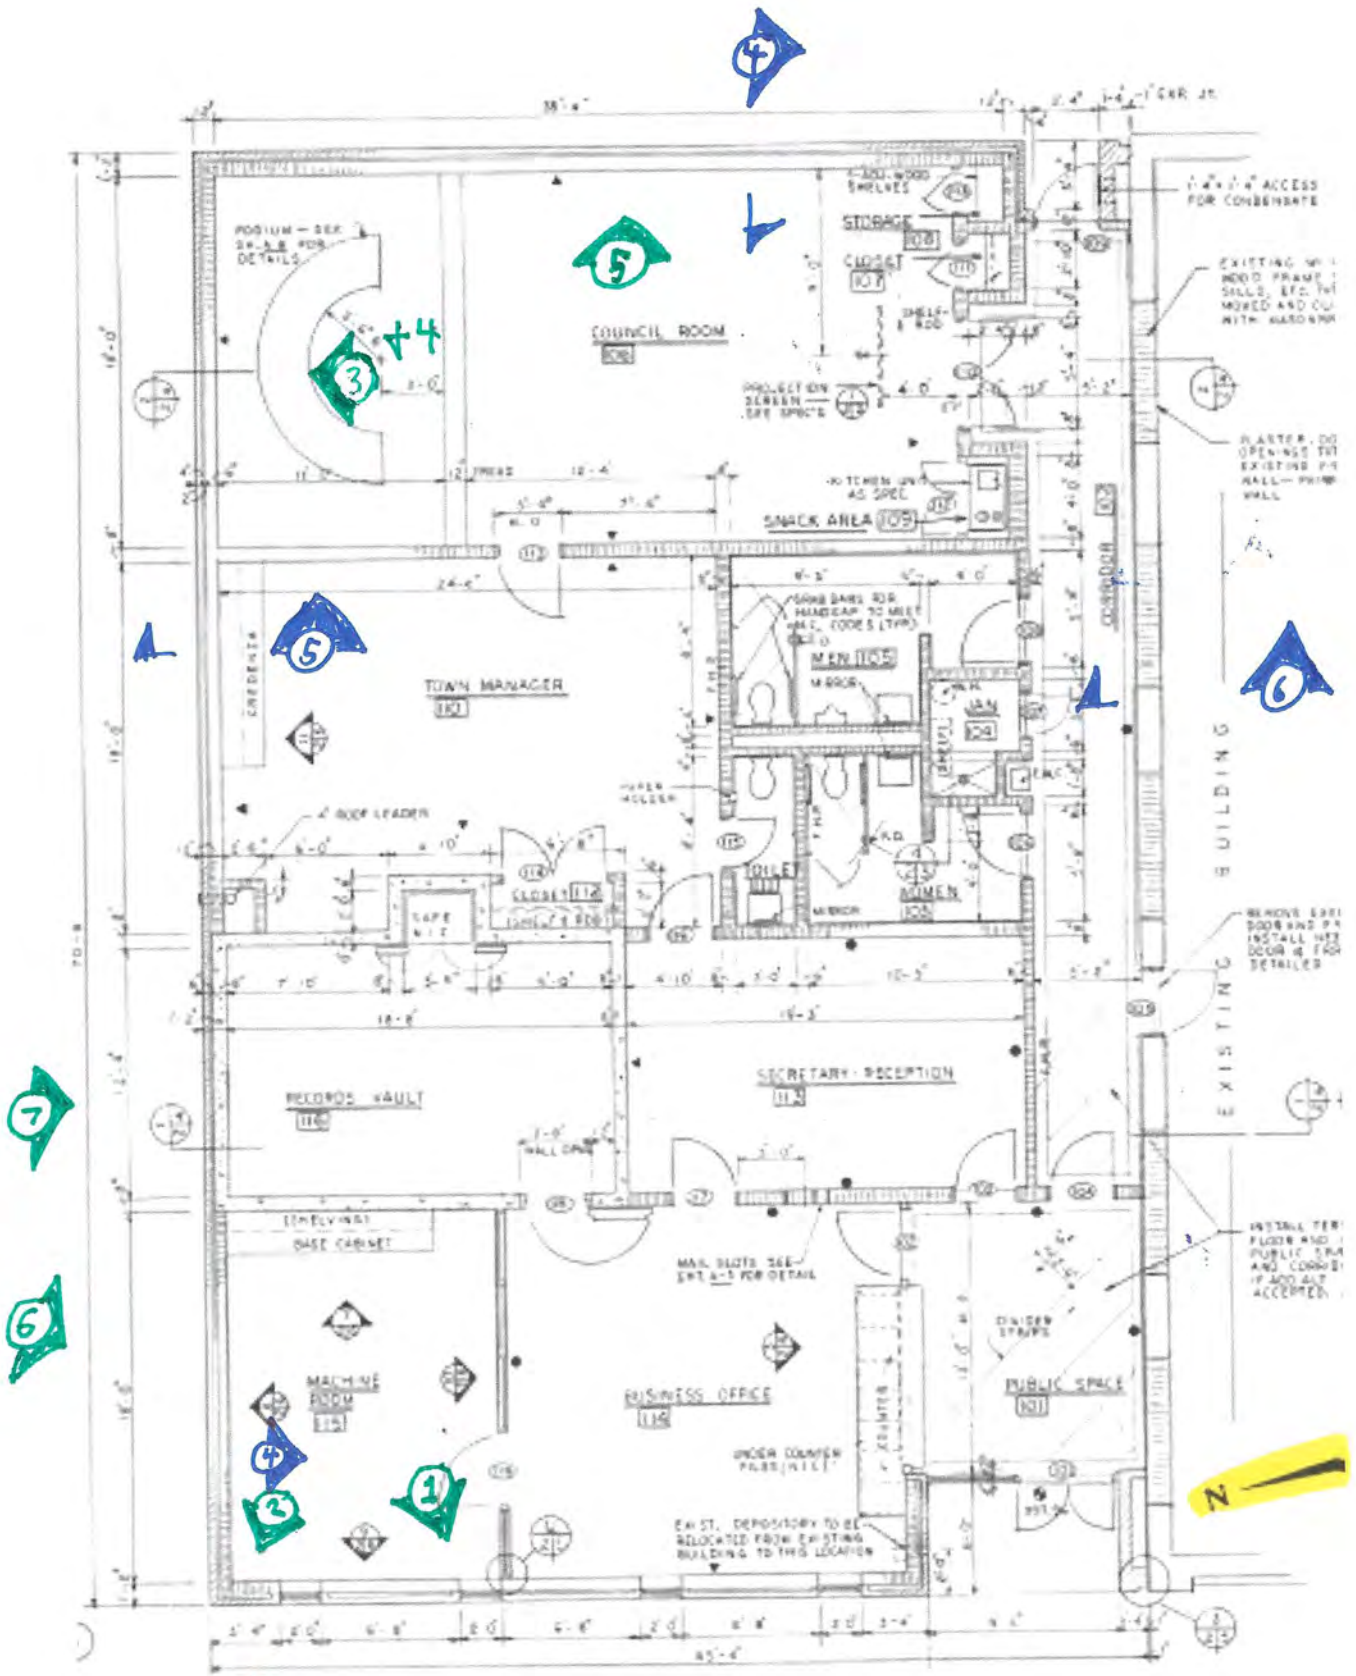
FIGURE 1

The Valdese Public Facilities Building was built in three distinct sections. The first was the old Firehouse which was built in excess of 60 years ago. The second was the Town Hall Addition which was built circa 1973. Lastly, the Public Safety Addition was built circa 1977 per available record drawings. The two additions flank the original Firehouse building to the North and the South as shown in figures 1 and 2.

Inspection included photo documentation of the masonry and floor slab defects internally and externally. Crack widths were measured as part of the photo documentation process. Locations of photos were documented and are shown in Figures 1 and 2. Additional Photos may be requested or may be viewed in Report provided by West Consultants, PLLC.

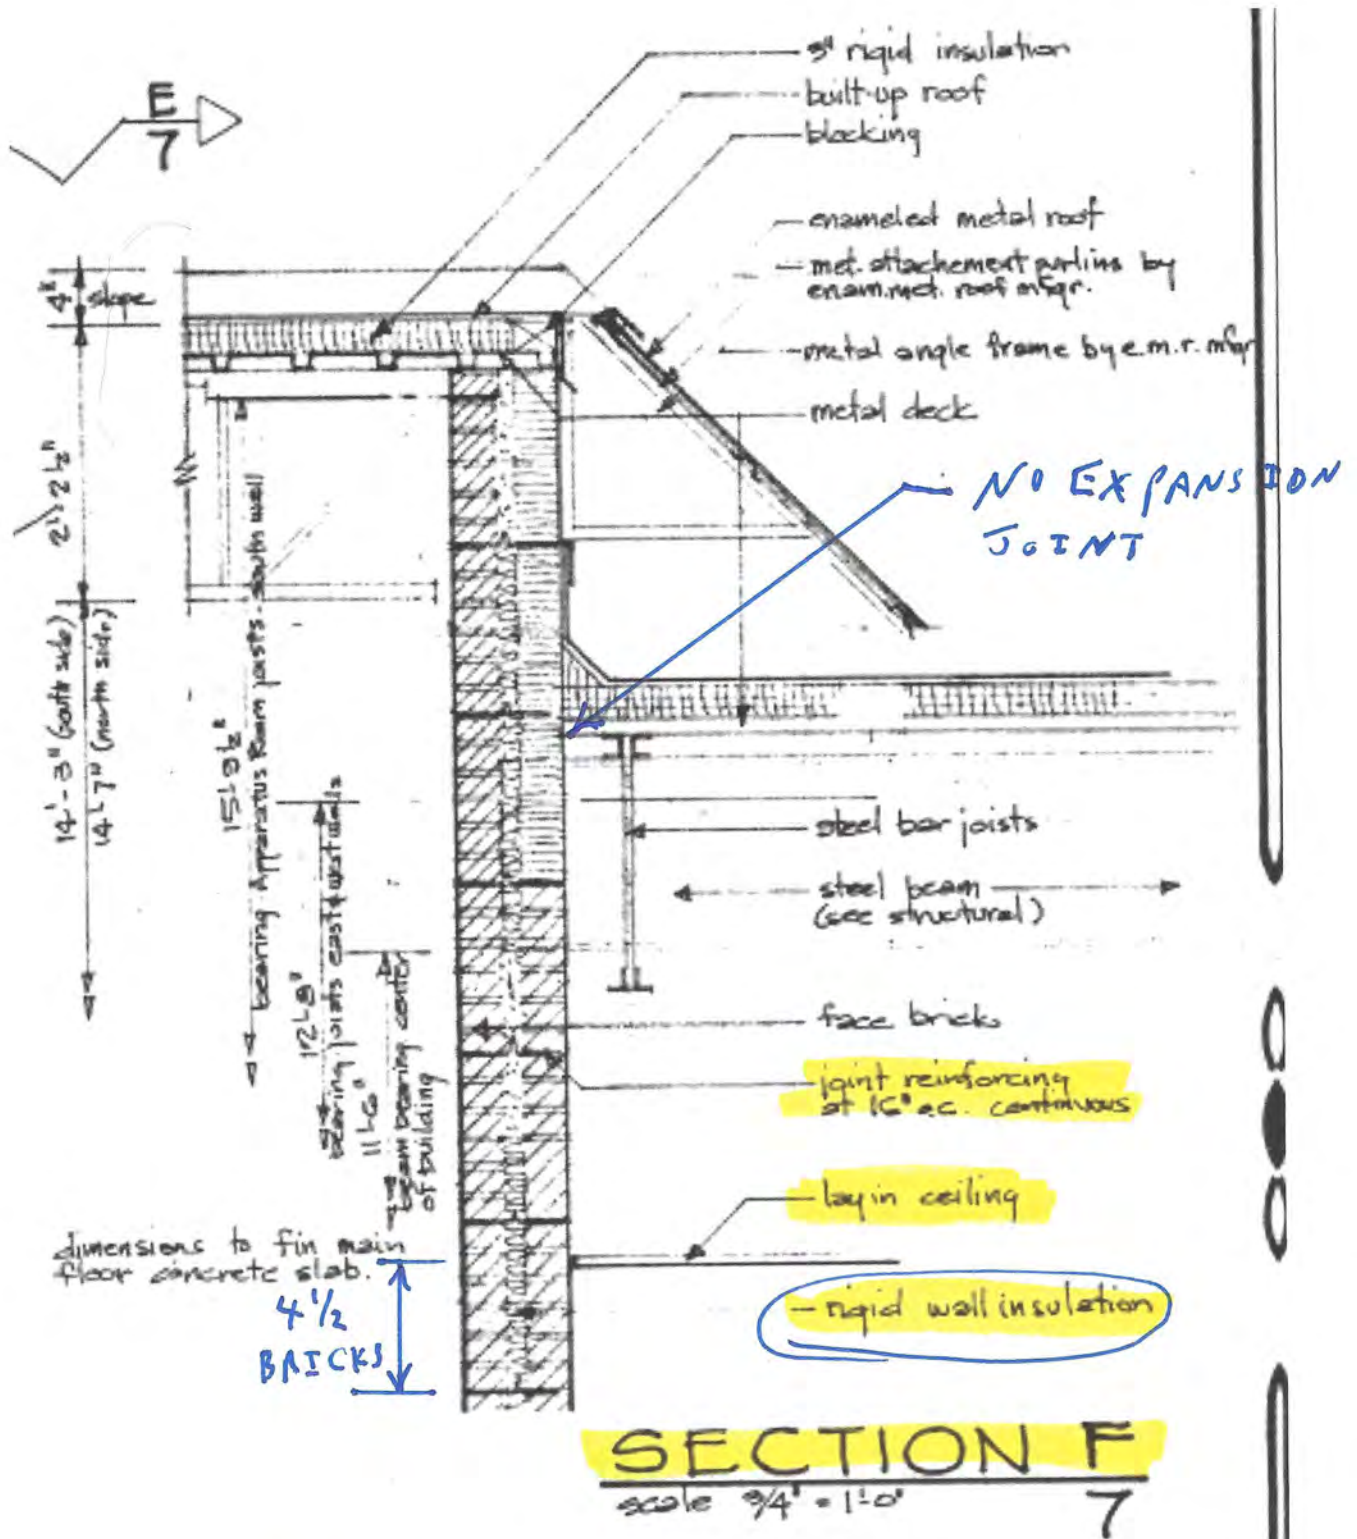
FIGURE 4
SECTION F

A horizontal crack runs virtually the entire perimeter of the building and is located approximately 4 ½ bricks below the drop ceiling on the east wall the south wall and part of the north wall per Photos 12 and 13. The west wall horizontal crack elevation varies to approximately 10 ½ bricks below the drop ceiling which is consistent with a horizontal joint reinforcing spacing of 16". Similarly, 4 ½ bricks below the drop ceiling is consistent with joint reinforcing detailed in Figure 4 per Record Drawings.

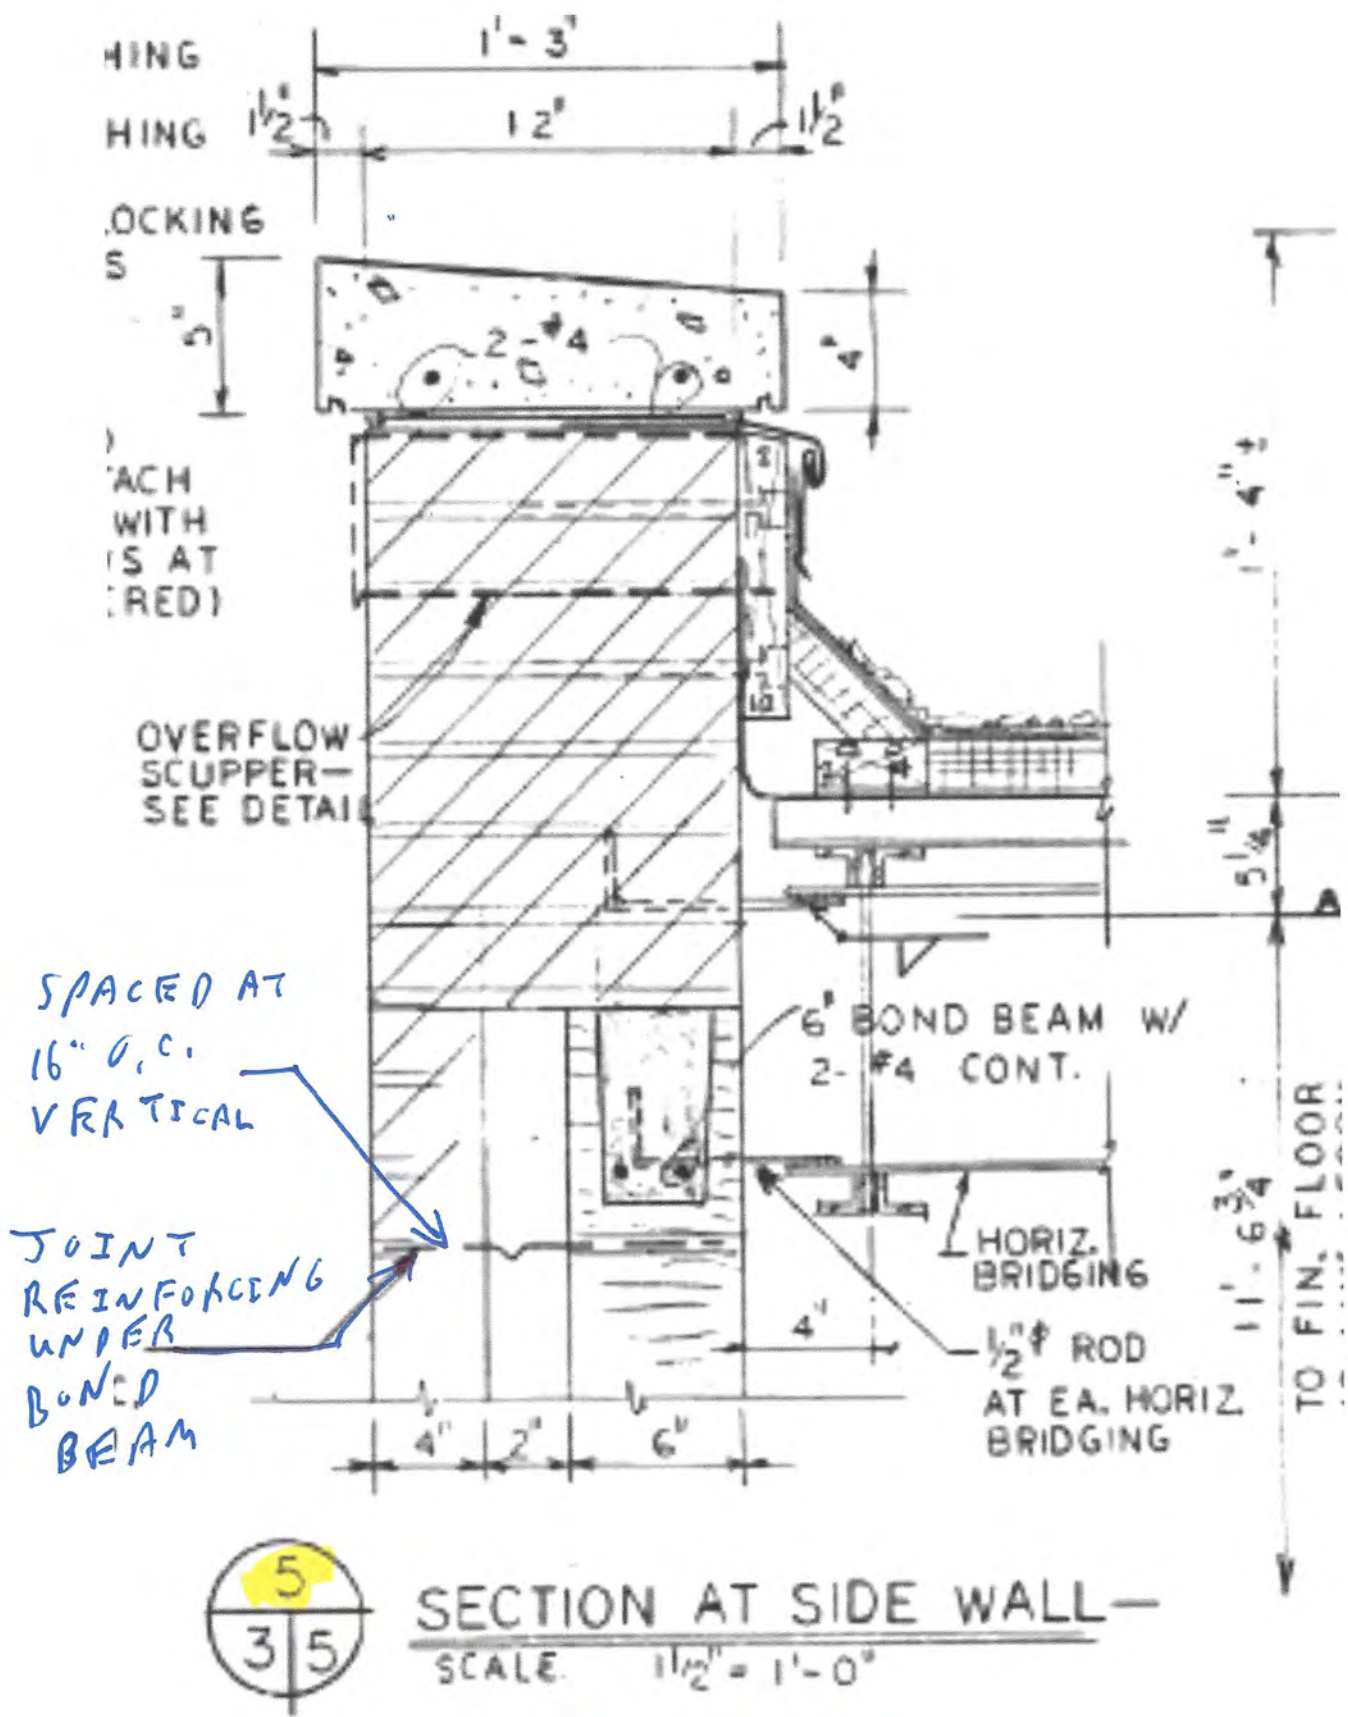
FIGURE 7
SECTION 5

The horizontal cracks are typically located at the approximate elevation of the bottom of the steel reinforced Bond Beam, see Photo 3 and 4 and Figure 7. This condition persists along the north exterior wall and east exterior wall. Per Figure 7 from the Town Hall record drawings, the joint at the bottom of the bond beam is located at the crack elevation. In addition, the presumed horizontal joint reinforcing elevation is at the joint at the bottom of the bond beam. Horizontal joint reinforcing and the infilled bond beam appear to create a stress concentration at that elevation with respect out of plane loading.

Outside, cracking is generally not apparent, but spalling is pervasive along the north exterior wall. The spalling is generally isolated to the masonry joints and is spaced at approximately 16" on center vertically. The spacing matches the joint reinforcing spacing detailed in Figure 7. It appears the steel joint reinforcing has corroded and spalled the joints (popped the mortar) due to expansive corrosion induced forces. Brick has also spalled in a few locations as shown in Photo 7. Buildings built circa the 1970's utilized joint reinforcing and walls ties that were not coated or galvanized. A short time later, galvanizing was introduced but was of a lesser quality when compared to modern hot dip galvanizing. It is reasonable to assume that this building built in 1973 utilized uncoated joint reinforcing and the apparent susceptibility to corrosion is the result. The joint reinforcing may have also been placed too close to the exterior mortar joint surface allowing for water to more quickly reach the susceptible steel.

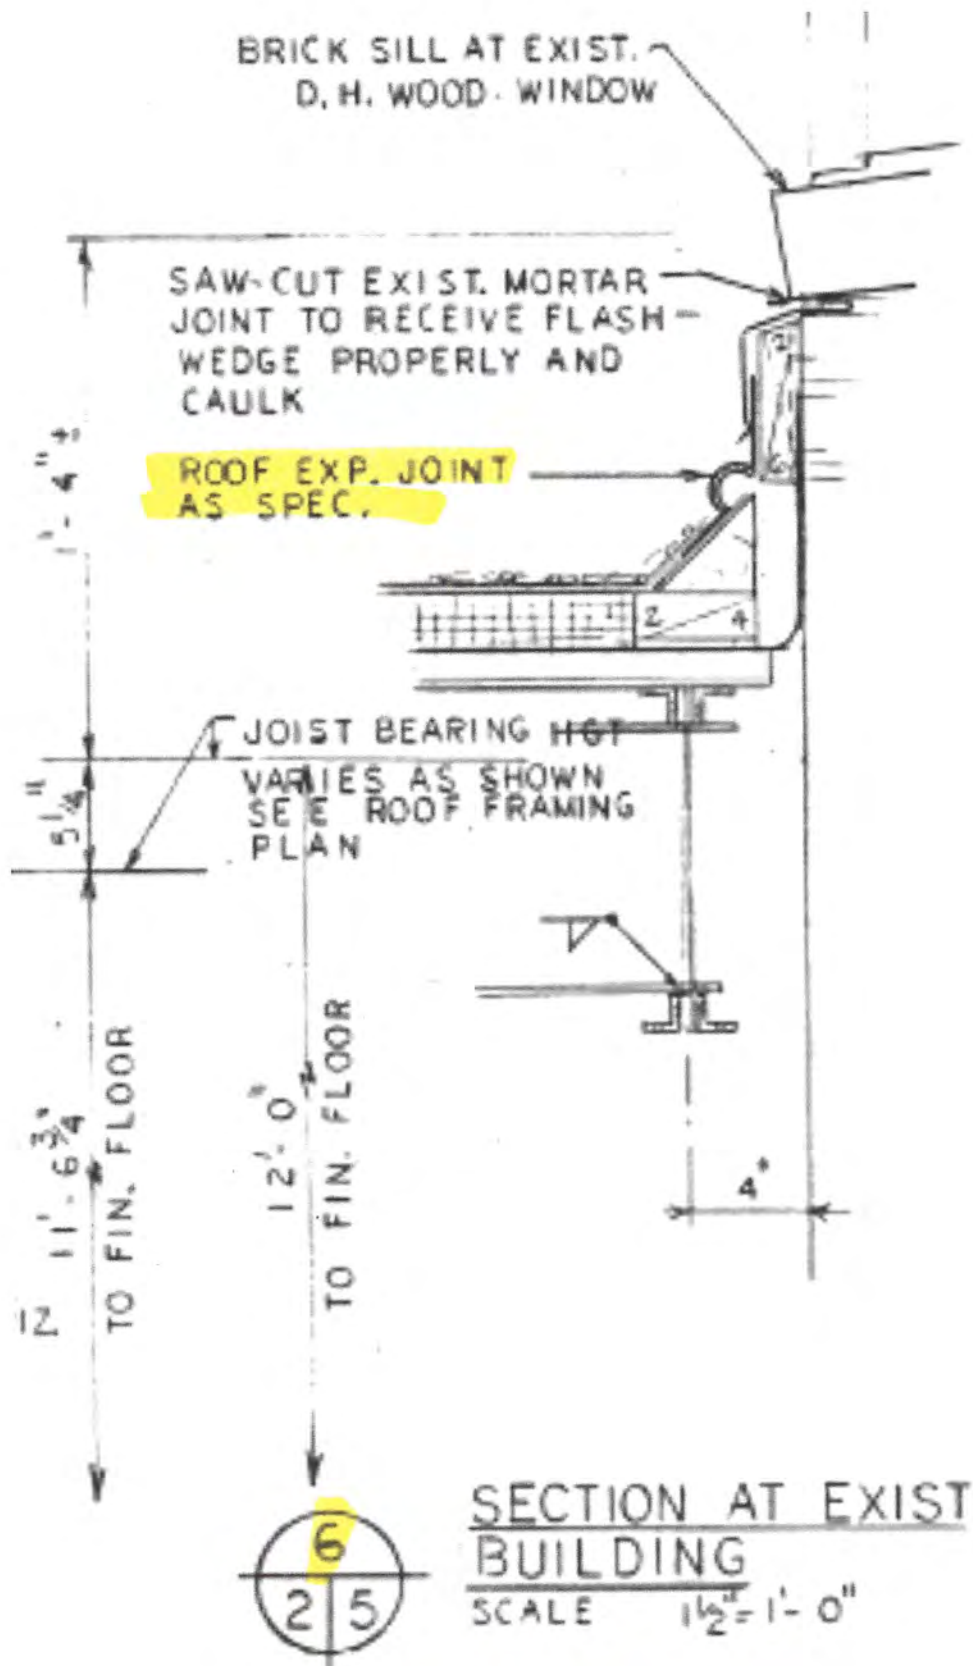
FIGURE 8

The roof was equipped with one expansion joint per record drawings and shown in attached Figure 8. The expansion joint is located along the south wall which is shared by the old previously existing Firehouse building. No expansion joints were provided, per record drawings, at either the east or west walls. It is clear that expansive forces should be expected in the east to west direction. It is less clear why expansive forces effected the horizontal crack in the north wall since expansion forces should have been partially alleviated by the joint at the south wall. It is possible the joint was either installed incorrectly or was less effective than the designer's intent.
