**Town of Valdese
Town Council Public Safety
Building Workshop
Old Rock School - Auditorium
400 Main St. W, Valdese
Tuesday, February 15, 2022
6:00 P.M.**

TOWN OF VALDESE PUBLIC SAFETY BUILDING EVALUATION

Version:	Final
Date of Issue:	February 10, 2022
Prepared By:	CBSA Architects
Prepared For:	Town of Valdese

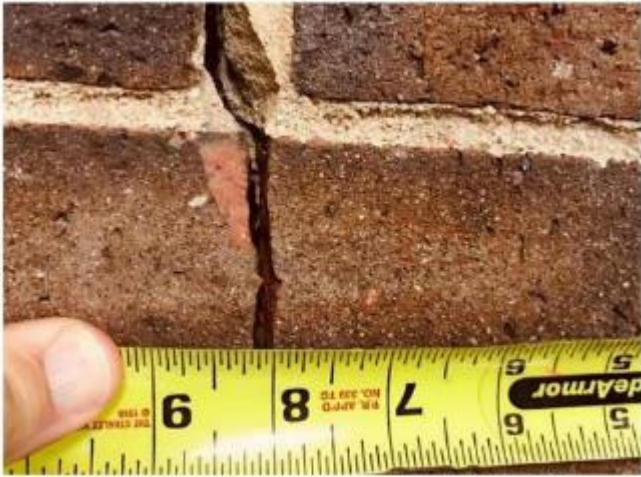
INTERIOR VERTICAL WALL CRACKS (POLICE)

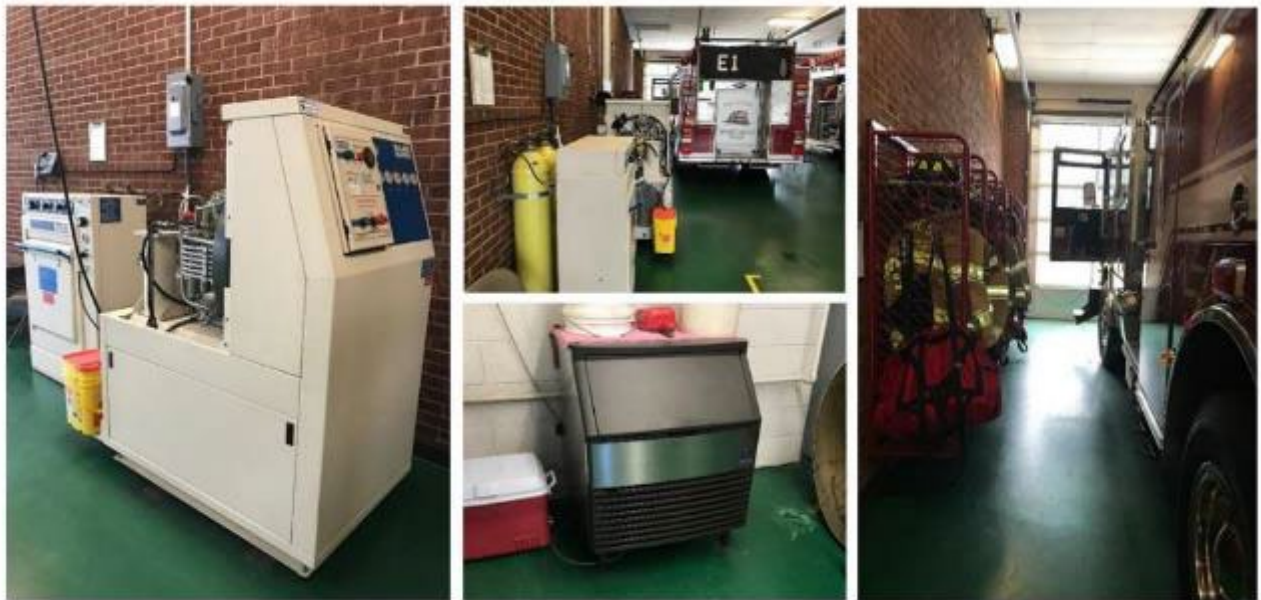
Health Risk:
Existing Condition

VEHICLE EXHAUST CONTAMINATION

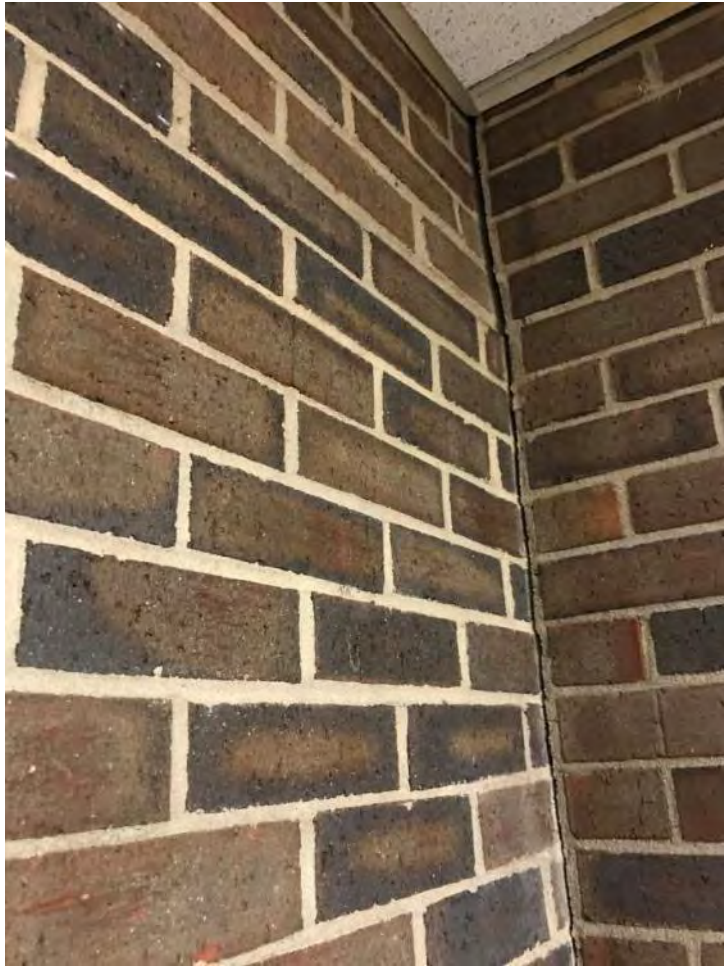
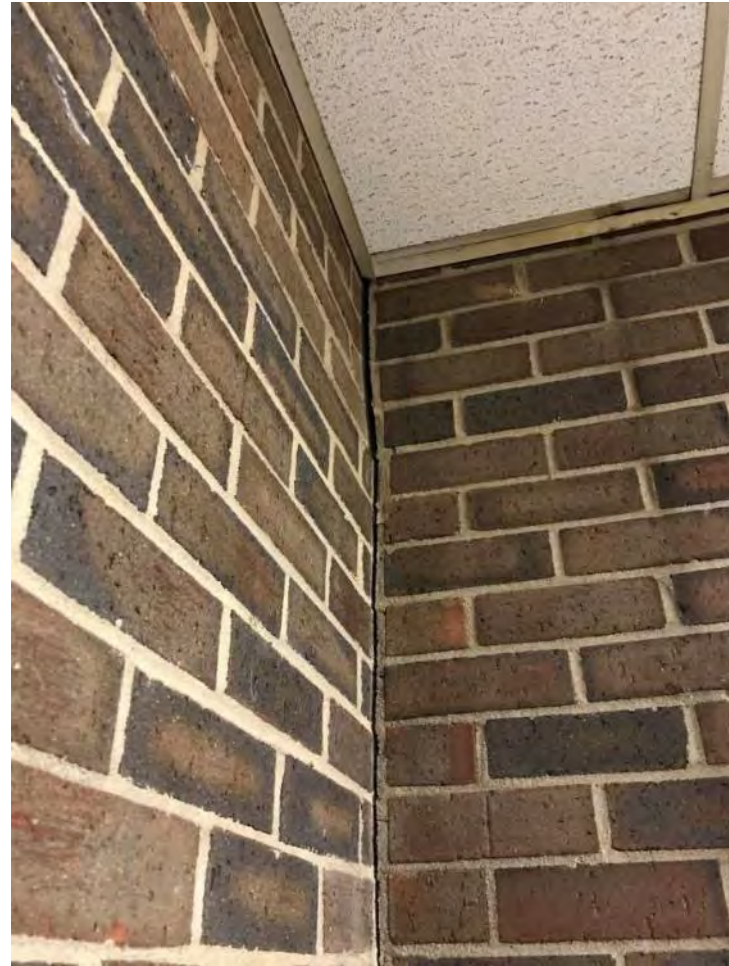
Interior Wall Displacement (Police)

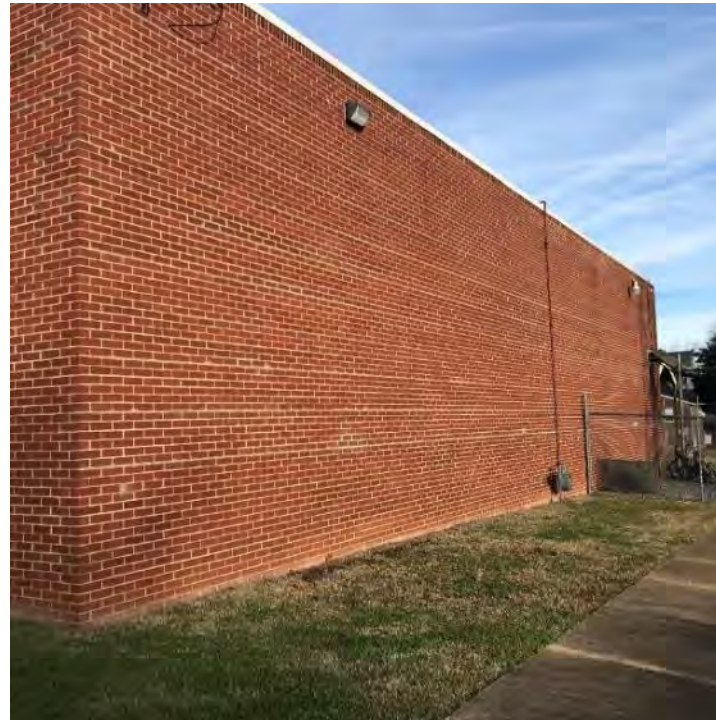
Exterior Horizontal Wall Crack Repair

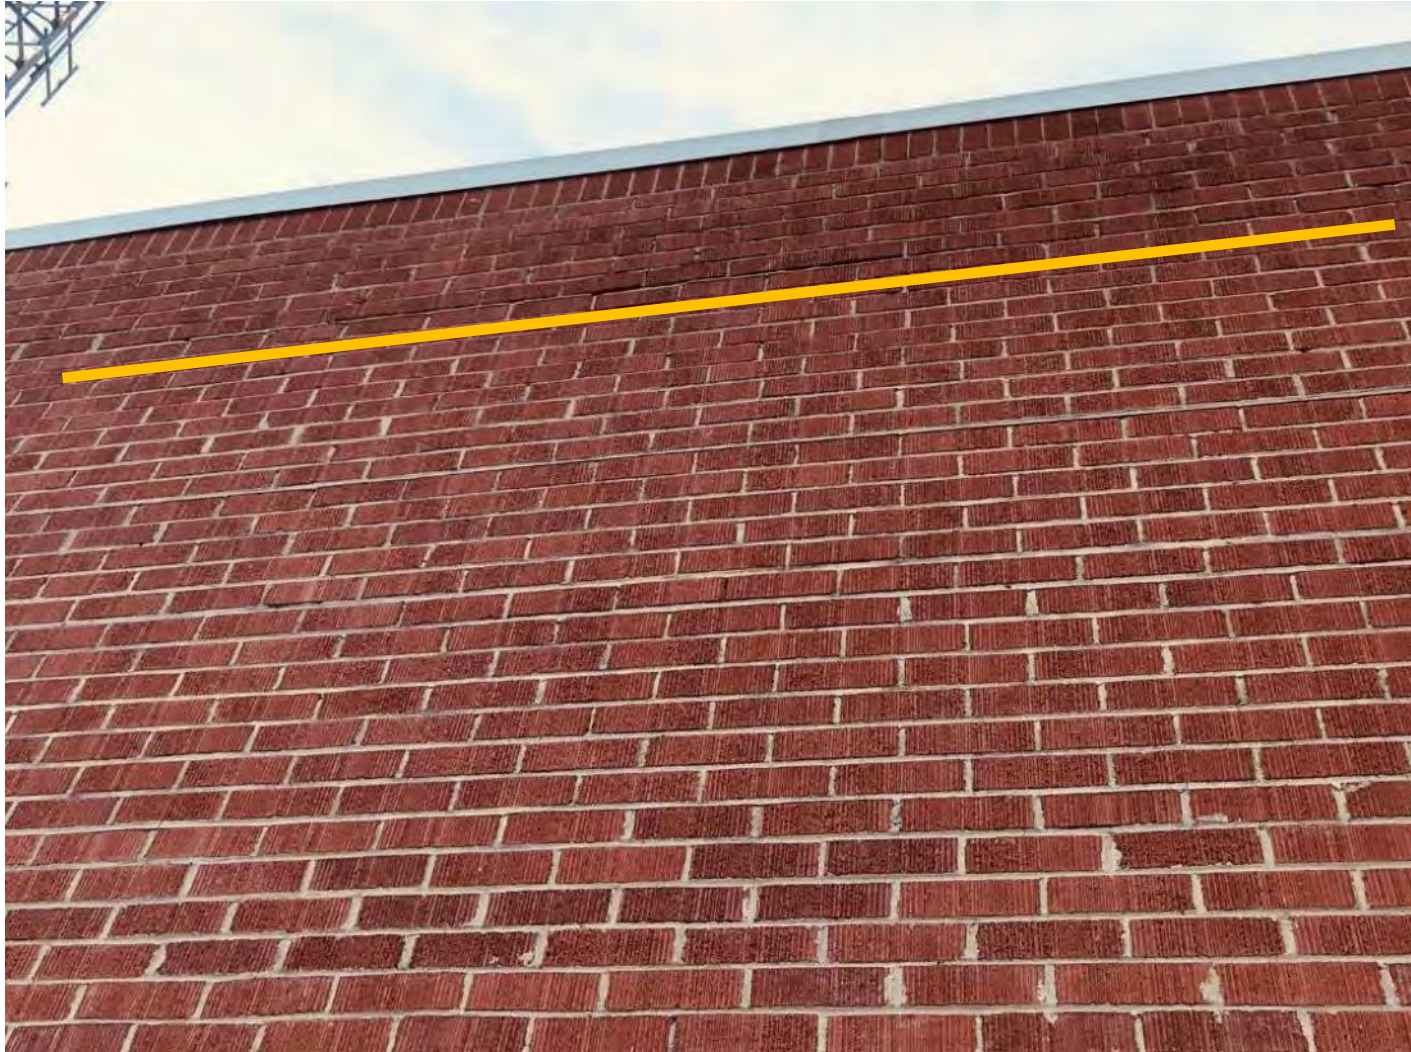
East Wall Parapet

Wall Repair

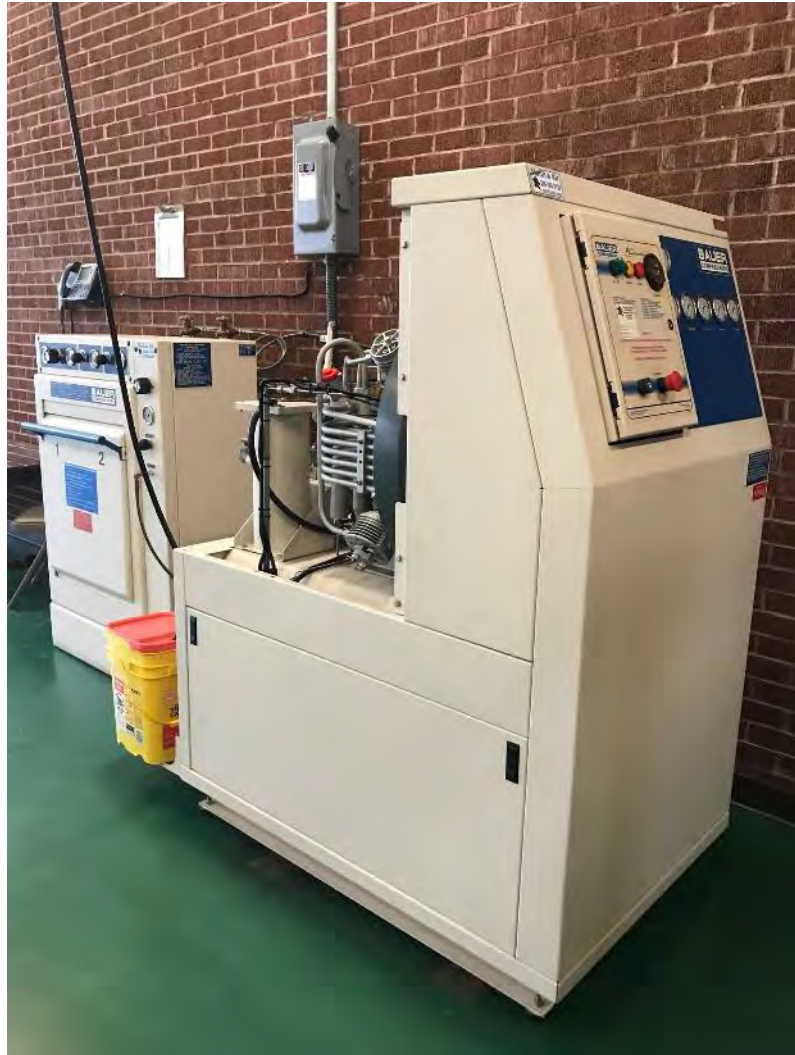
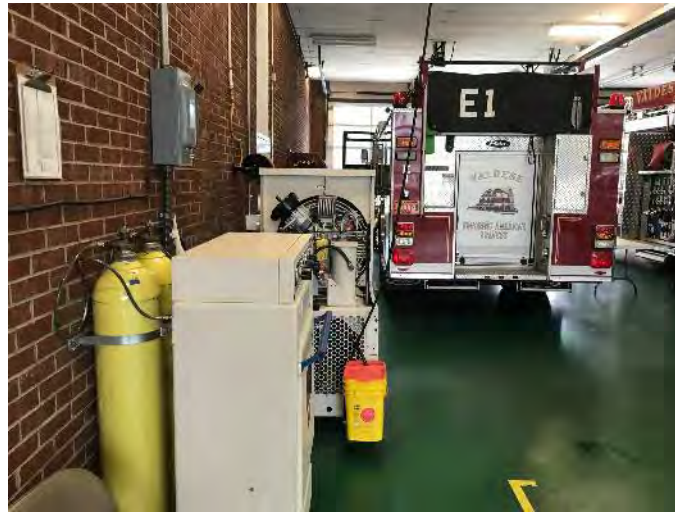
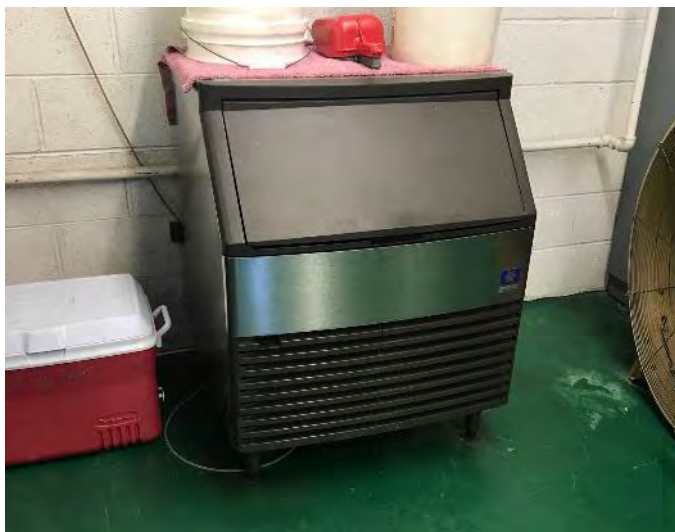
Vehicle Exhaust Contamination

- ❑ Turn-out gear storage within Apparatus Bay. ***Truck exhaust creates hazardous contaminants.***
- ❑ Lack of sufficient areas for Storage Support is ***forcing the diversion of some Apparatus equipment, materials and supplies to improvised locations, impairing operational efficiency.***
